KIRKLAND PARKS & COMMUNITY SERVICES

Shoreline Structures Assessment Kirkland, Washington

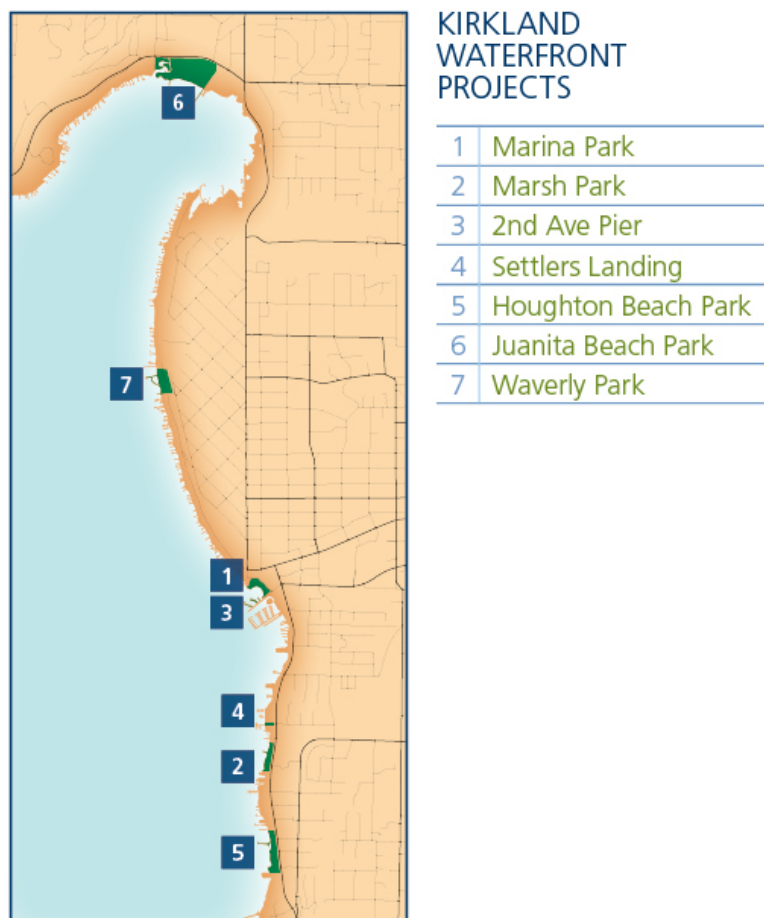
Figure 1. Location of Kirkland Parks in Condition Assessment.

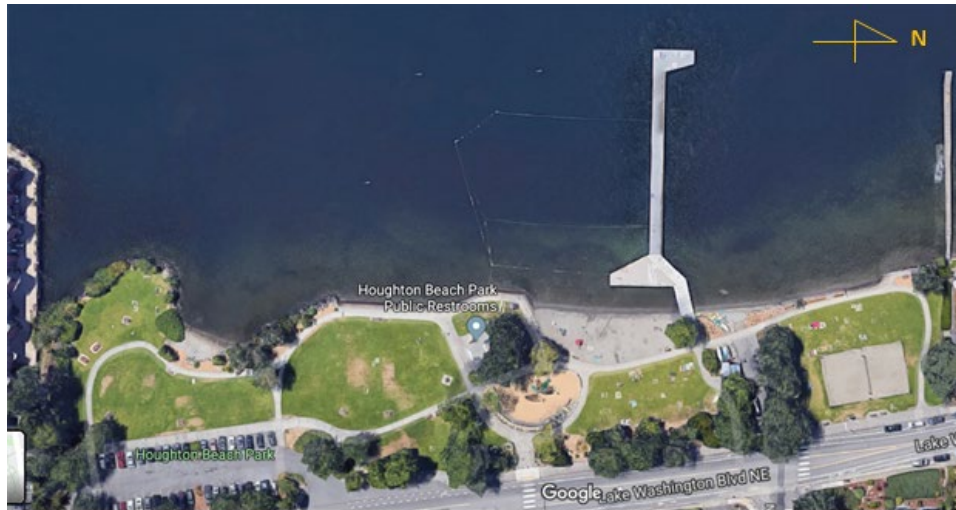
Figure 2. Houghton Beach Park Aerial.

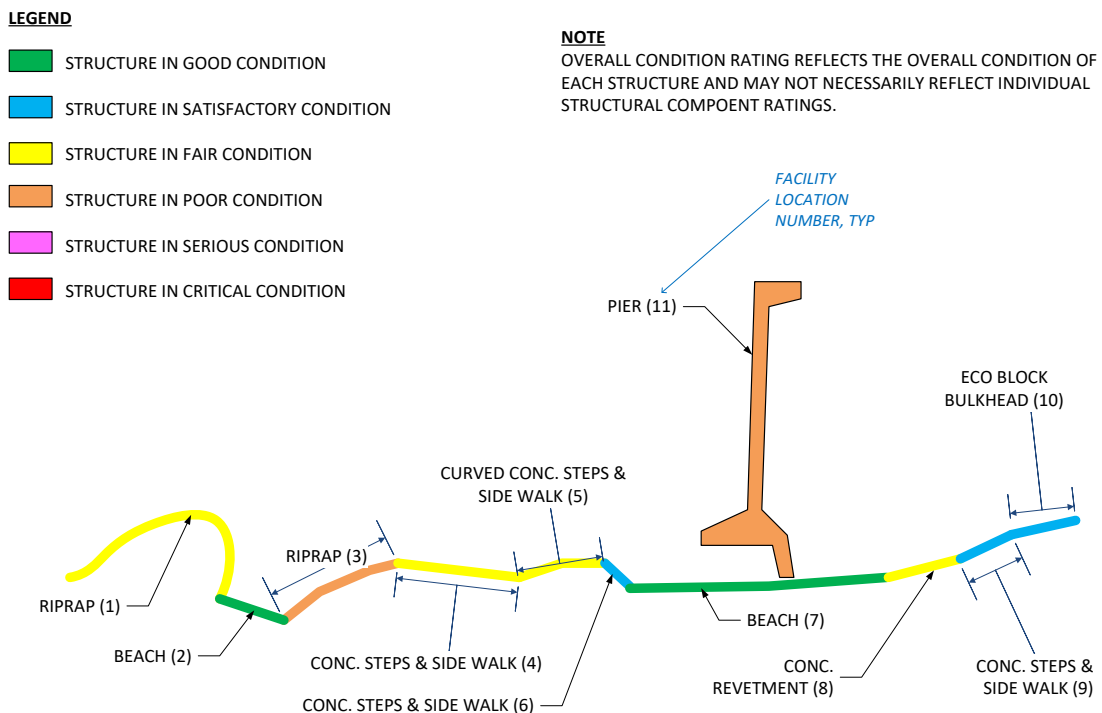
Figure 3. Houghton Beach Park Overall Condition.

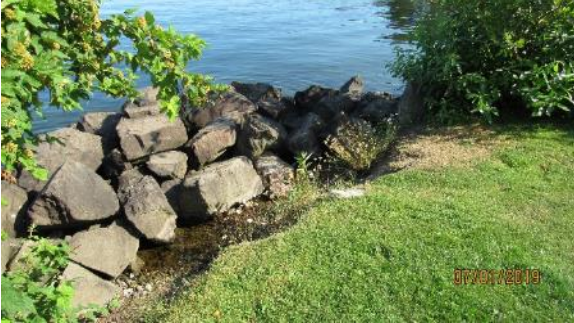
<p><u>Existing Condition</u></p> <ul style="list-style-type: none"> • Approximately 200 feet of riprap shoreline. • Large (8" to 3') riprap with large voids. • Fair condition with evidence of wave erosion behind riprap at point. Approx. 6'x2'x1' deep. • Erosion is only affecting landscaped (grass) area. <p><u>Recommended Repairs and Remaining Life</u></p> <ul style="list-style-type: none"> • Install quarry spalls to fill large voids in riprap and install geotextile fabric and additional quarry spalls or granular material behind riprap. • 15 years with current condition (30 or more years of service life after repairs).
FACILITY LOCATION: 2

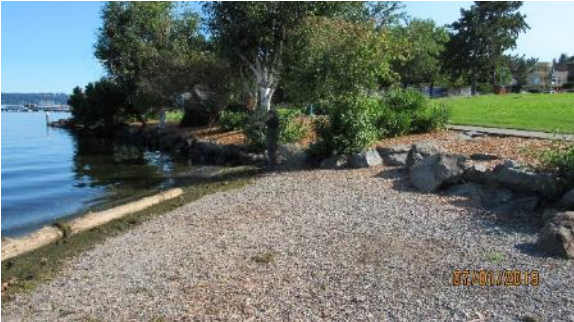
<p><u>Existing Condition</u></p> <ul style="list-style-type: none"> • Approximately 50 feet of shoreline. • Gravel beach with anchor logs at water's edge. • Low to no slope beach. • Riprap boulders provide separation between landscaping and beach areas. • Good condition with no observed deficiencies. <p><u>Recommended Repairs and Remaining Life</u></p> <ul style="list-style-type: none"> • No recommended repairs. • 30 or more years of service life.

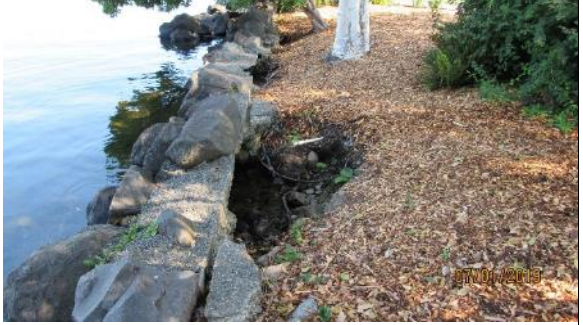
<p><u>Existing Condition</u></p> <ul style="list-style-type: none"> • Approximately 130 feet of shoreline. • Large (8" to 3') riprap with large voids. Portion of upper riprap partially encased in concrete. • Poor condition with evidence of wave erosion (sinkholes) behind riprap at five locations with sinkholes approx. 4'x2'x2' deep each. • Irrigation piping and spray head exposed at one sinkhole location (piping appears intact). <p><u>Recommended Repairs and Remaining Life</u></p> <ul style="list-style-type: none"> • Install quarry spalls to fill large voids in riprap and install geotextile fabric and additional quarry spalls or granular material behind riprap. • 5 years with current condition (30 or more years of service life after repairs).

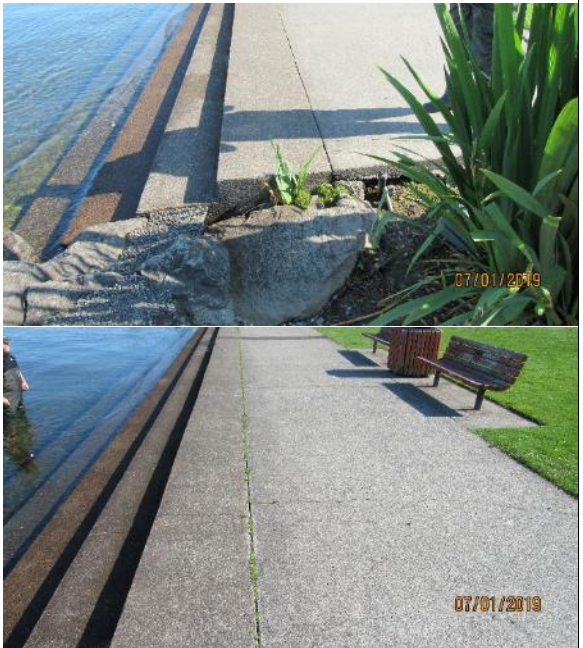
<p><u>Existing Condition</u></p> <ul style="list-style-type: none"> • Approximately 100 feet of shoreline. • The south end of the sidewalk next to the steps is undermined (approx. 3" tall), and the sidewalk corner is cracked. This may be partially due to a sprinkler head being located here as well. • Sidewalk is in fair condition overall with intermittent cracking (1/8" max). • Steps are in fair condition overall with intermittent cracking (1/8" to 1/4") and some spalling of step edges. No undermining at toe observed. <p><u>Recommended Repairs and Remaining Life</u></p> <ul style="list-style-type: none"> • Repair sidewalk by removing cracked corner/edge and installing thickened edge with new concrete. • Repair cracks and spalls. • 15 years with current condition (25 or more years of service life after repairs).

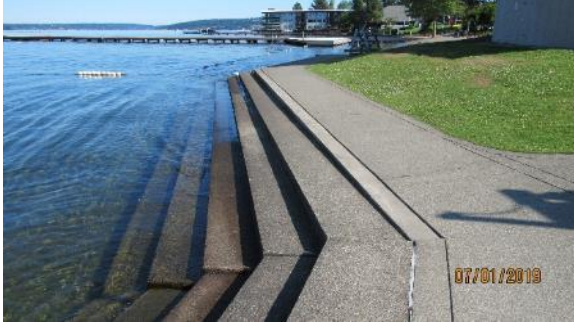
<p><u>Existing Condition</u></p> <ul style="list-style-type: none"> • Approximately 80 feet of shoreline. • The toe of the steps is undermined uniformly approximately 2 inches. • Sidewalk and steps are in fair condition overall with intermittent cracking (1/8" to 1/4") approx. every 5 feet and some spalling of step edges. Large spall at north end on bottom step (approx. 1'x1'). • Steps appear to have settled approximately 1 inch. <p><u>Recommended Repairs and Remaining Life</u></p> <ul style="list-style-type: none"> • Repair cracks and spalls. • 15 years with current condition (25 or more years of service life after repairs).

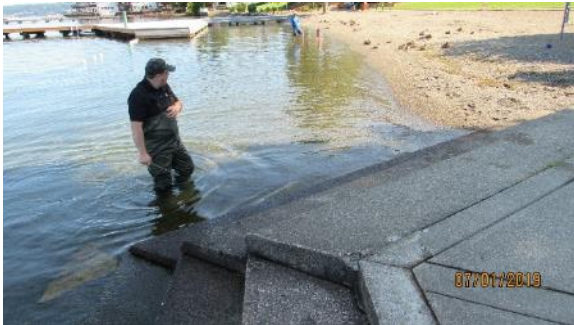
<p><u>Existing Condition</u></p> <ul style="list-style-type: none"> • Approximately 30 feet of shoreline. • Sidewalk and steps are in satisfactory condition overall with minor cracking. Spall and associated cracking at SE intersection of steps and sidewalk. • No undermining of toe observed. <p><u>Recommended Repairs and Remaining Life</u></p> <ul style="list-style-type: none"> • Repair cracks and spalls • 20 years with current condition (25 or more years of service life after repairs).

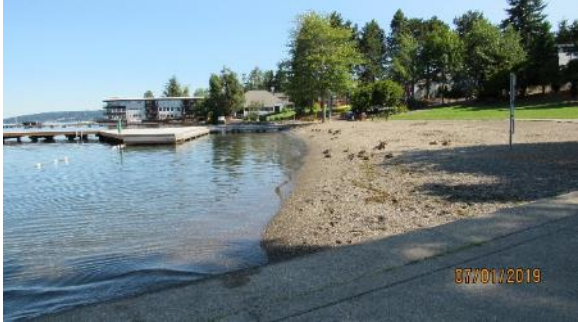
<p><u>Existing Condition</u></p> <ul style="list-style-type: none"> • Approximately 240 feet of shoreline. • Gravel beach with low slope. • Beach north of dock has anchor logs at water's edge. • Good condition with no observed deficiencies. Note that PVC drain pipe is filled with beach material. <p><u>Recommended Repairs and Remaining Life</u></p> <ul style="list-style-type: none"> • No recommended repairs. • 30 or more years of service life.

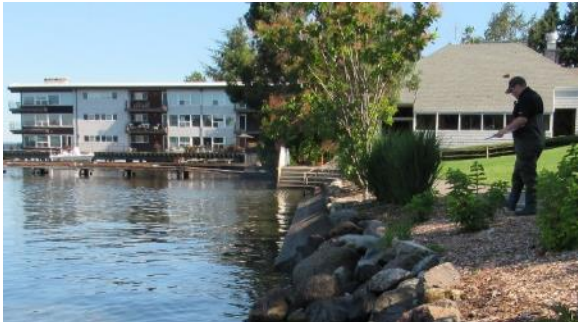
<p><u>Existing Condition</u></p> <ul style="list-style-type: none"> • Approximately 60 feet of shoreline. • Revetment is in fair condition overall with minor cracking (3 locations) and spalling. • No undermining of toe observed. <p><u>Recommended Repairs and Remaining Life</u></p> <ul style="list-style-type: none"> • Repair cracks and spalls. • 15 years with current condition (25 or more years of service life after repairs)

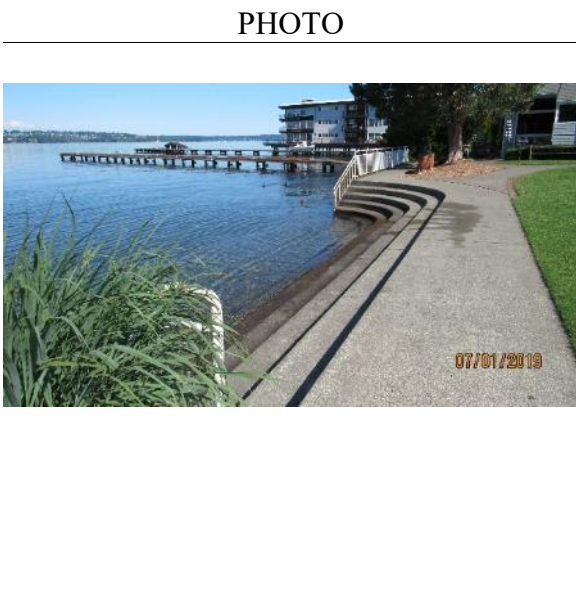
EXISTING CONDITION / RECOMMENDATIONS

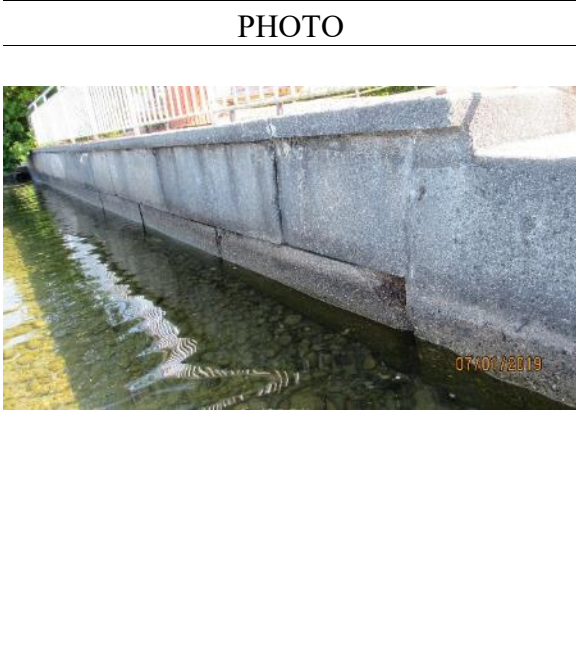
EXISTING CONDITION / RECOMMENDATIONS

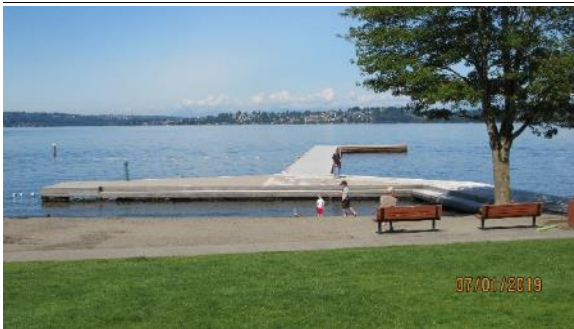
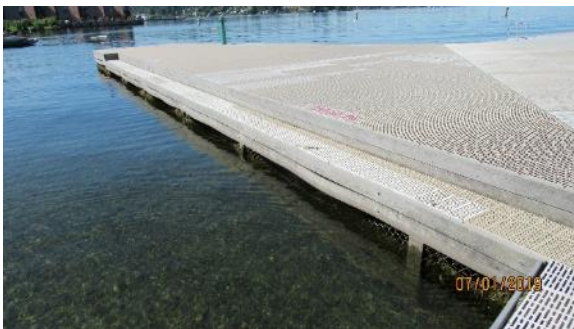
EXISTING CONDITION / RECOMMENDATIONS

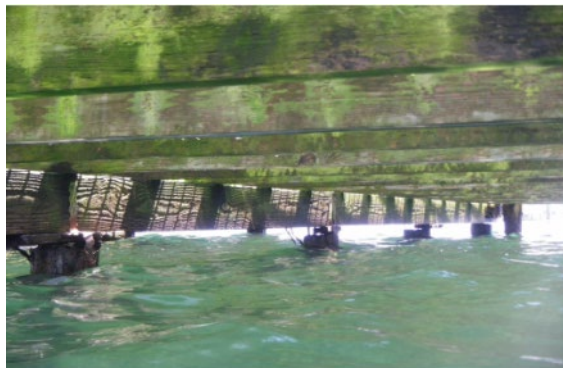
EXISTING CONDITION / RECOMMENDATIONS

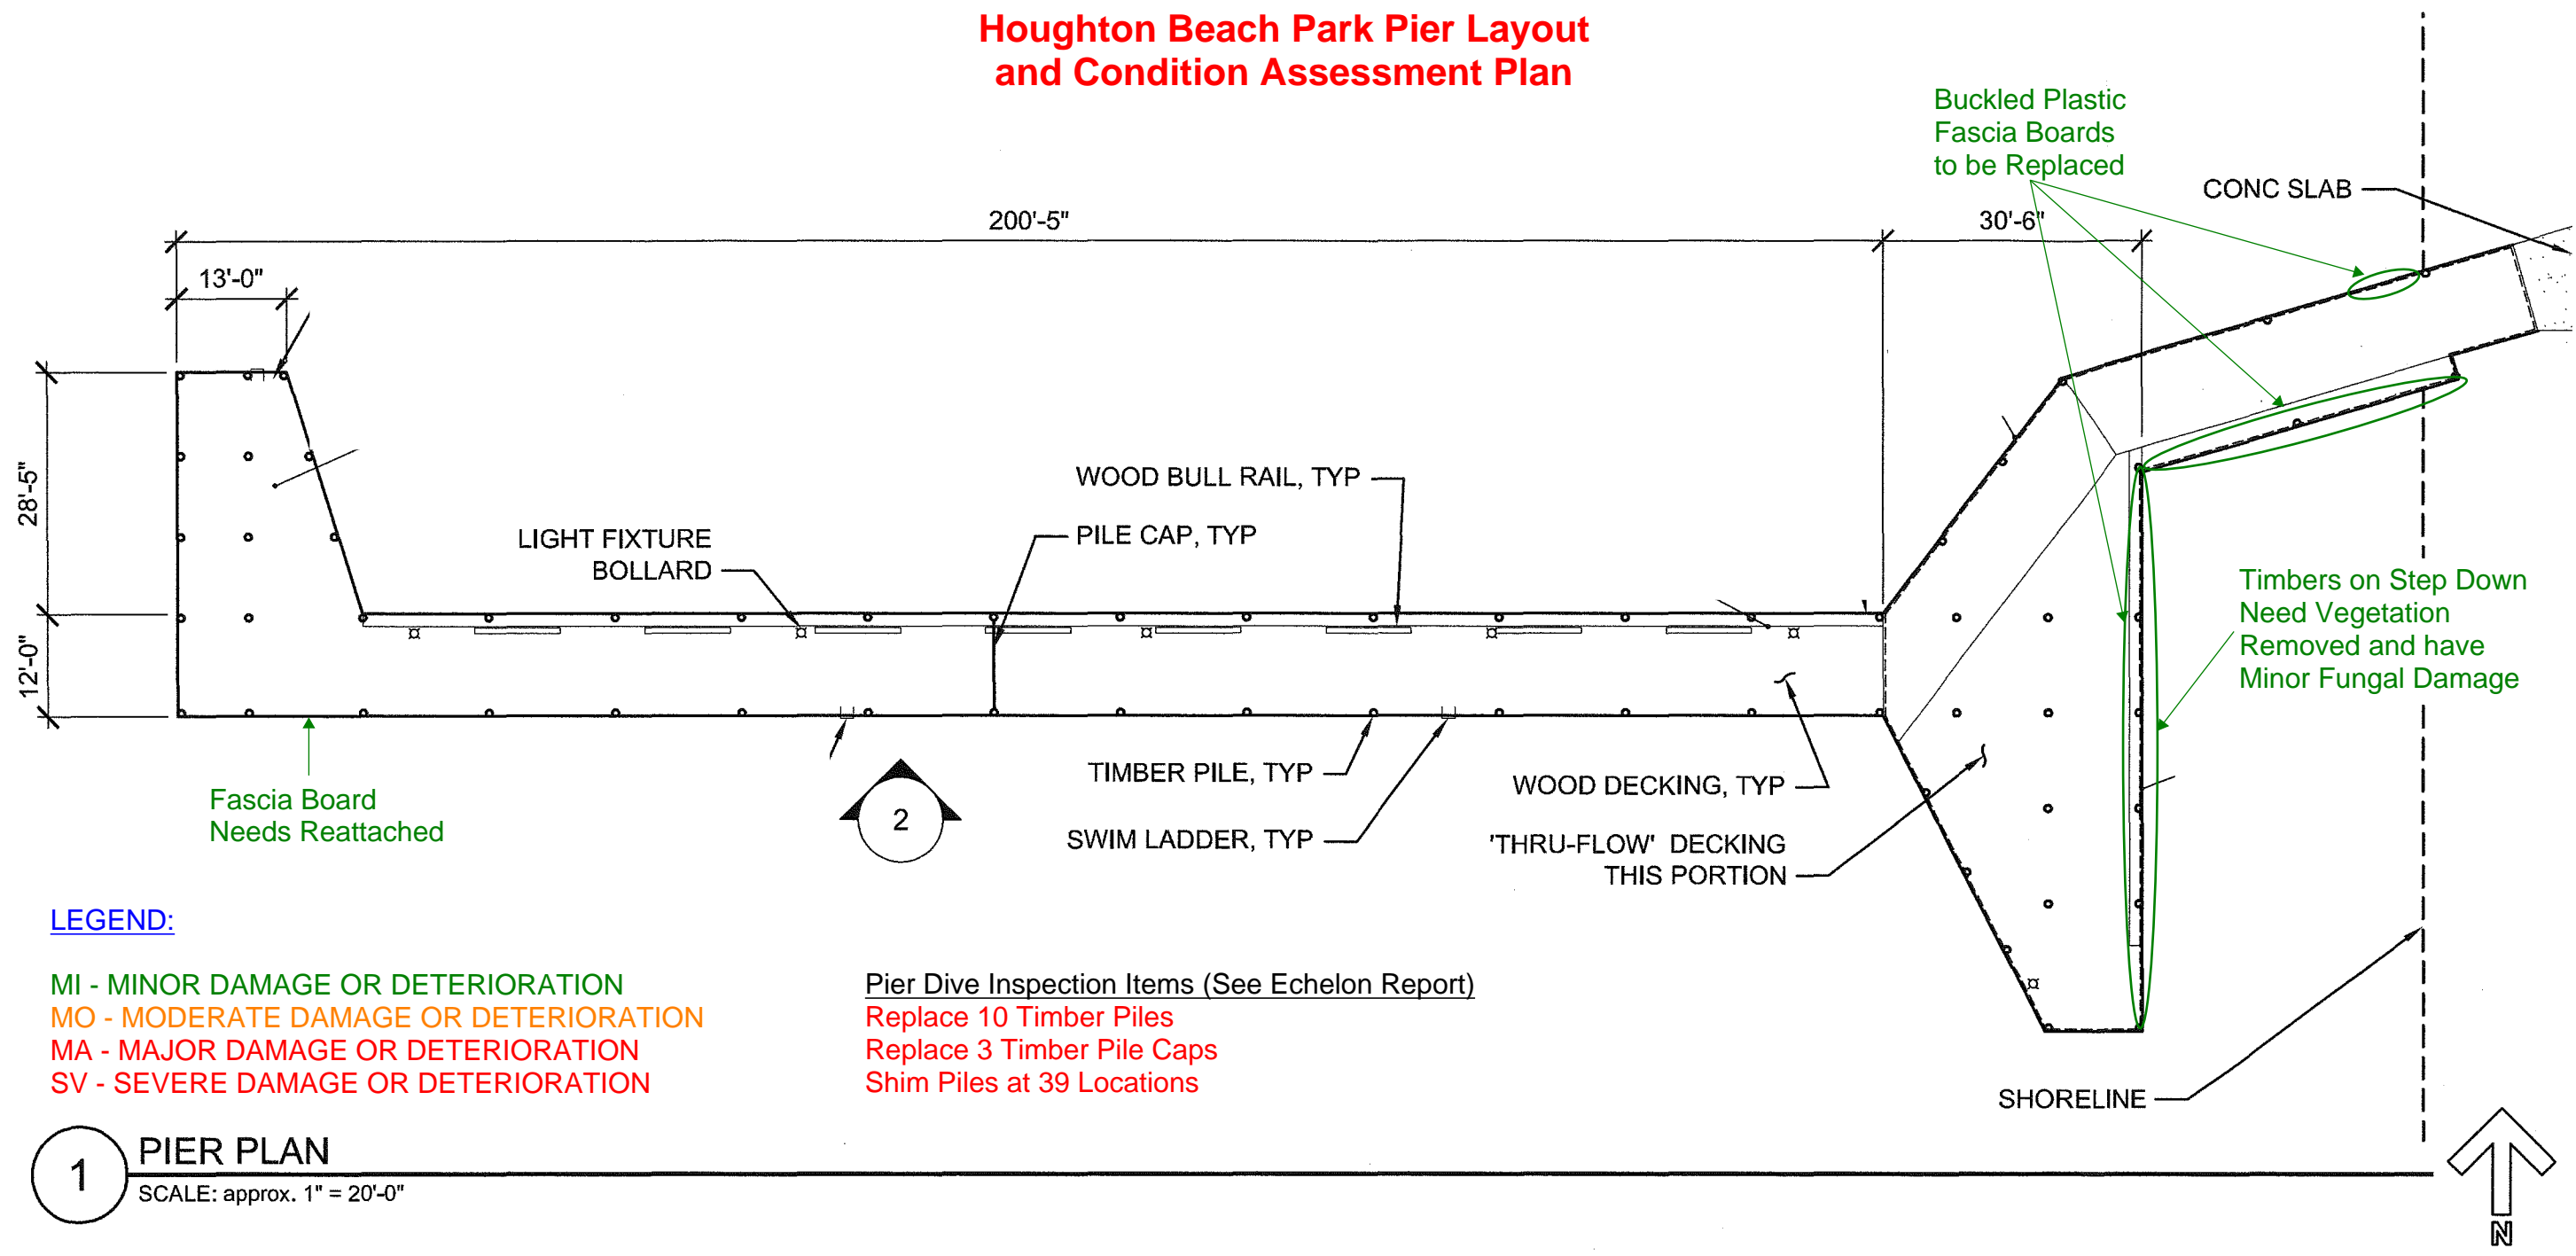
Houghton Beach Park Pier Layout and Condition Assessment Plan

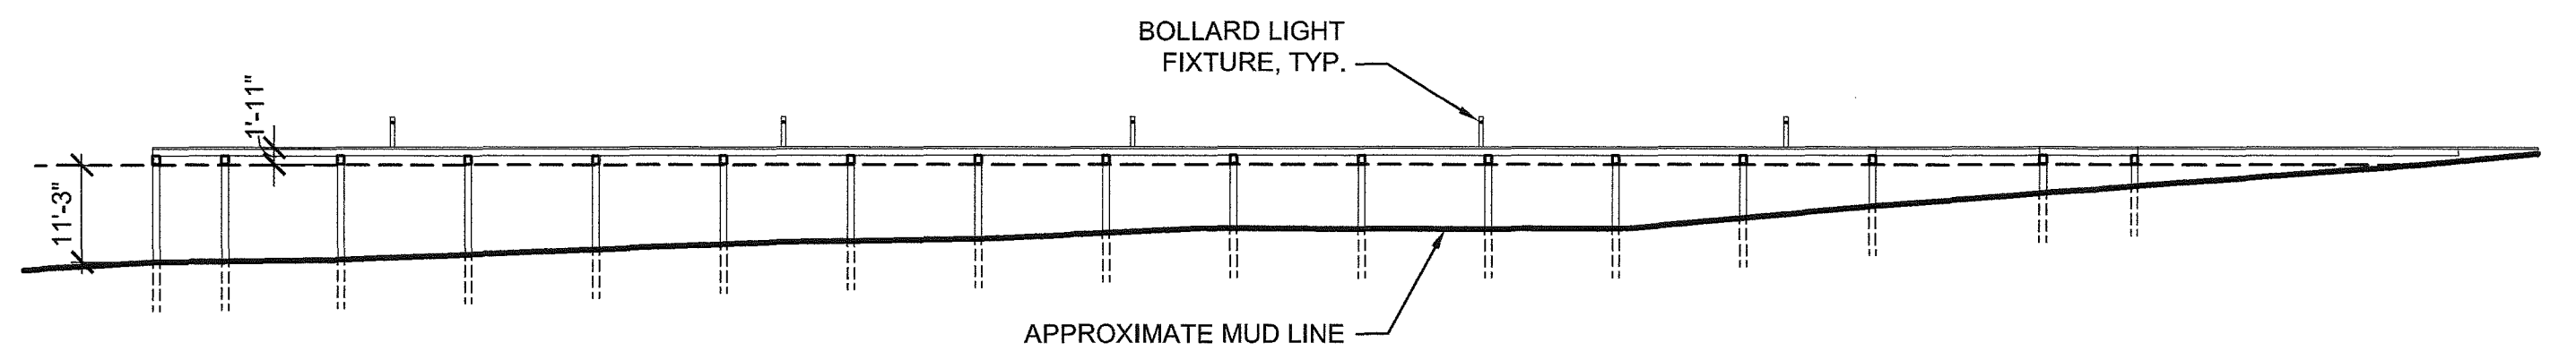
- Pier Dive Inspection Items (See Echelon Report)**
- Replace 10 Timber Piles
 - Replace 3 Timber Pile Caps
 - Shim Piles at 39 Locations

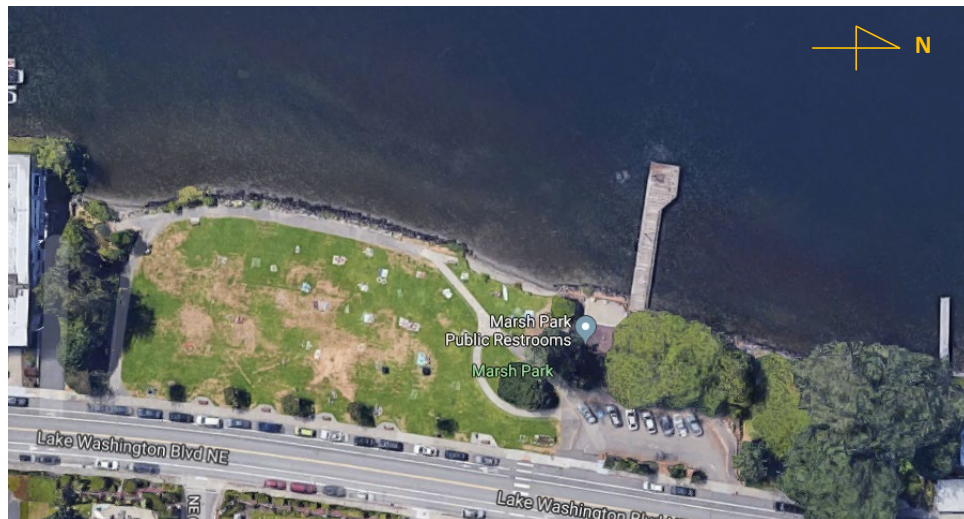
Figure 5. Marsh Park Aerial.

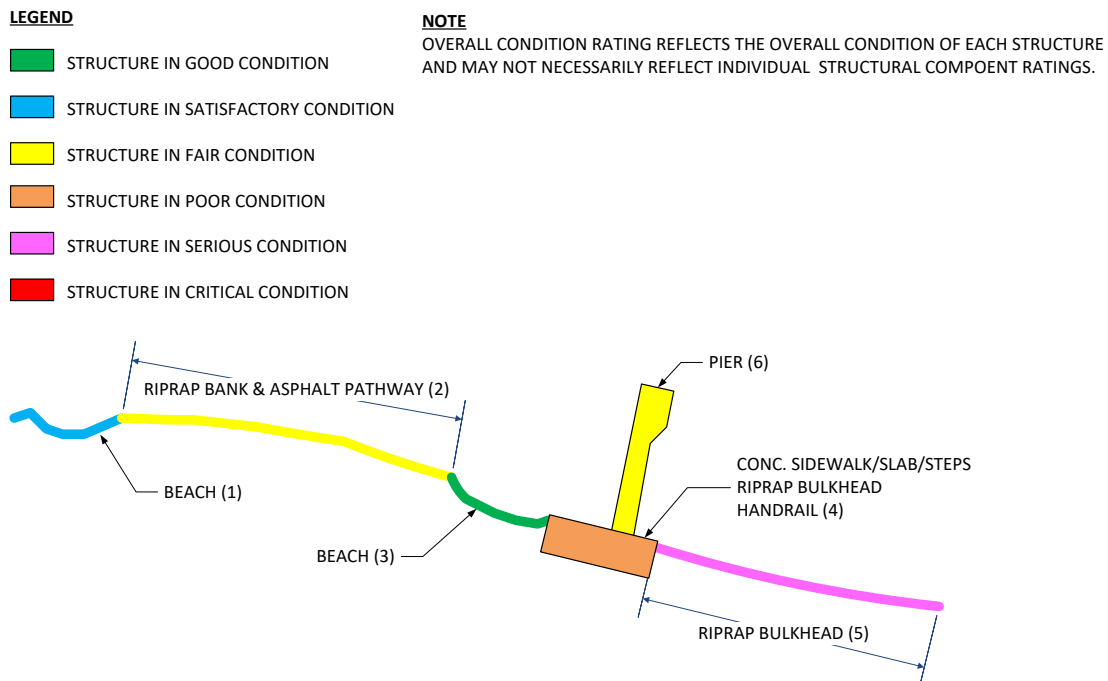
Figure 6. Marsh Park Overall Condition.

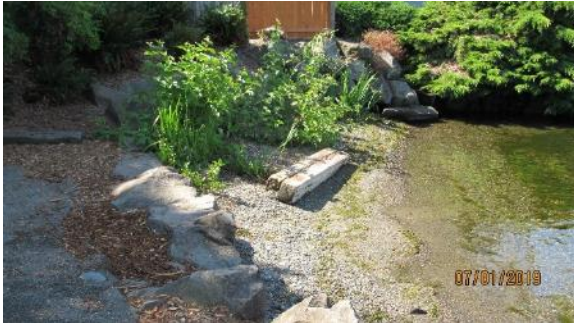
<p><u>Existing Condition</u></p> <ul style="list-style-type: none"> • Approximately 40 feet of shoreline. • Gravel pocket beach with low slope. • Riprap boulders provide separation between landscaping and beach areas. • Erosion of asphalt pathway edge at north side of beach on east side of riprap (approx. 6'x 2' wide). <p><u>Recommended Repairs and Remaining Life</u></p> <ul style="list-style-type: none"> • Patch asphalt pathway to prevent erosion / undermining and eliminate possible trip hazards. • 30 or more years of service life.

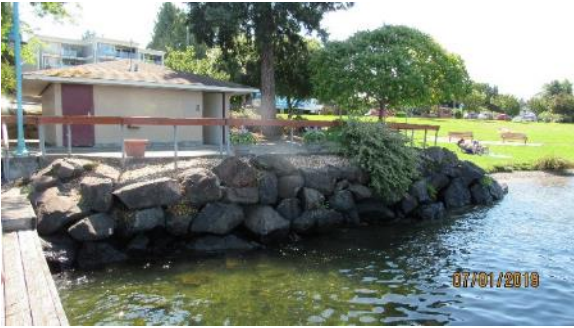
<p><u>Existing Condition</u></p> <ul style="list-style-type: none"> • Approximately 50 feet of riprap bulkhead. • Large (1.5' to 3') riprap with large voids. • Fair condition with evidence of previous settlement. Several boulders from wall on lakebed. • No filter fabric or smaller granular material. <p><u>Recommended Repairs and Remaining Life</u></p> <ul style="list-style-type: none"> • Install quarry spalls to fill large voids in riprap and install geotextile fabric and additional quarry spalls or granular material behind riprap. • 10 yrs (current), 30 yrs (repaired).

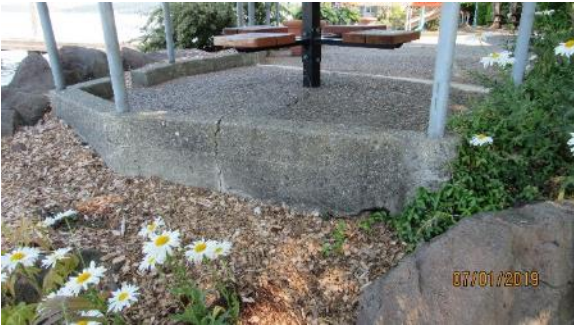
<p><u>Existing Condition</u></p> <ul style="list-style-type: none"> • Concrete slab with thickened curbs. Slab has settled in past and been patched. • Some cracking (1/2" max) and large spalls at north steps. Spalls in curbs near SE corner of dock steps. <p><u>Recommended Repairs and Remaining Life</u></p> <ul style="list-style-type: none"> • Repair cracks. • 10 yrs (current), 30 yrs (repaired).

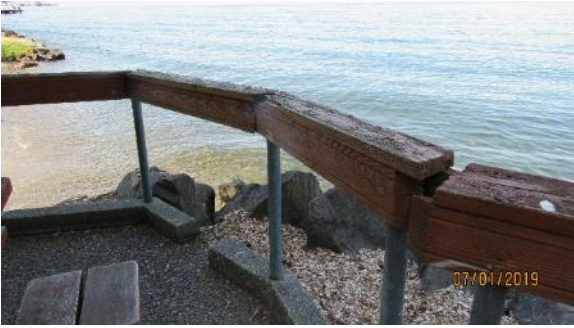
<p><u>Existing Condition</u></p> <ul style="list-style-type: none"> • Galvanized posts in fair condition with surface rust observed. • Timber handrail in critical condition and severely deteriorated due to fungal decay and weathering. <p><u>Recommended Repairs and Remaining Life</u></p> <ul style="list-style-type: none"> • Remove rust and paint posts with zinc paint. • Install new handrails. • 0 yrs (current), 20 yrs (repaired)

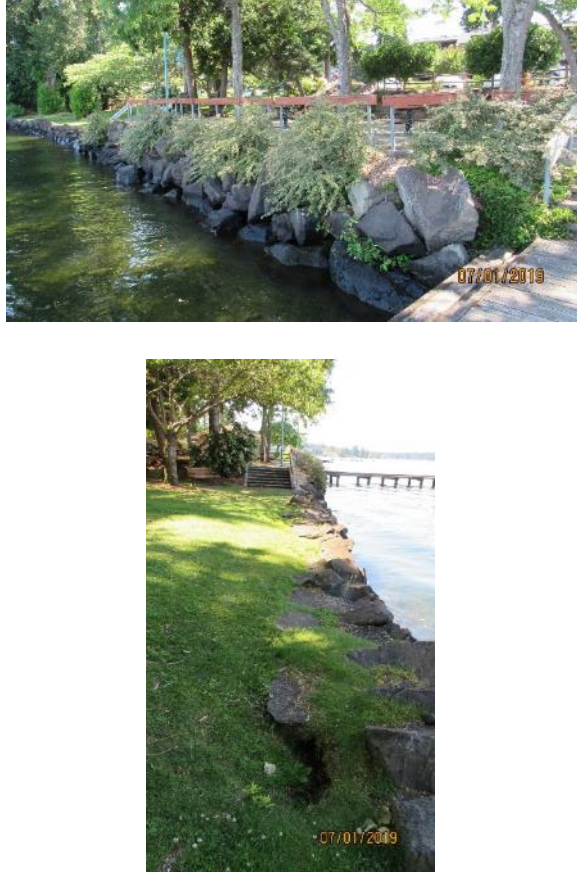
PHOTO	EXISTING CONDITION / RECOMMENDATIONS

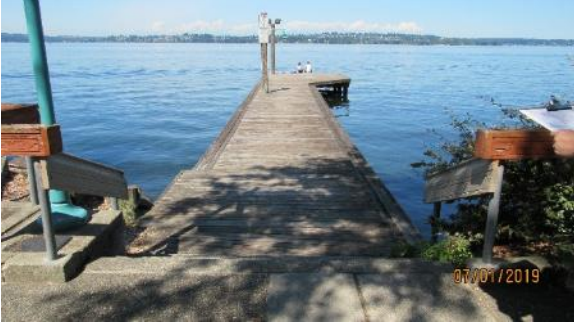
<p><u>Existing Condition</u></p> <ul style="list-style-type: none"> • Typical construction of 2x8 timber decking over timber stringers and blocking. Nail heads loose. • Timber decking on main pier is weathered and has some fungal decay (fair condition). • Timber decking on step downs is weathered and has approx. 25% fungal damage (poor condition). • Galvanized tie-up rings are only lag bolted into timbers but are secure (satisfactory condition). • Light fixture cover is damaged (fair condition). • Aluminum swim ladders is bent (fair condition). <p><u>Recommended Repairs and Remaining Life</u></p> <ul style="list-style-type: none"> • Replace decking with timber or grated decking. • Fix swim ladder and light fixture. • 10 yrs (current), 25 yrs (repaired).

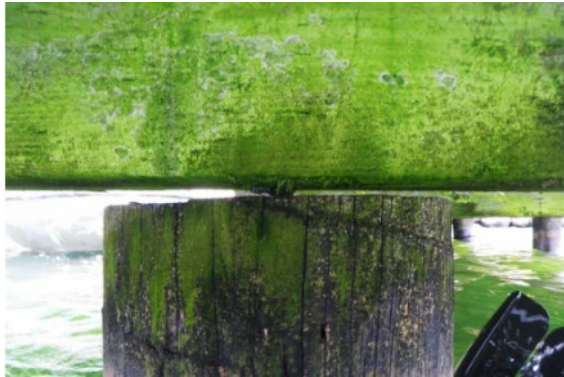
<p><u>Existing Condition</u></p> <ul style="list-style-type: none"> • 23 piles: 12-14" dia. treated timber. Good condition. 2 piles: 0% category but shimming would restore near full capacity. • Pile caps are 12x12 treated timber. Fair to good condition. Some localized areas of weathering and fungal decay on the member surface and cut ends. • Stringers are 3x10 treated timber. Fair to good condition. Some localized areas of weathering and fungal decay on the member surface and cut ends. <p><u>Recommended Repairs and Remaining Life</u></p> <ul style="list-style-type: none"> • Shim 2 piles to restore bearing capacity. • Piles: non-bearing piles, 10 yr (current), 20 yrs (repaired); other piles, 20 yrs (current). • Pile Caps: 15 yrs (current). • Stringers: 15 years (current).

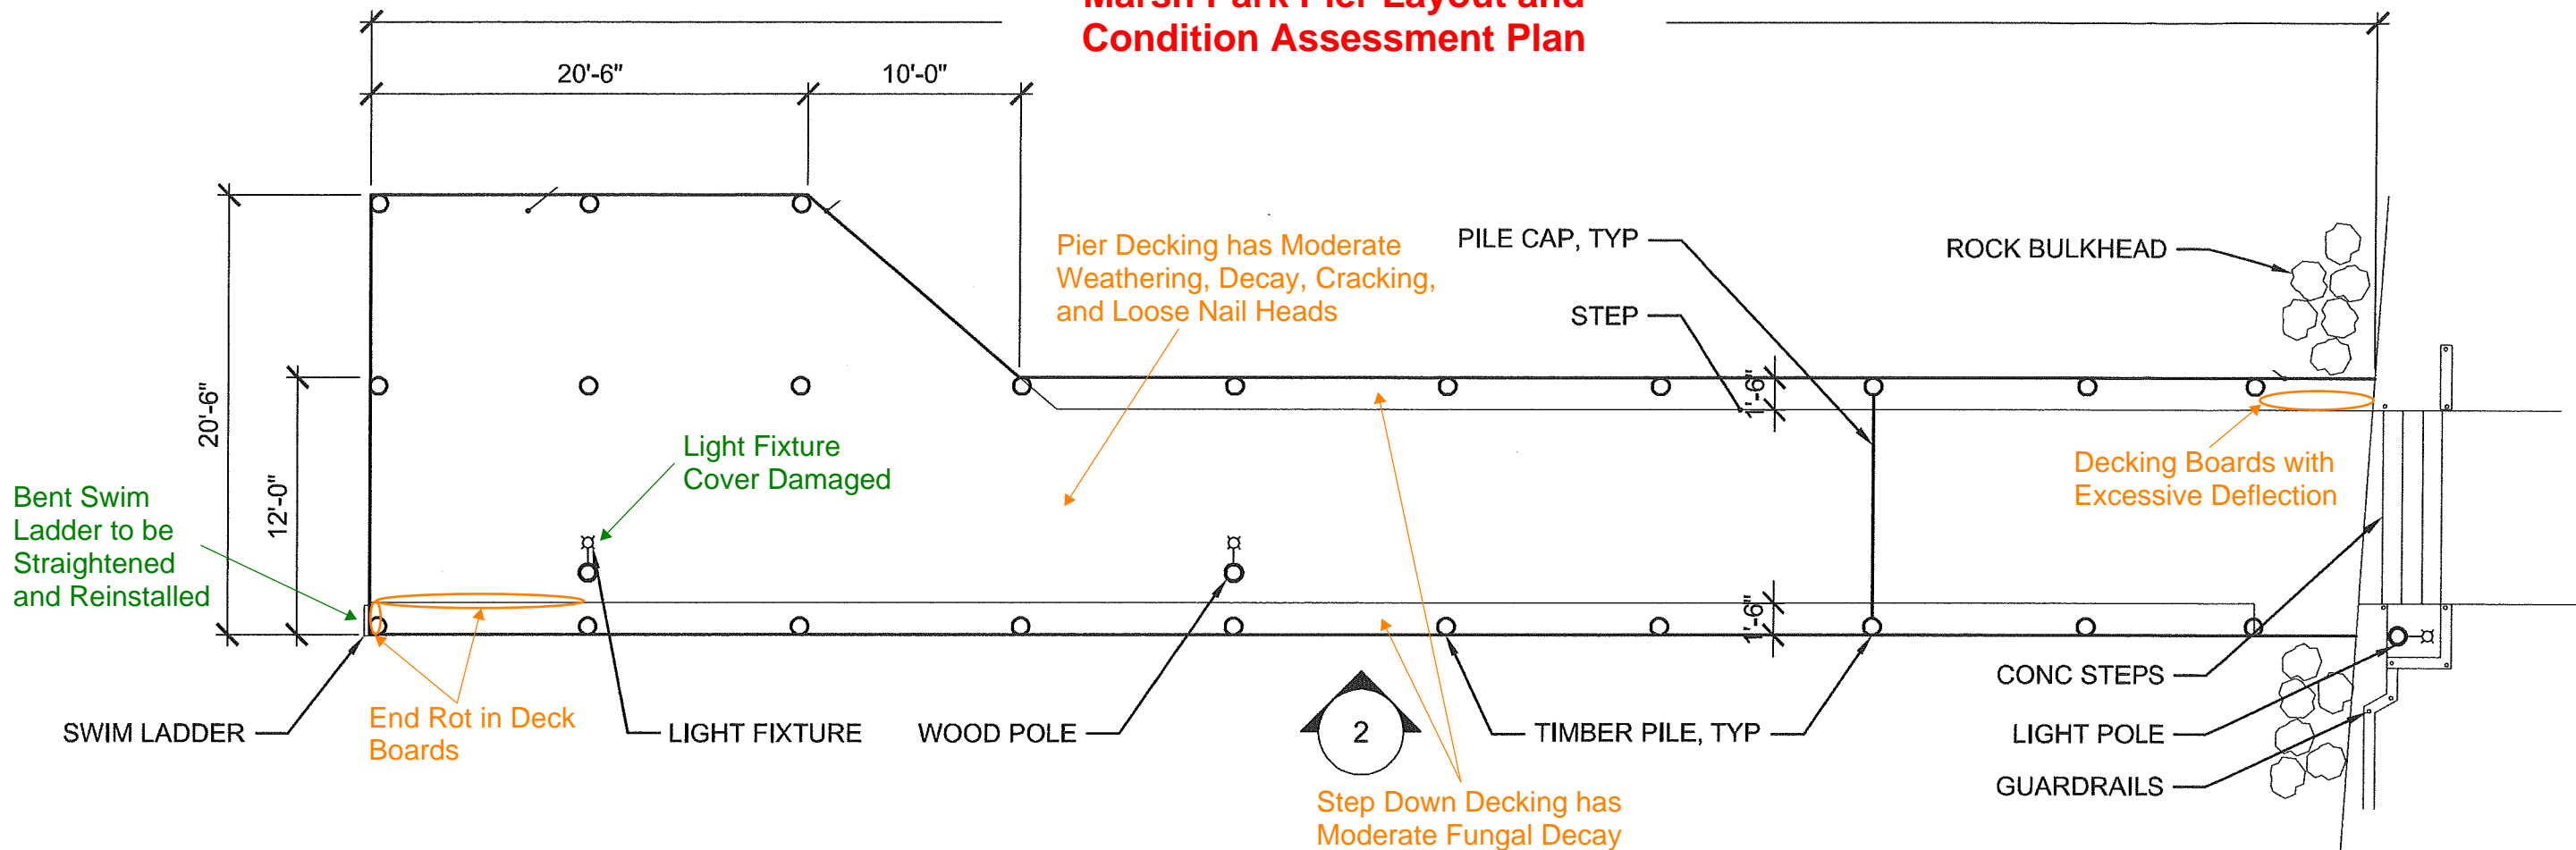
Marsh Park Pier Layout and Condition Assessment Plan

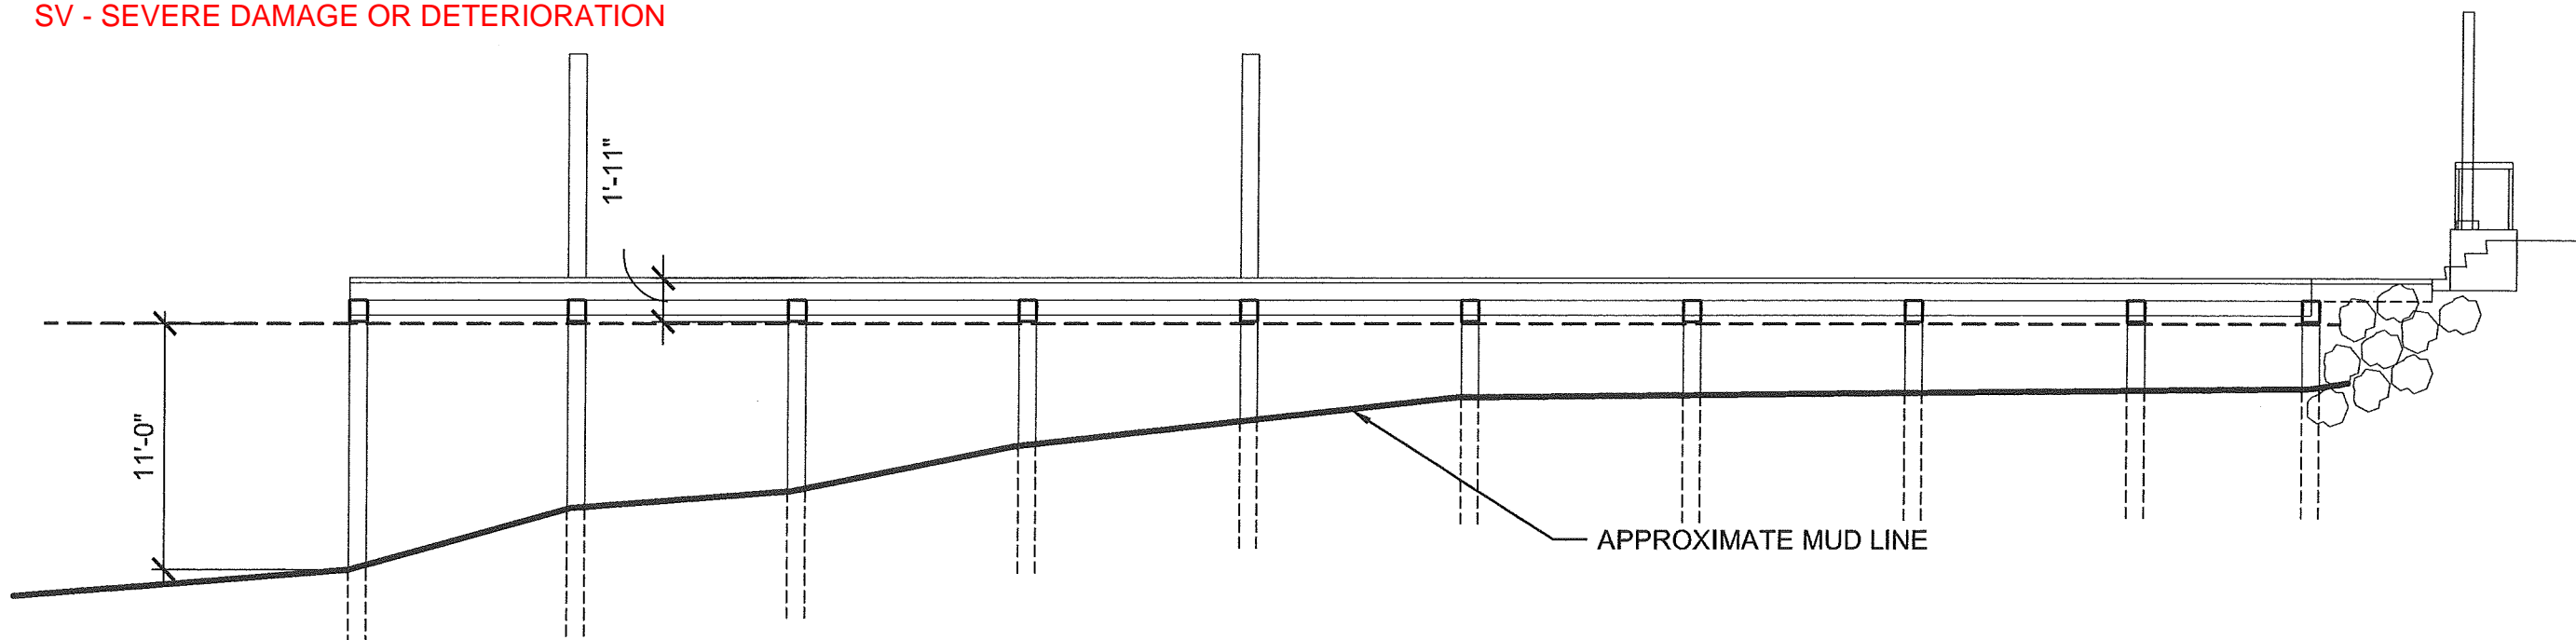
2 PIER SECTION
 SCALE: approx. 1/8" = 1'-0"

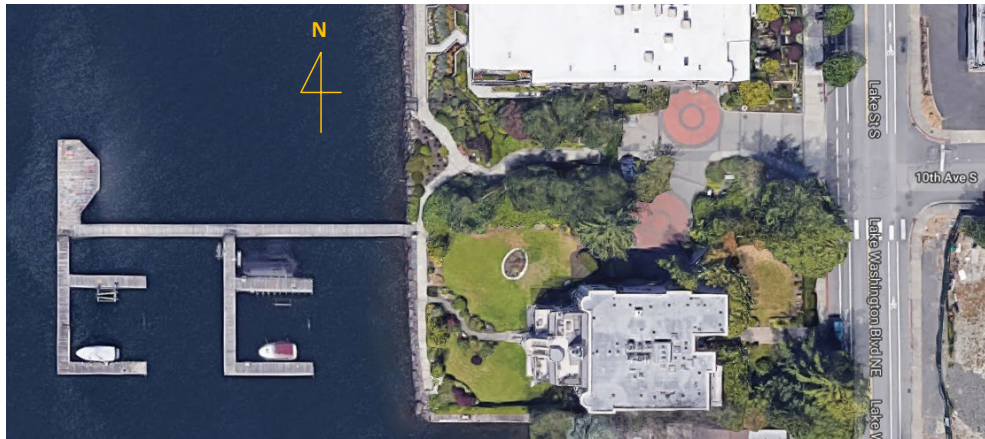
Figure 8. Settler's Landing Park Aerial.

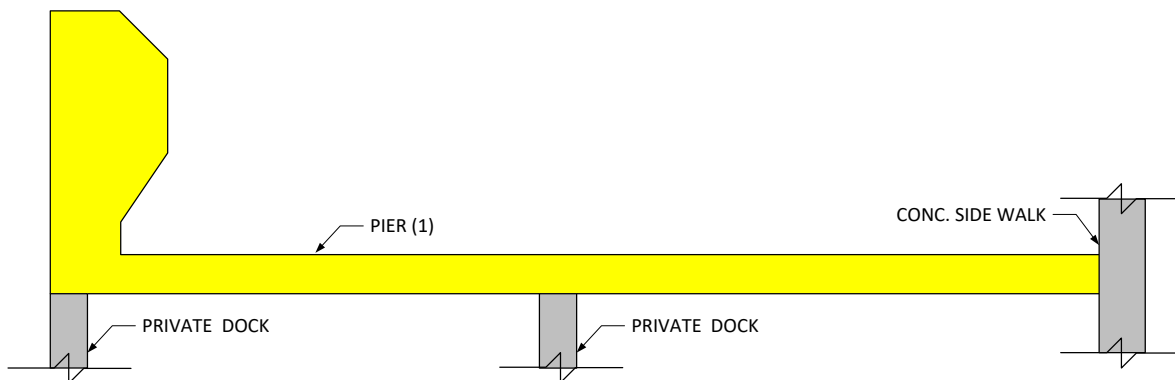
Figure 9. Settler's Landing Park Overall Condition.

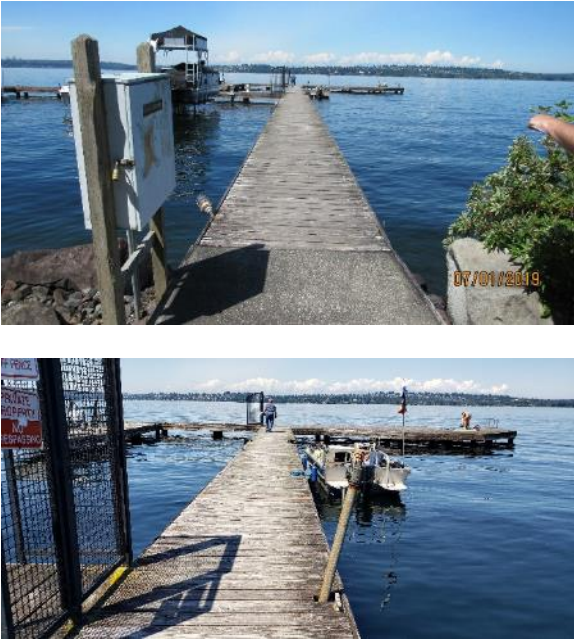
<p><u>Existing Condition</u></p> <ul style="list-style-type: none"> • Typical construction of 2x6 timber decking over timber stringers. Decking and timber 2x8 fascia weathered w/ fungal decay (15-25%). Nail heads loose and some trip hazards due to loose boards. Overall timber condition is in fair condition. • Fire standpipe is loose and doesn't appear to be connected under the pier (poor condition). • Cleats and aluminum swim ladder are in satisfactory condition. • Two light fixture are broken and others have condensation (poor condition). • Riprap shoreline is stable and has fabric and quarry spalls behind (good condition). <p><u>Recommended Repairs and Remaining Life</u></p> <ul style="list-style-type: none"> • Replace decking with timber or grated decking. • Replace light fixtures and fire standpipe supports. • 10 yrs (current), 25 yrs (repaired).

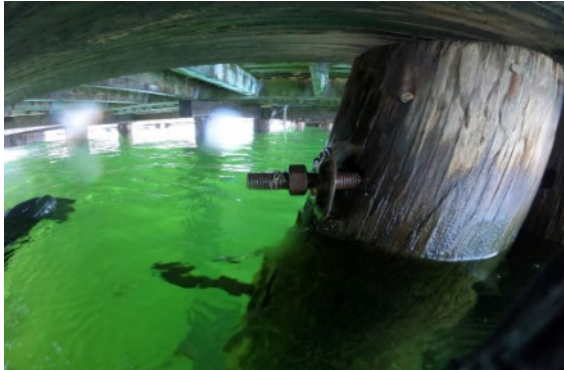
<p><u>Existing Condition</u></p> <ul style="list-style-type: none"> • 54 piles: 12-14" dia. treated timber. Fair to good condition. 5 piles: 50% category or less but shimming would restore near full capacity. • Pile caps on approach pier are 6x8 & on pier head are 4x8 & 6x8 treated timbers. Good condition. • Stringers on approach pier are 6x8 and on pier head are 4x8 treated timber. Good condition. • Pile caps and stringers have some localized areas of weathering and fungal decay on the member surface and cut ends. <p><u>Recommended Repairs and Remaining Life</u></p> <ul style="list-style-type: none"> • Shim 5 piles to restore bearing capacity. • Piles: non-bearing piles, 10 yrs (current), 20 yrs (repaired); other piles, 20 yrs (current). • Pile Caps: 15 yrs (current). • Stringers: 15 years (current).

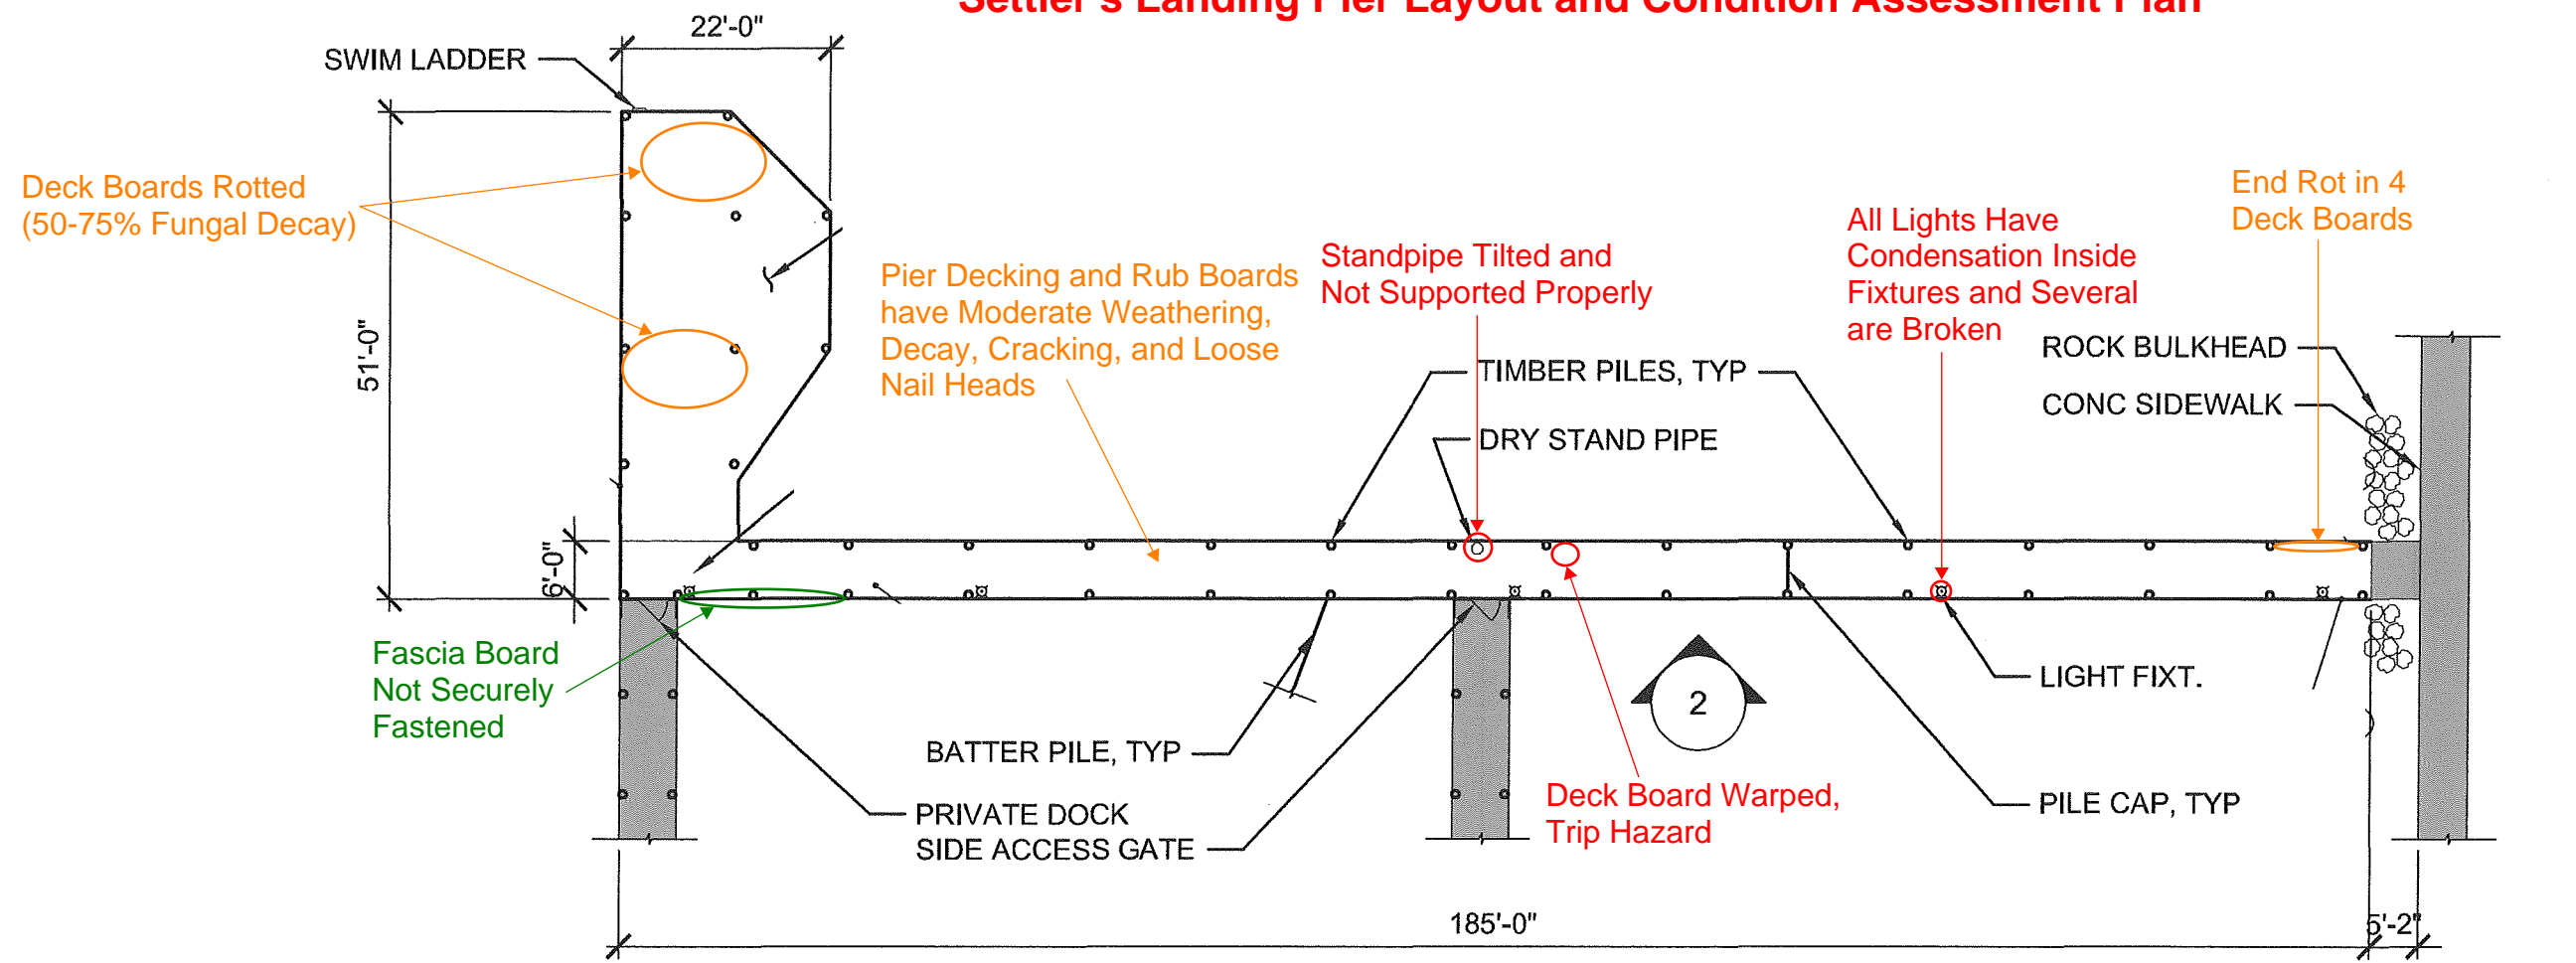
Settler's Landing Pier Layout and Condition Assessment Plan
