KIRKLAND PARKS & COMMUNITY SERVICES

Shoreline Structures Assessment Kirkland, Washington

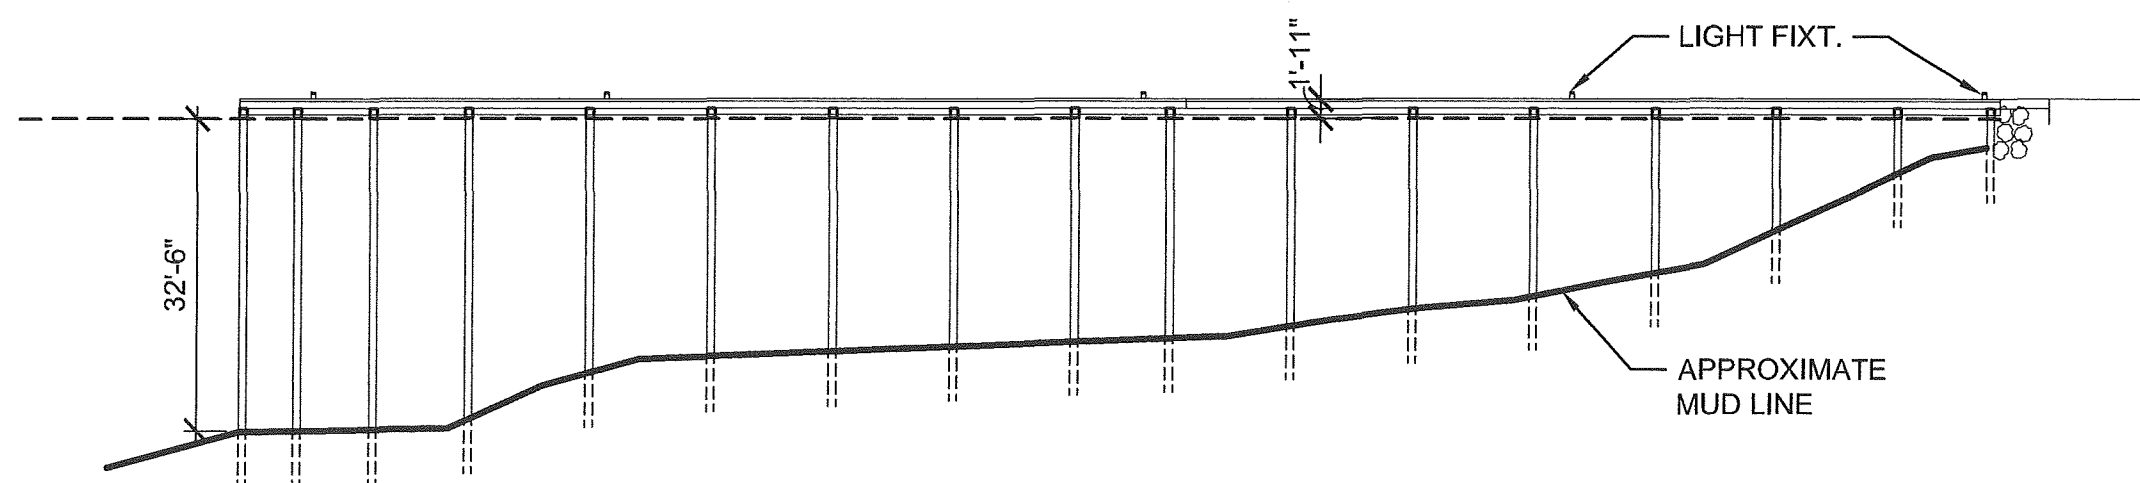
2 PIER SECTION
 SCALE: approx. 1" = 20'-0"

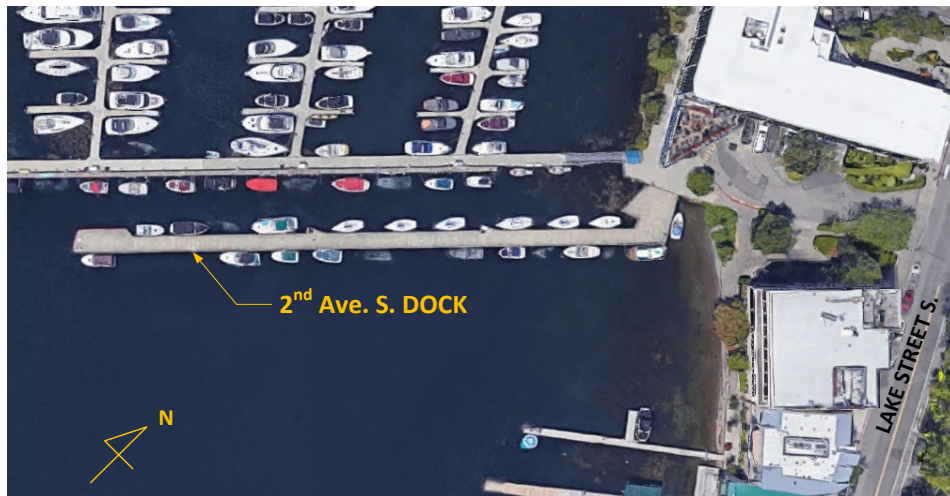
Figure 11. 2nd Avenue South Dock Aerial.

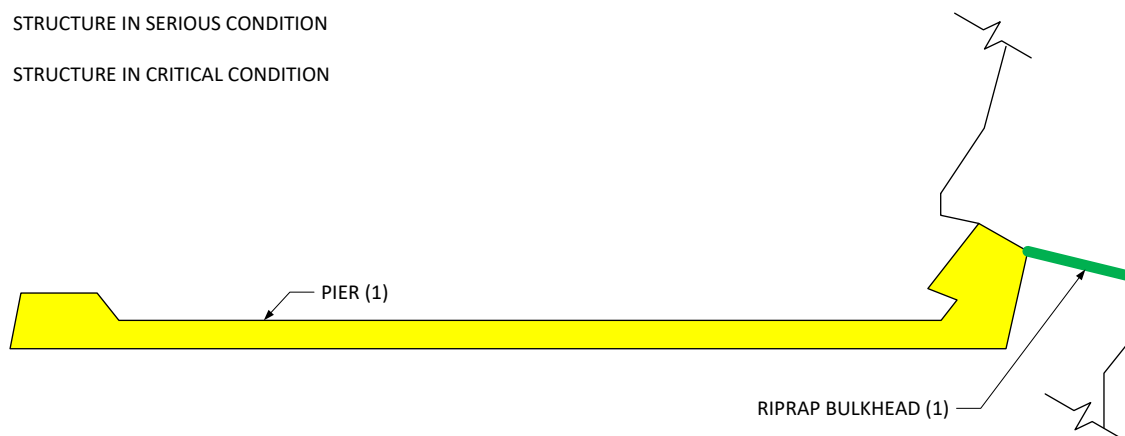
Figure 12. 2nd Avenue South Dock Overall Condition.

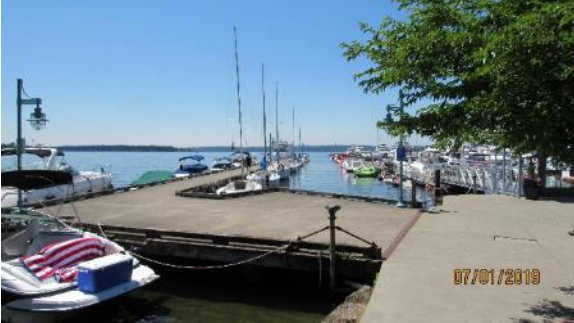
<p><u>Existing Condition</u></p> <ul style="list-style-type: none"> • Cast-in place concrete over corrugated metal over timber stringers. • Concrete has intermittent transverse cracking (1/8" typical) every 8-10 feet and minor spalls throughout at edges / corners. Overall concrete decking condition is fair. • Riprap bulkhead is in good condition. <p><u>Recommended Repairs and Remaining Life</u></p> <ul style="list-style-type: none"> • Repair cracks and spalls. • 10 yrs (current), 20 yrs (repaired).

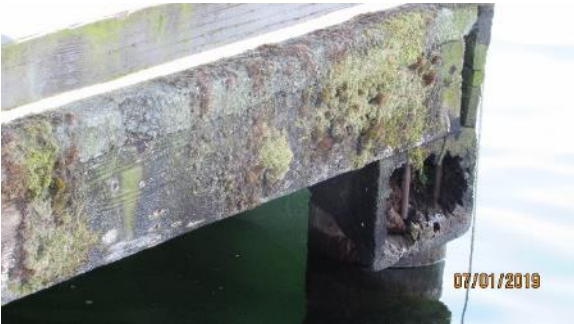
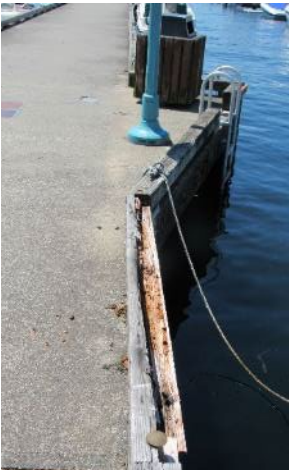
<p><u>Existing Condition</u></p> <ul style="list-style-type: none"> • Timber fascia is 4x12 and has light to heavy fungal damage. Overall condition is poor. • Timber bull rails (6x6 with 3x6 spacer blocks) have weathering, fungal, and mechanical damage. There are approx. 6 newer bull rail sections and 10 heavily damaged bull rails. Overall condition for bull rails is fair. • Cleats have multiple sizes installed but are in satisfactory condition overall. One cleat is loose. • Aluminum ladders are in fair condition with one bent ladder at the SW end of the pier and one damaged ladder at the SE end of the pier. <p><u>Recommended Repairs and Remaining Life</u></p> <ul style="list-style-type: none"> • Fascia: 2 years (current), 25 years (replaced). • Bull Rails: 5 years (current), 25 years (repaired). • Cleats: 20 years (current). • Ladders: 10 yrs (current), 25 yrs (repaired).

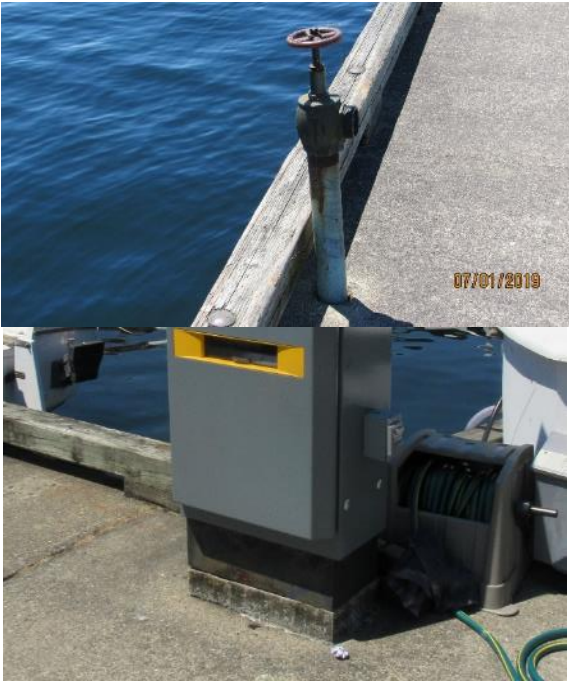
<p><u>Existing Condition</u></p> <ul style="list-style-type: none"> • Fire standpipes are in satisfactory condition overall with some missing caps and handles and surface rusting observed. • Light poles are in satisfactory condition. • Pay kiosk structure is rusting at the bottom but appears in fair condition overall. <p><u>Recommended Repairs and Remaining Life</u></p> <ul style="list-style-type: none"> • Replace missing fire standpipe caps & handles. • Repair rust on kiosk and repaint. • Fire Standpipes: 15 years (current). • Light Poles: 15 years (current). • Pay Kiosk: 5 years (current), 10 years (repaired).

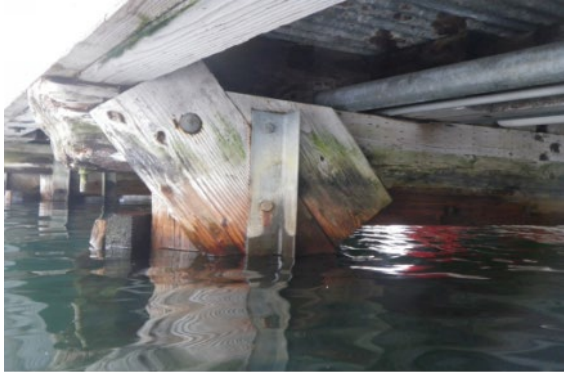
<p><u>Existing Condition</u></p> <ul style="list-style-type: none"> • 115 piles: 12-14" dia. treated timber. Good condition with minor biological damage / fungal decay. • Pile caps are a mix of 12x16 glu-lam and sawn timbers. Fair to poor condition. Fungal and biological damage at cut ends (9 locations) • Stringers are mixed 4x10 (primarily) and 8x10 treated timbers. Good condition. • Diagonal braces are 3x8 treated timber. Good condition. <p><u>Recommended Repairs and Remaining Life</u></p> <ul style="list-style-type: none"> • Replace damaged timber caps (10). • Piles: 15 yrs (current). • Pile Caps: damaged caps, 2 yrs (current), 25 yrs (replaced); other caps, 10 yrs (current). • Stringers: 15 years (current). • Diagonal braces: 15 years (current).

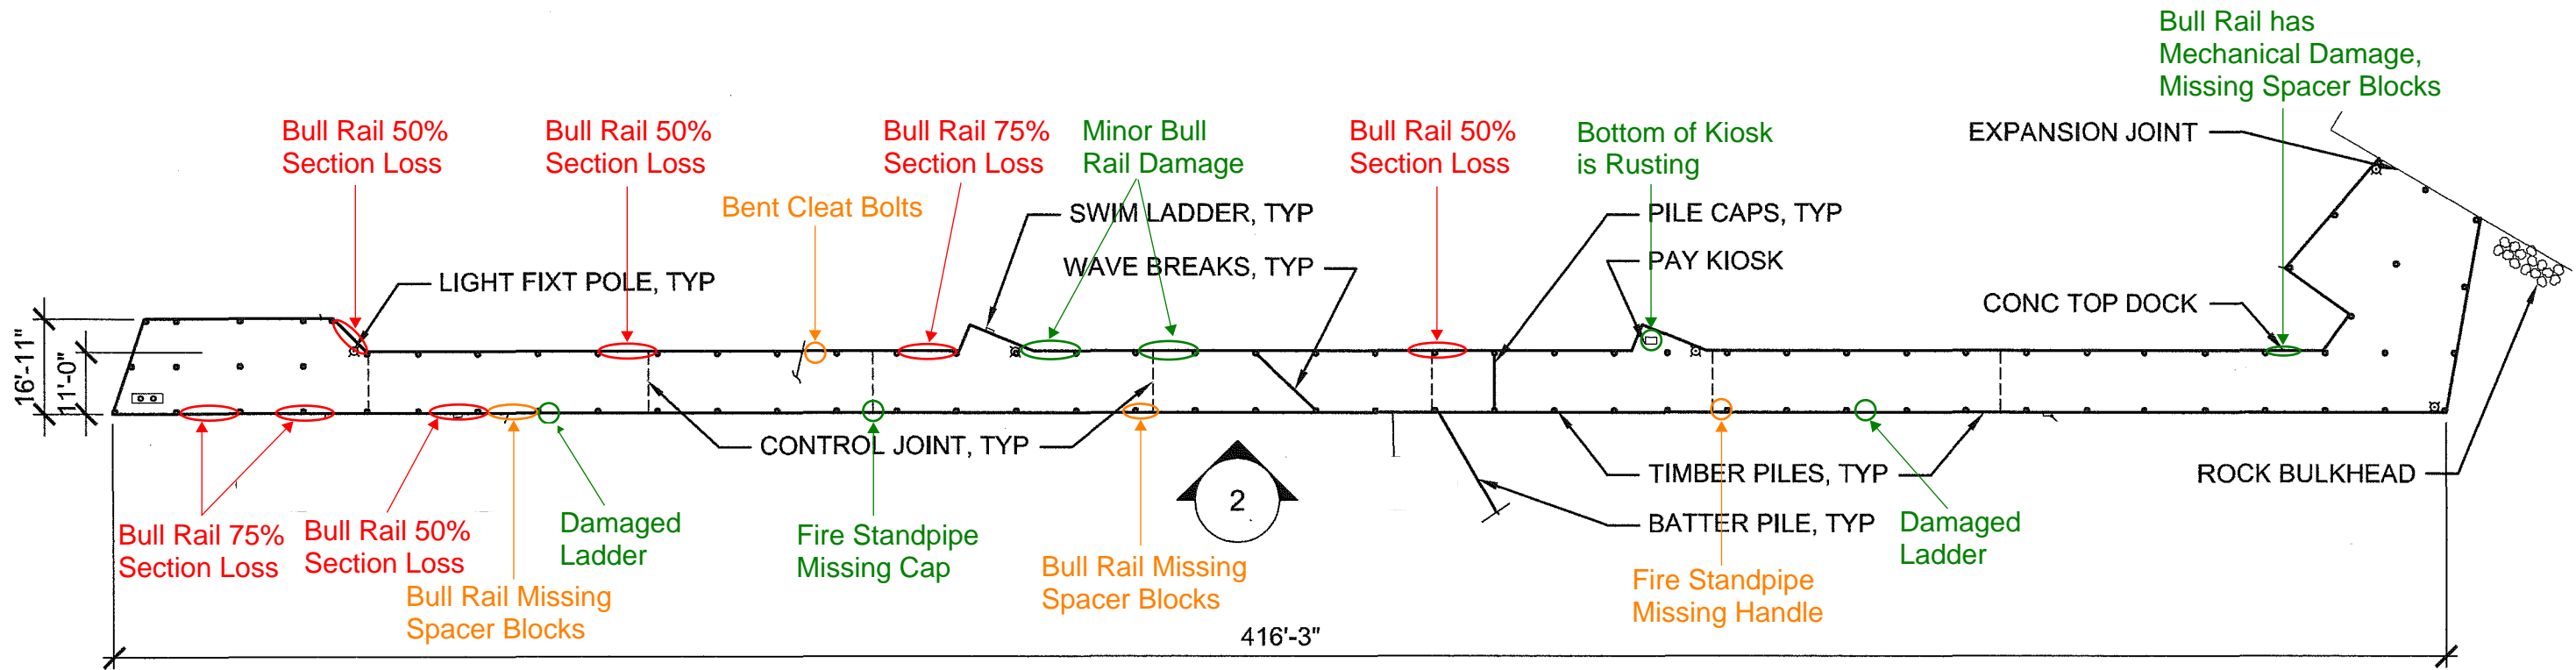
2nd Ave S Pier Layout and Condition Assessment Plan

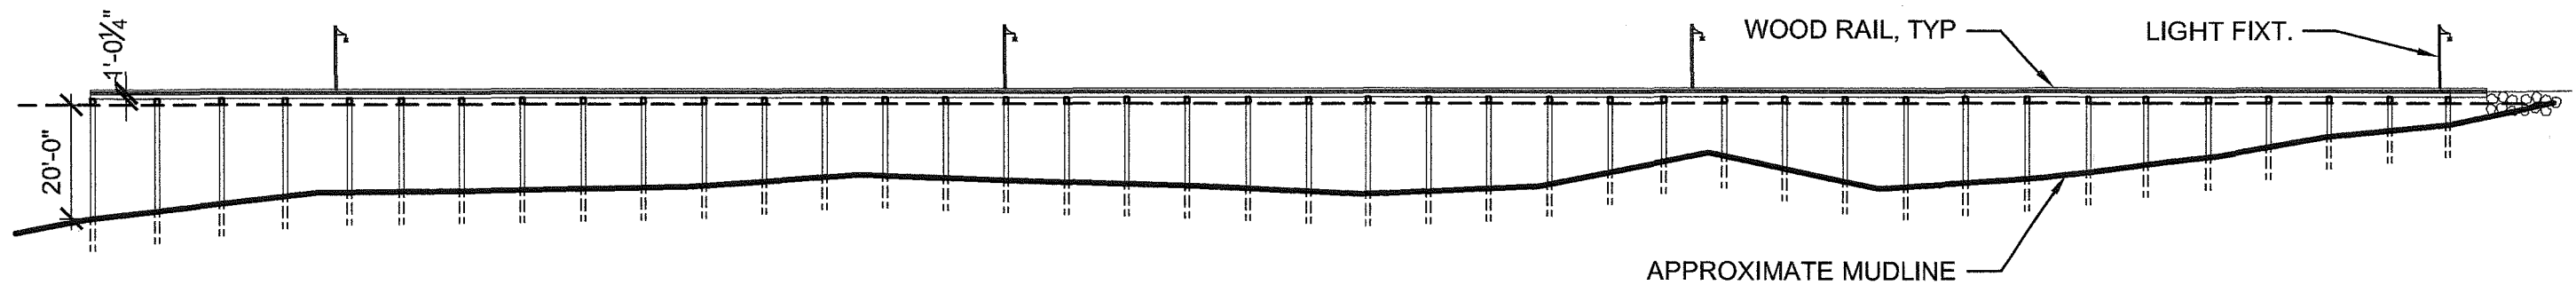
2 PIER SECTION
 SCALE: approx. 1" = 30'-0"

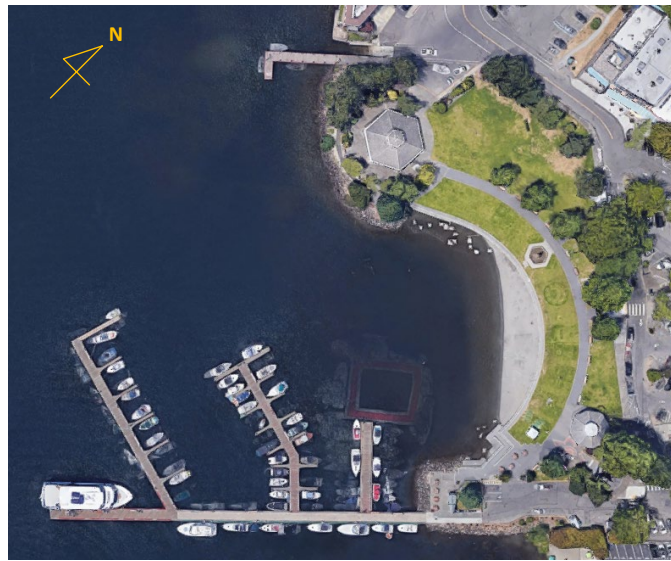
Figure 14. Marina Park Aerial.

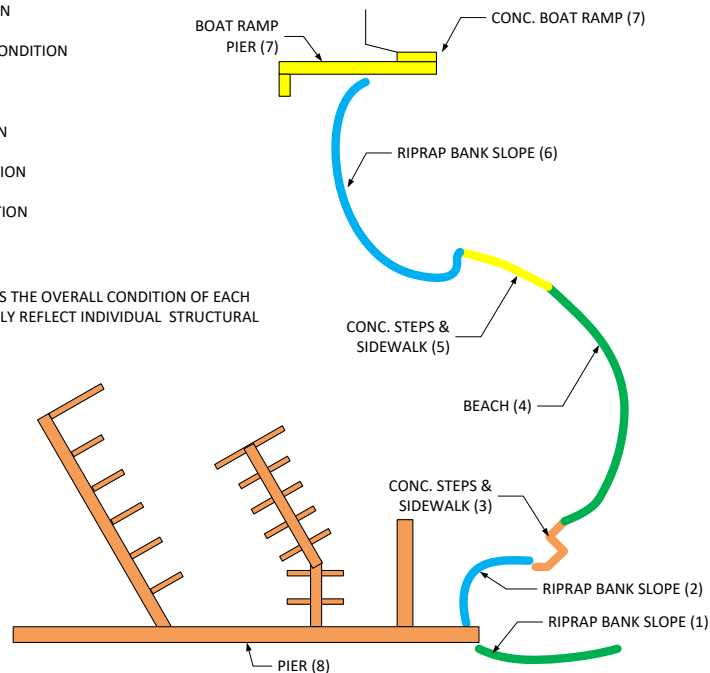
Figure 15. Marina Park Overall Condition.

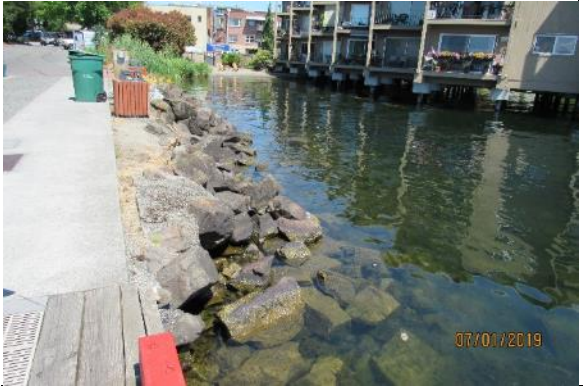
<p><u>Existing Condition</u></p> <ul style="list-style-type: none"> • Approximately 80 feet of riprap shoreline. • Large (1' to 3') riprap with no smaller aggregate or filter fabric observed. • Approximate slope 2:1. • No erosion or shifting of riprap observed. <p><u>Recommended Repairs and Remaining Life</u></p> <ul style="list-style-type: none"> • None. • 20 years.

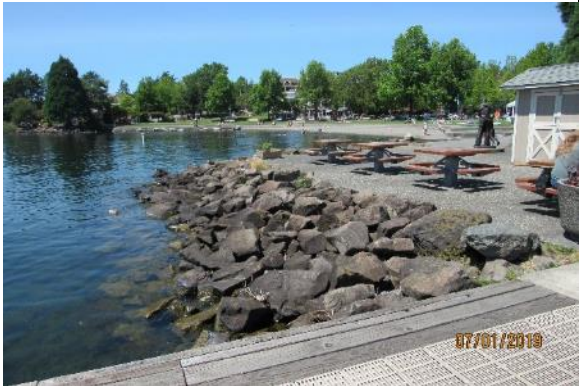
<p><u>Existing Condition</u></p> <ul style="list-style-type: none"> • Approximately 50 feet of riprap shoreline. • Large (8" to 3') riprap with no smaller aggregate or filter fabric observed. • Approximate slope 3:1. • No erosion or shifting of riprap observed. • Minor erosion (1" max) under concrete sidewalk along west side. Erosion likely due mainly to stormwater runoff. <p><u>Recommended Repairs and Remaining Life</u></p> <ul style="list-style-type: none"> • None. • 20 years.

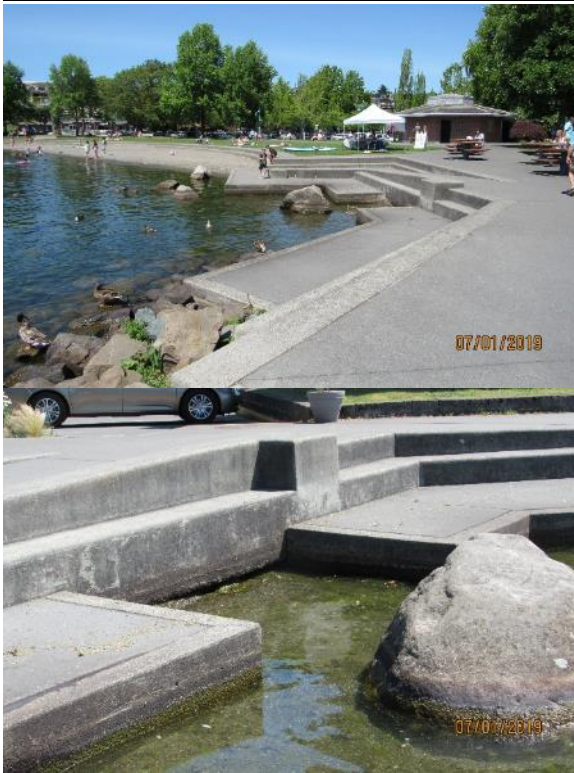
EXISTING CONDITION / RECOMMENDATIONS

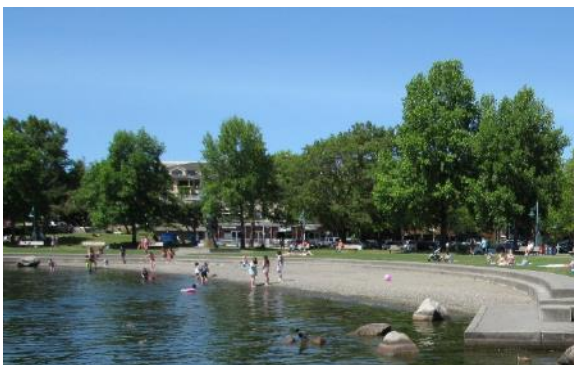
EXISTING CONDITION / RECOMMENDATIONS

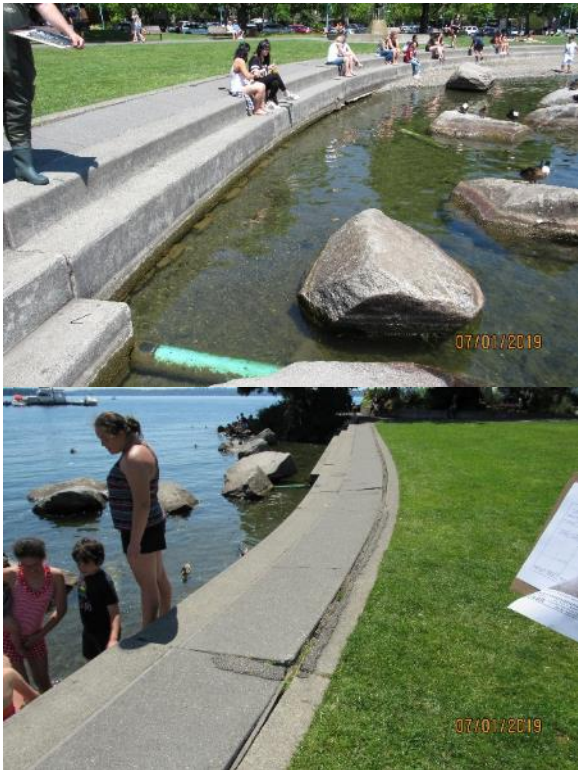
PHOTOS	EXISTING CONDITION / RECOMMENDATIONS

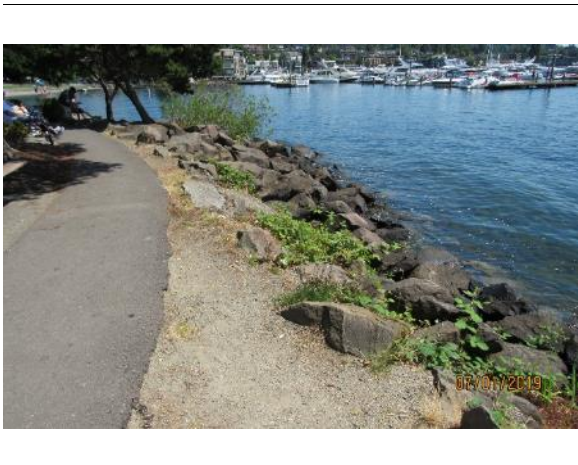
<p><u>Existing Condition</u></p> <ul style="list-style-type: none"> • Approximately 250 feet of riprap shoreline. • Large riprap with fabric observed. • Approximate slope 2:1. • No erosion or shifting of riprap observed. <p><u>Recommended Repairs and Remaining Life</u></p> <ul style="list-style-type: none"> • None. • 30 years.

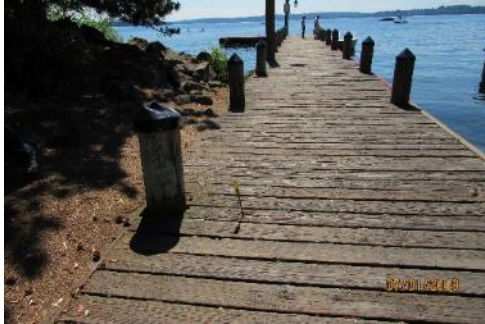
EXISTING CONDITION / RECOMMENDATIONS

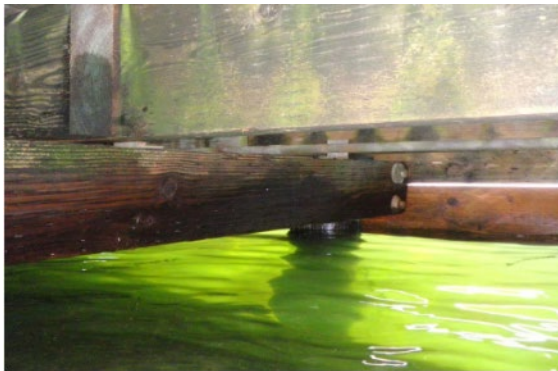
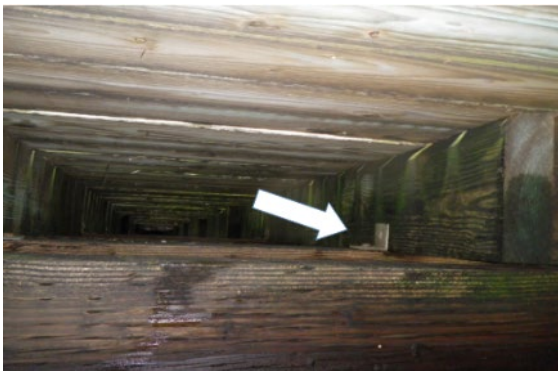
EXISTING CONDITION / RECOMMENDATIONS

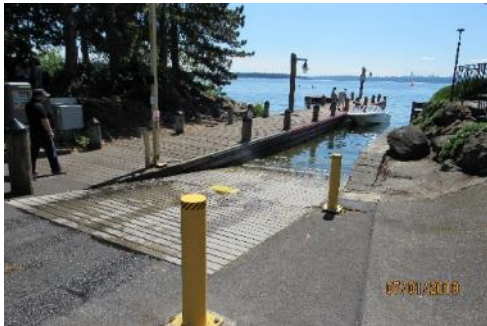
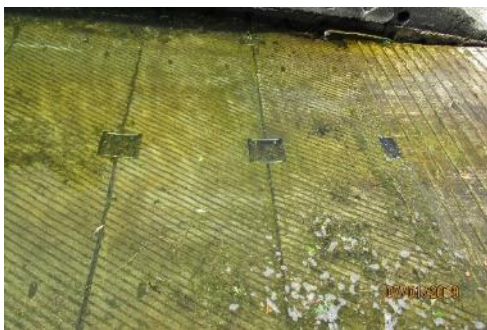
EXISTING CONDITION / RECOMMENDATIONS

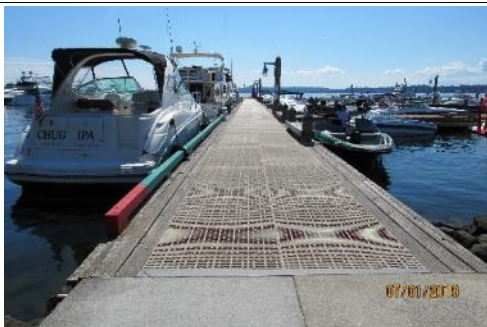
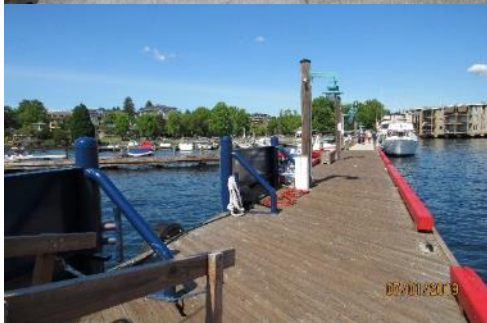
EXISTING CONDITION / RECOMMENDATIONS

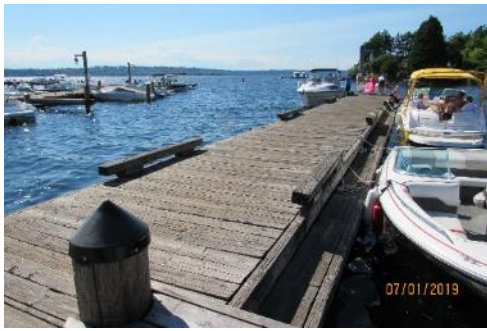
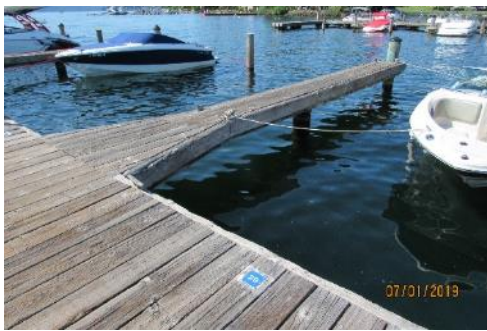
- Timber finger piers are in poor condition due to mechanical and weathering damage and fungal decay and are generally unstable.
- The straight NE lateral pier has significant damage to the NE edge of the step down pier and is currently safety coned off and unusable.
- Cleats are in satisfactory condition. Note that there are multiple locations where the cleats are pulling out of the support timbers they are fastened to.

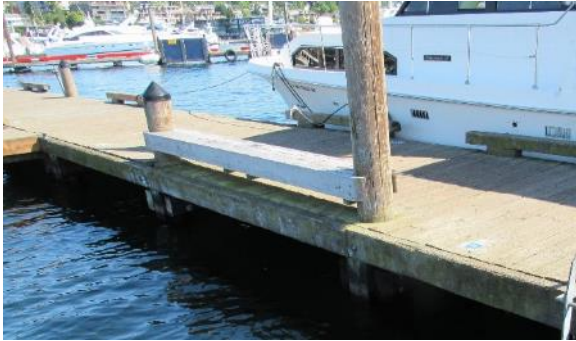
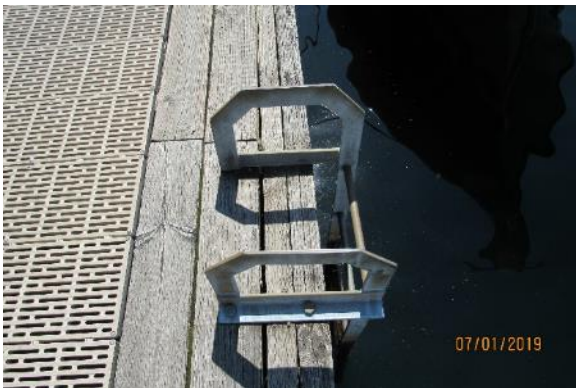
- Benches: 15 years (current).
- Ladders: 25 yrs.

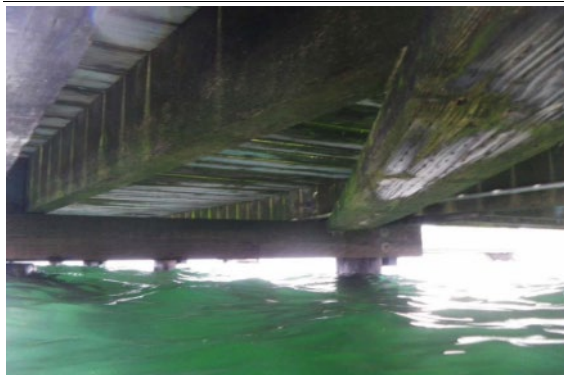
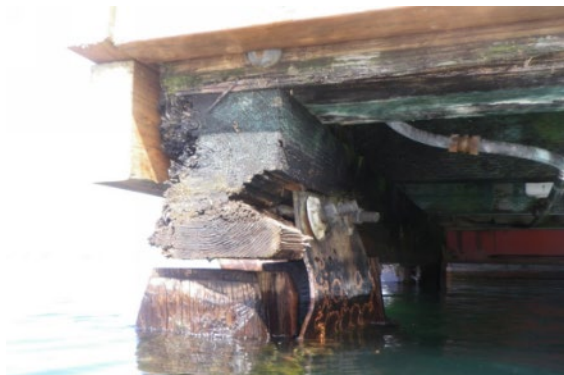
EXISTING CONDITION / RECOMMENDATIONS

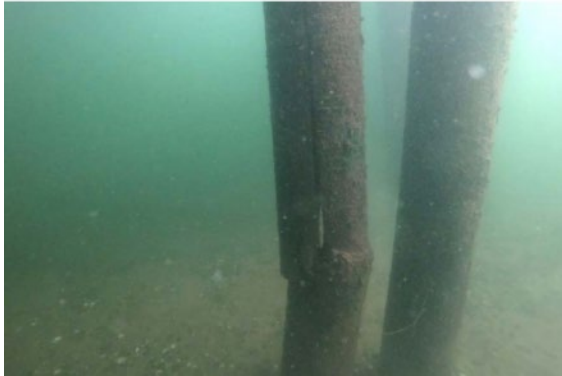
- Galvanized steel brace system at/near mudline on outer piles on E & W sides of center lateral and E side of outer (western) lateral. Good condition.
- 5 timber firewalls at intervals along structure. Fair condition. 2 firewalls have loose/ missing boards.

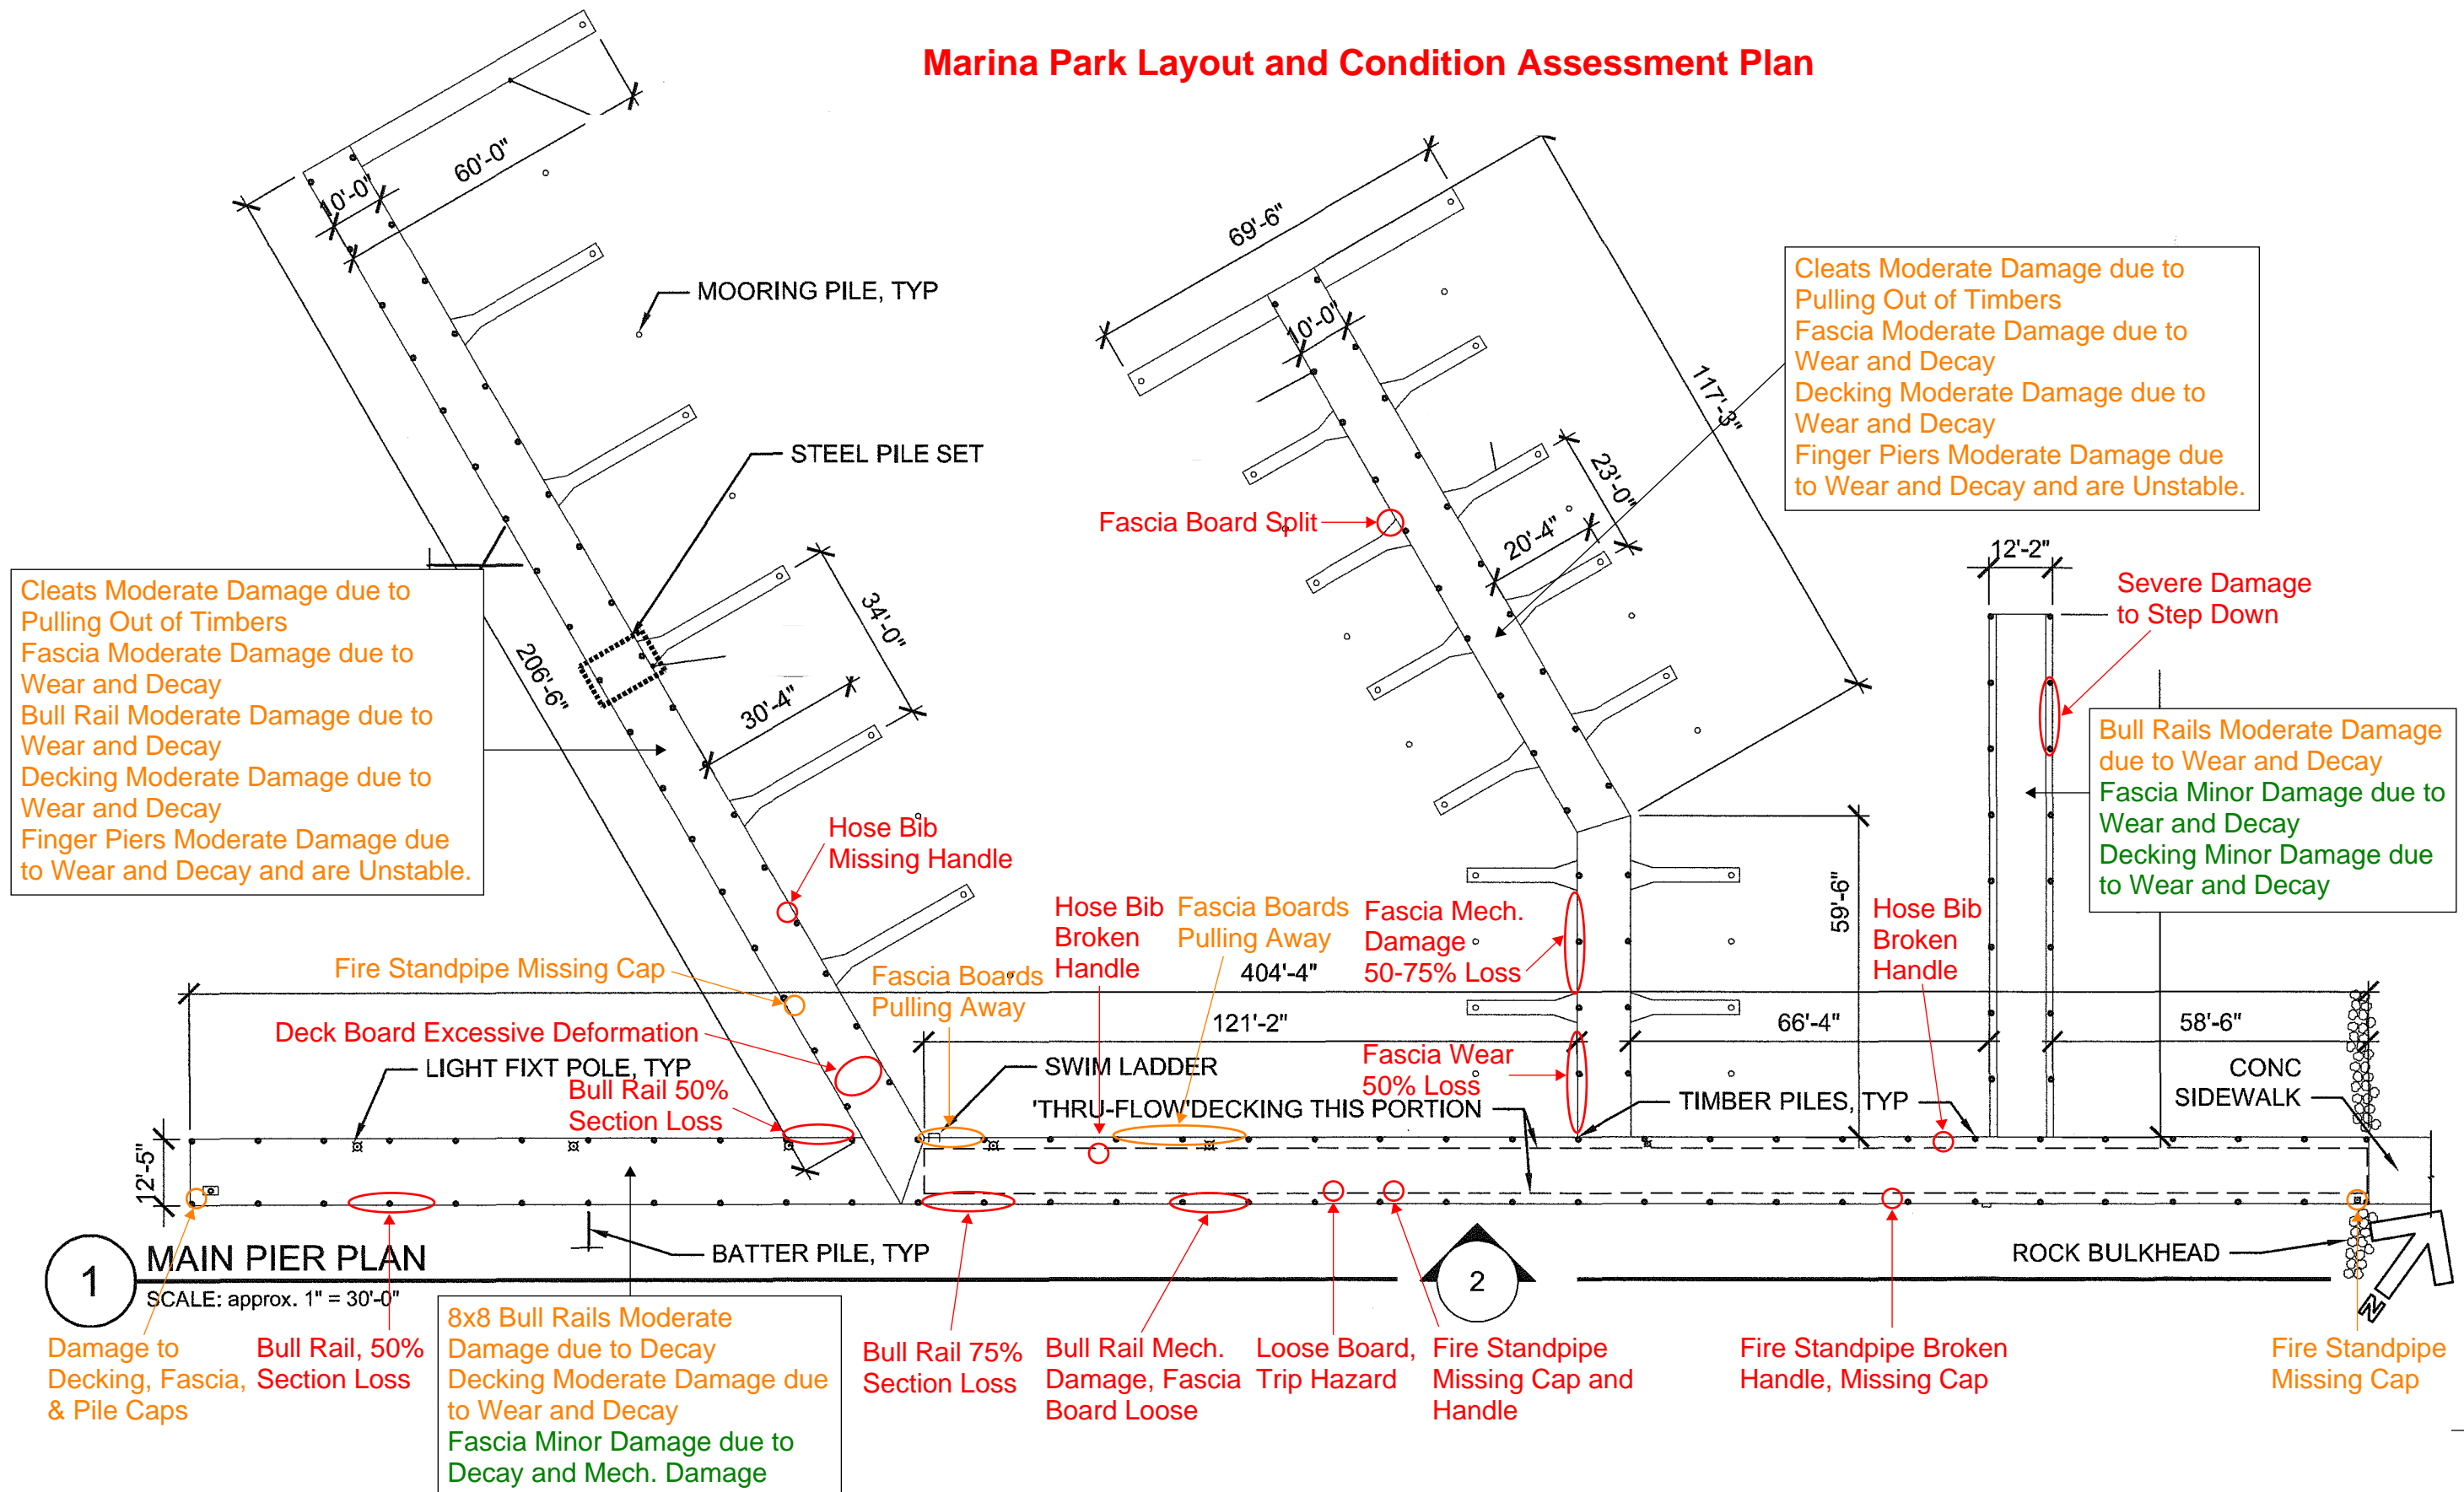
Marina Park Layout and Condition Assessment Plan

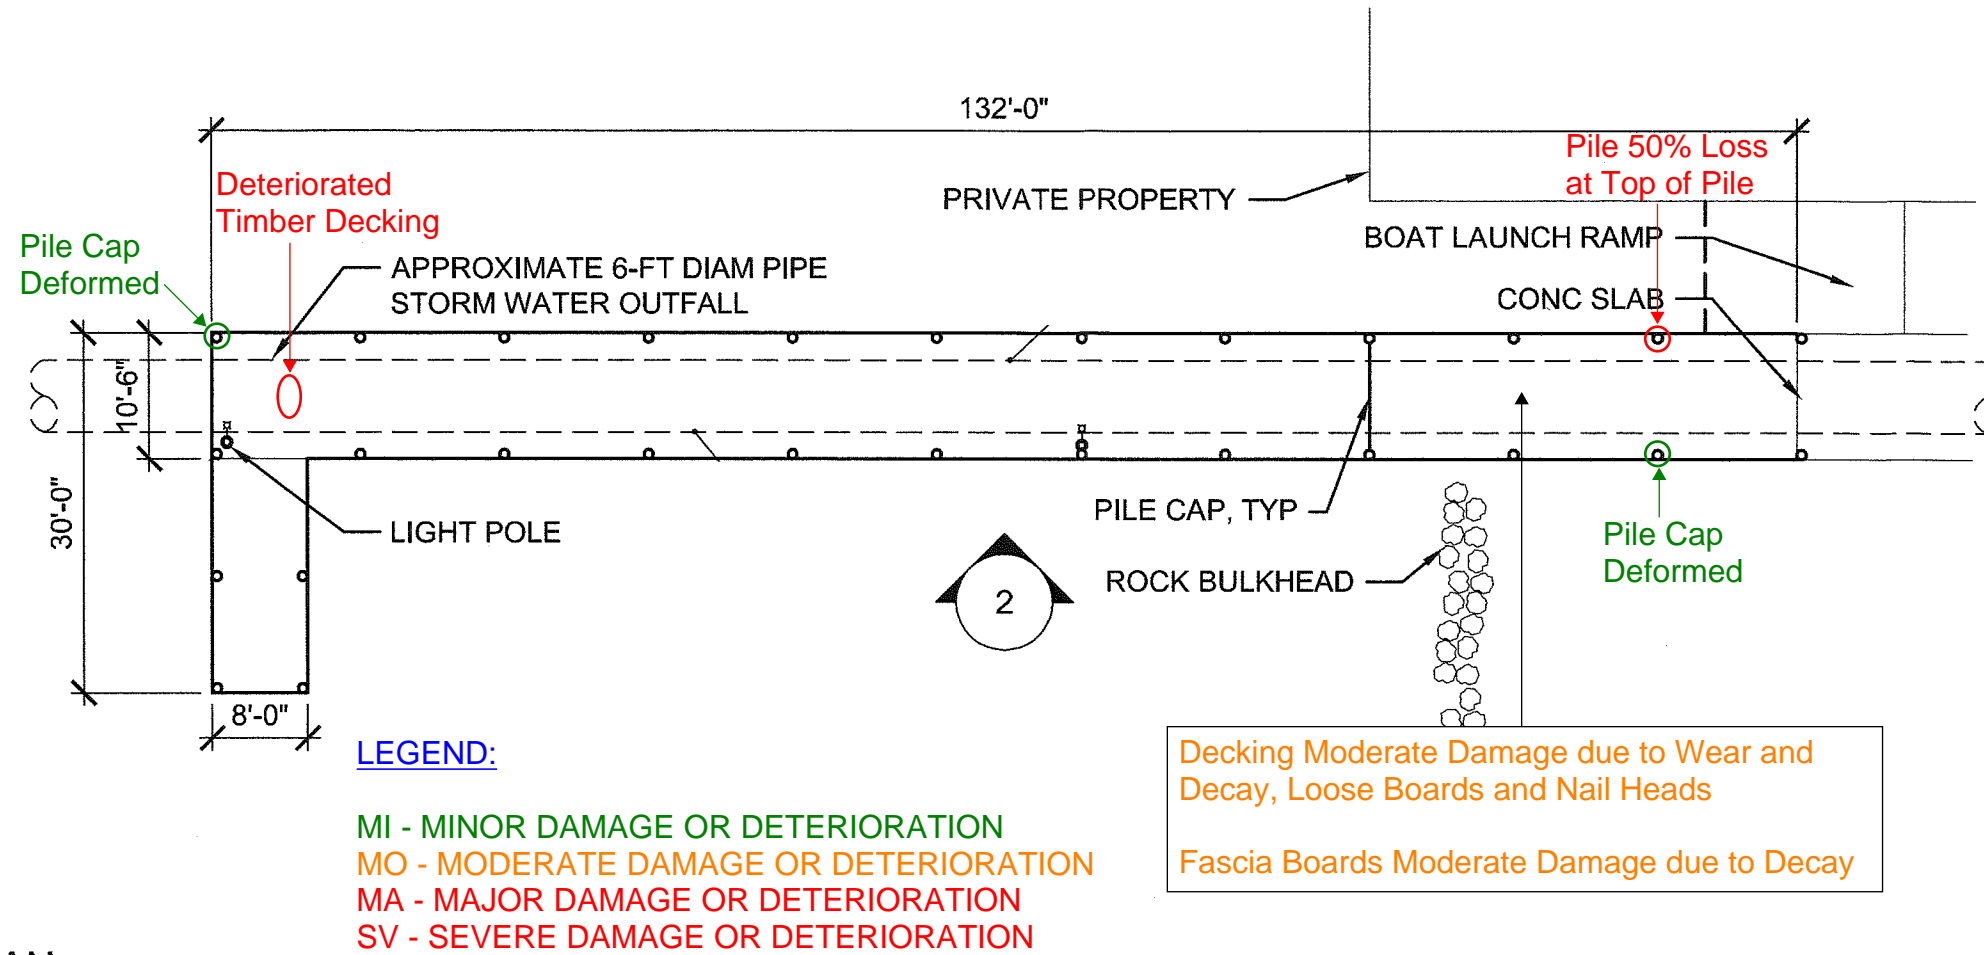
1 SMALL PIER PLAN
 SCALE: approx. 1/16" = 1'-0"

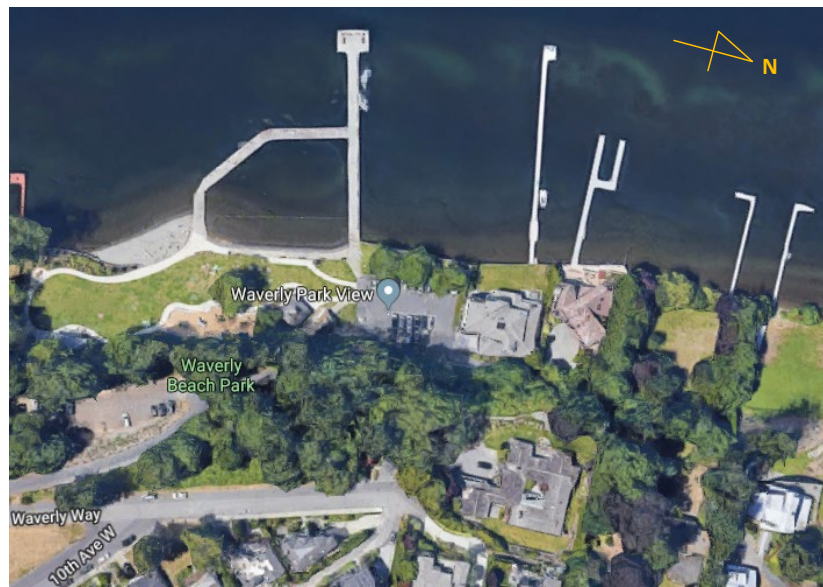
Figure 18. Waverly Park Aerial.

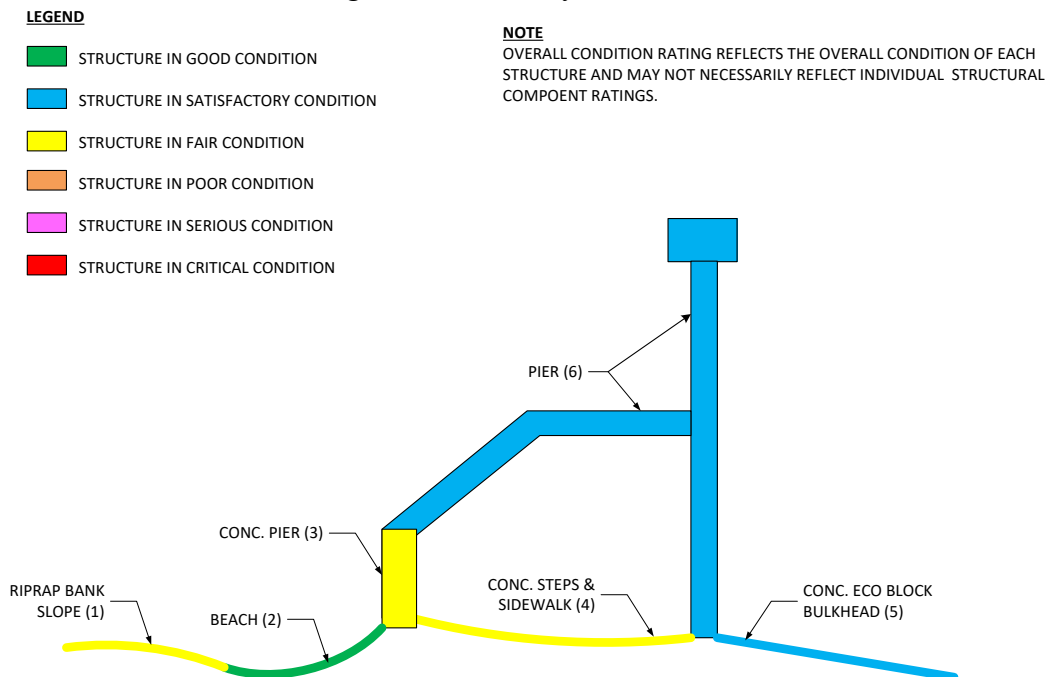
Figure 19. Waverly Park Overall Condition.

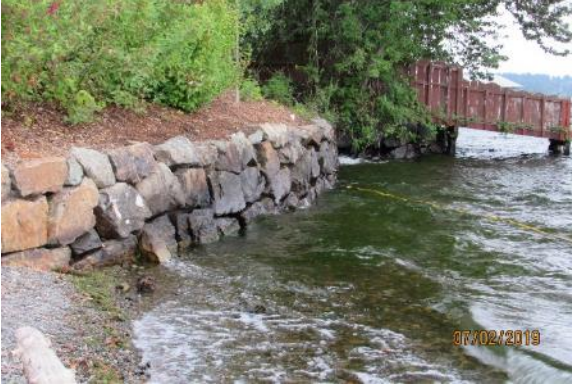
<p><u>Existing Condition</u></p> <ul style="list-style-type: none"> • Approximately 115 feet of riprap shoreline. • Large riprap with filter fabric behind and well arranged. • Wall stable with no evidence of erosion at toe or settlement of rocks. • Riprap bulkhead is in good condition. <p><u>Recommended Repairs and Remaining Life</u></p> <ul style="list-style-type: none"> • None. • Riprap: 30 yrs .

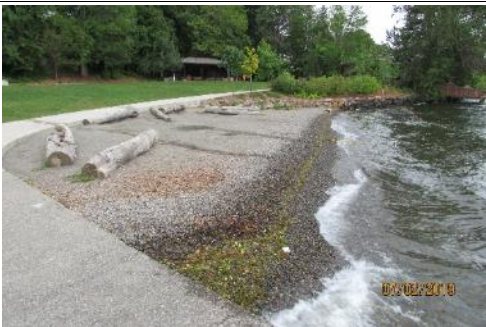
<p><u>Existing Condition</u></p> <ul style="list-style-type: none"> • Approximately 130 feet of shoreline. • Gravel beach with low slope. • Good condition with no observed deficiencies. <p><u>Recommended Repairs and Remaining Life</u></p> <ul style="list-style-type: none"> • No recommended repairs. • 30 or more years of service life.

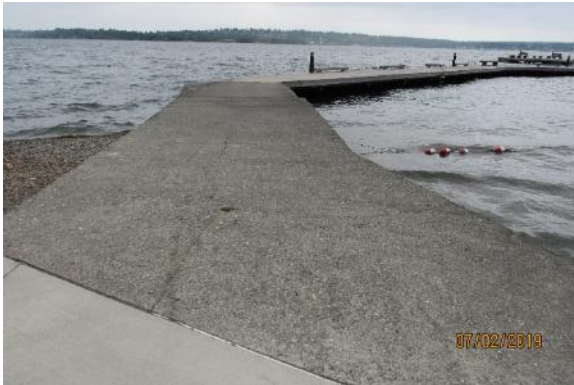
<p><u>Existing Condition</u></p> <ul style="list-style-type: none"> • Approximately 45 feet of shoreline. • Concrete pier toe has minor undermining along south edge. Small void at intersection of NE corner of concrete pier and SW corner of steps. • Concrete pier surface has minor cracking throughout (hairline to 1/4" max). <p><u>Recommended Repairs and Remaining Life</u></p> <ul style="list-style-type: none"> • Install granular material to fill undermined areas at toe of pier structure. • Repair cracks. • 15 years with current condition (25 or more years of service life after repairs).

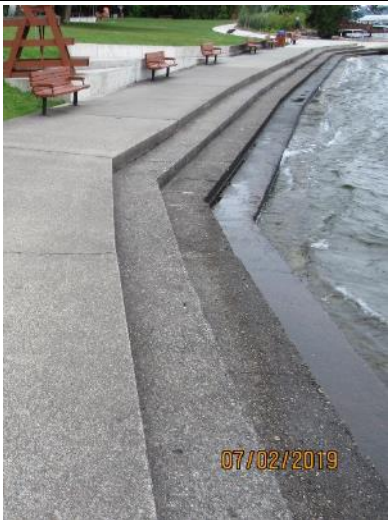
PHOTOS	EXISTING CONDITION / RECOMMENDATIONS

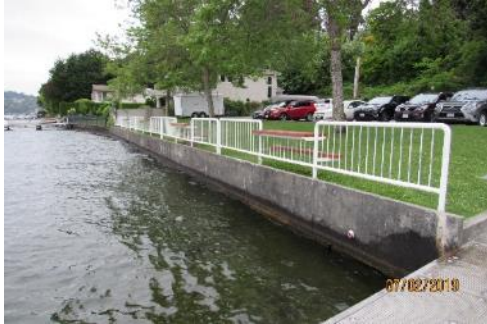
EXISTING CONDITION / RECOMMENDATIONS

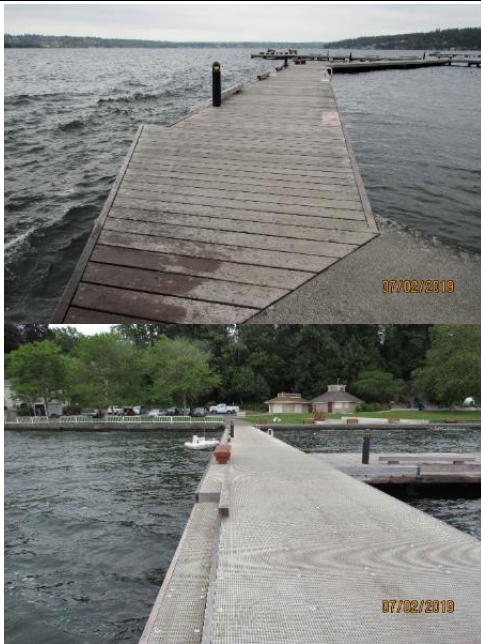
EXISTING CONDITION / RECOMMENDATIONS

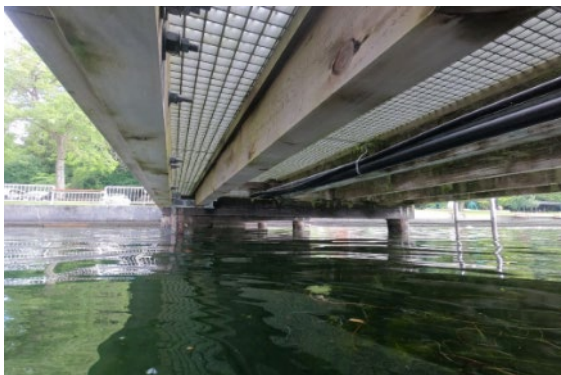
EXISTING CONDITION / RECOMMENDATIONS
