KIRKLAND PARKS & COMMUNITY SERVICES

Shoreline Structures Assessment Kirkland, Washington

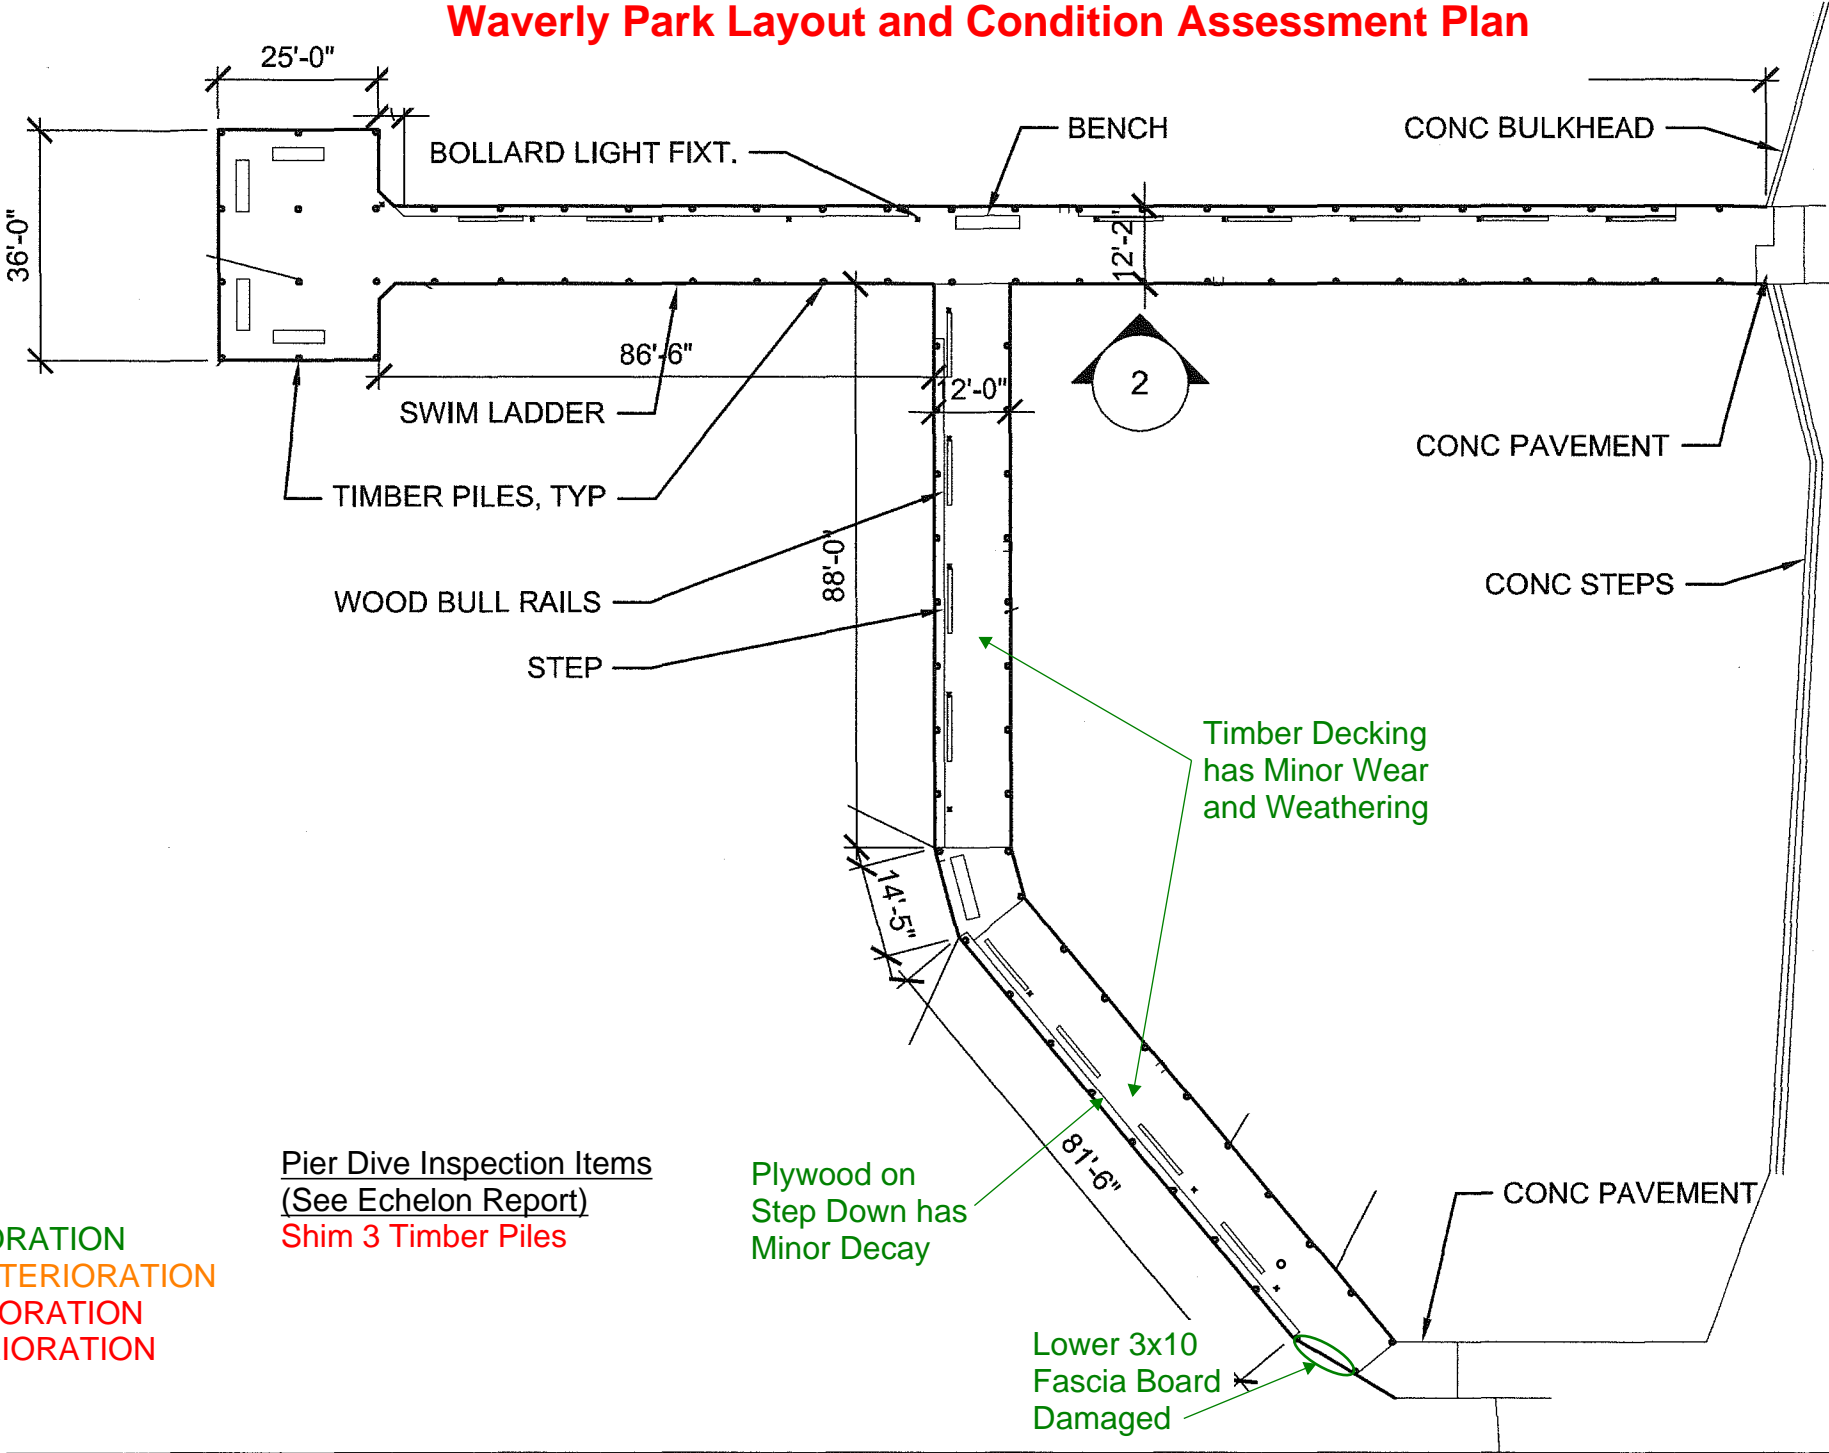
Waverly Park Layout and Condition Assessment Plan

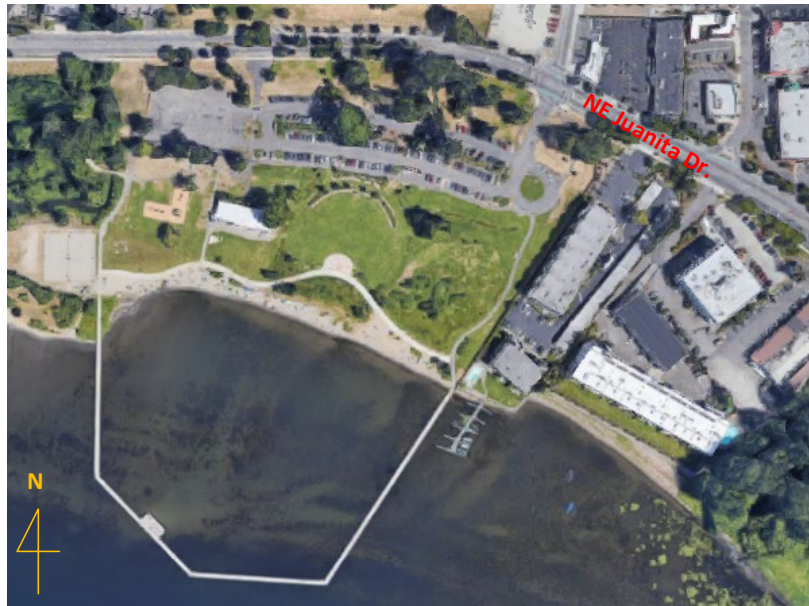
Figure 21. Juanita Beach Park Aerial.

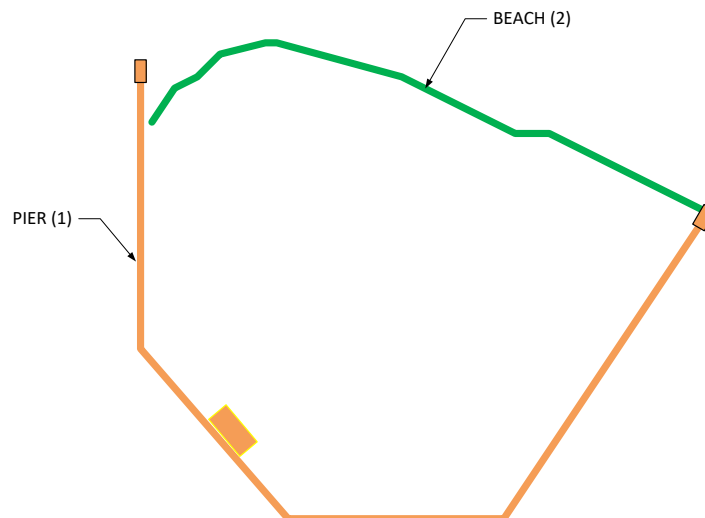
Figure 22. Juanita Beach Park Overall Condition.

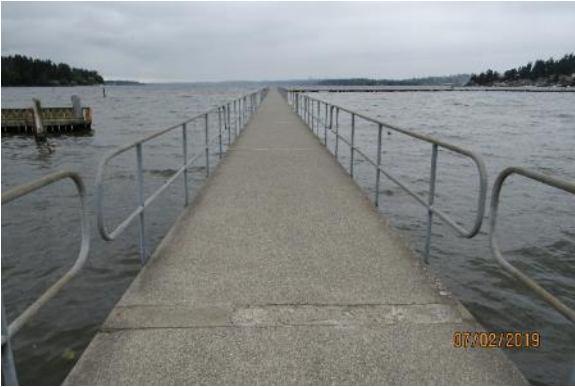
FACILITY LOCATION: 1 (Pier)		OVERALL RATING: Poor
ITEM: Pier Superstructure		ITEM RATING: Fair
PHOTO	EXISTING CONDITION / RECOMMENDATIONS

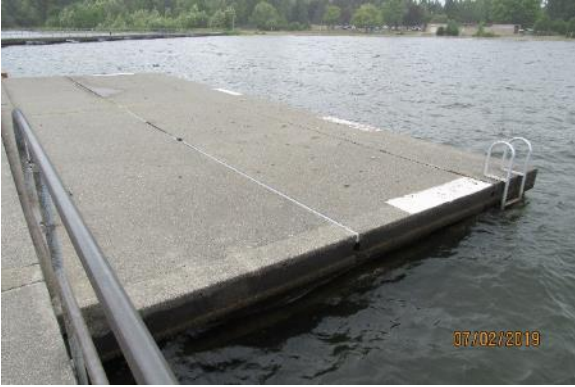
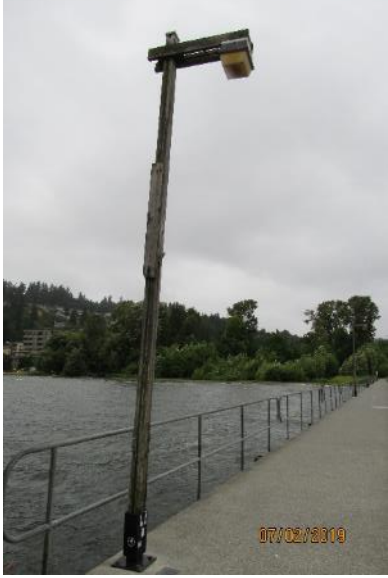
ITEM: Pier Substructure		ITEM RATING: Poor
PHOTO		EXISTING CONDITION / RECOMMENDATIONS

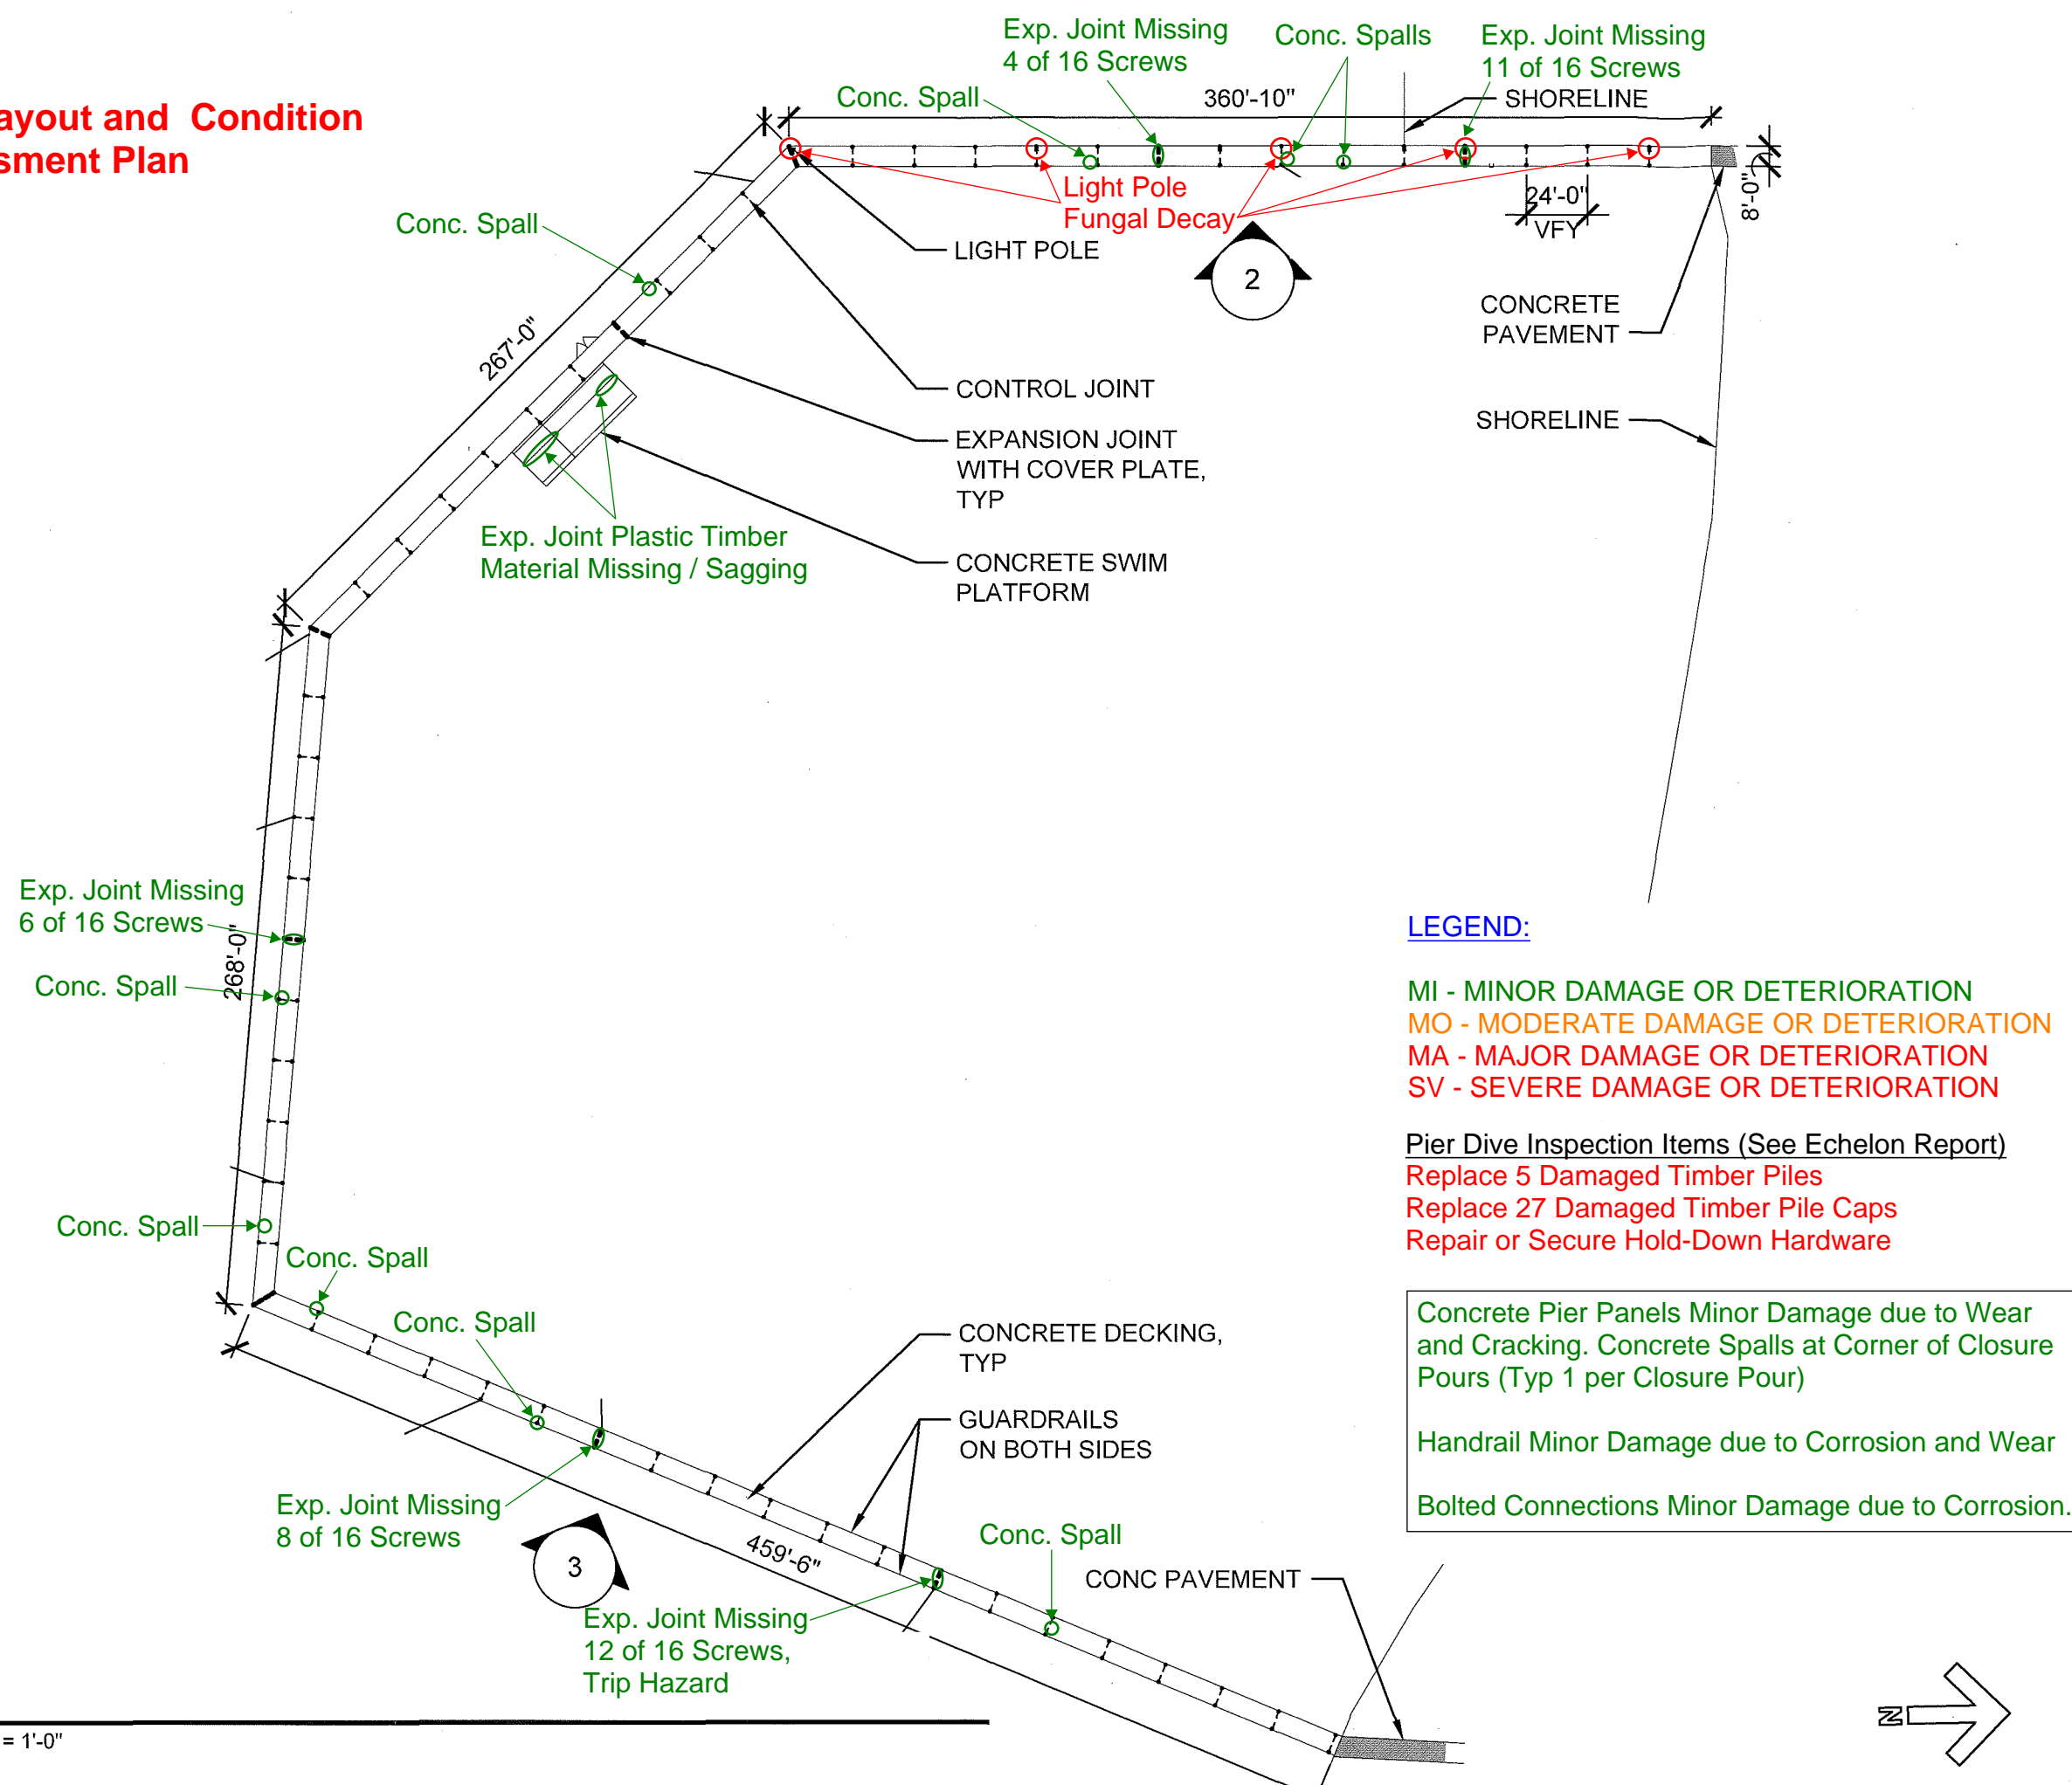
1 PIER PLAN
SCALE: approx. 1/64" = 1'-0"

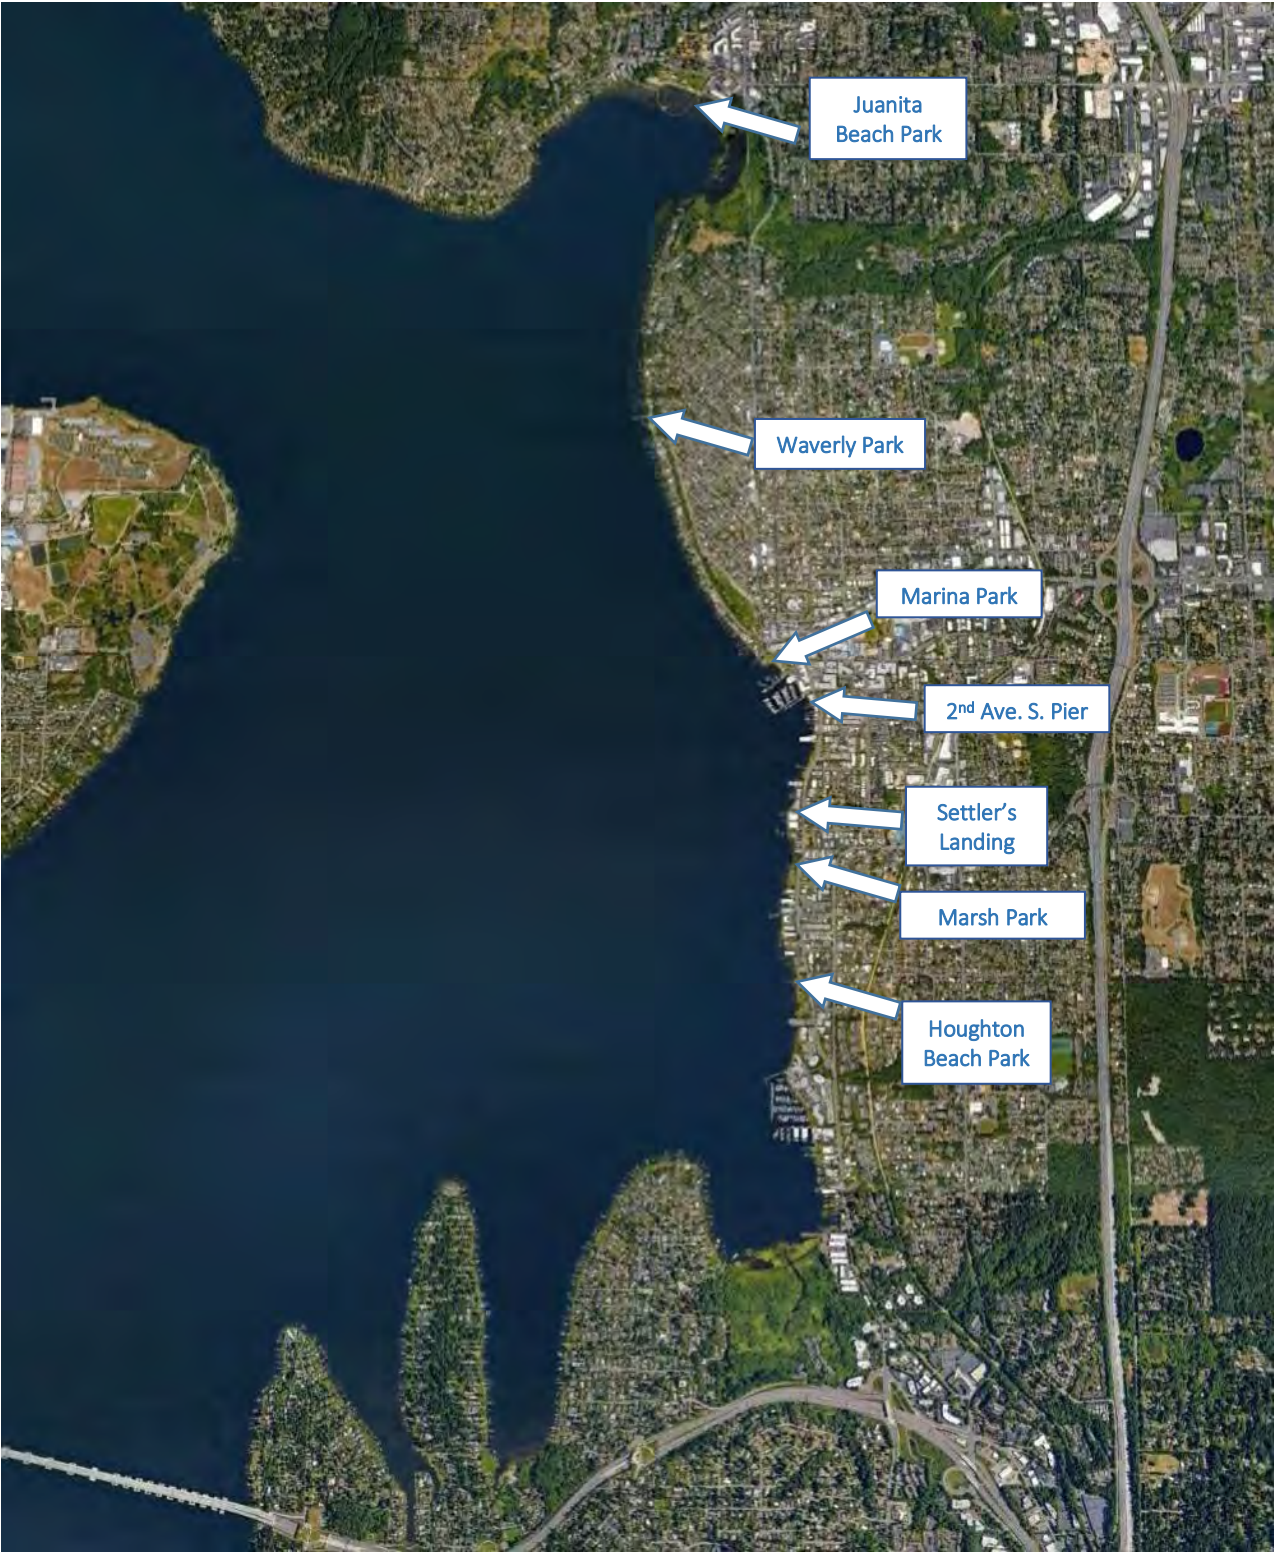
Figure 1 – Facility Locations

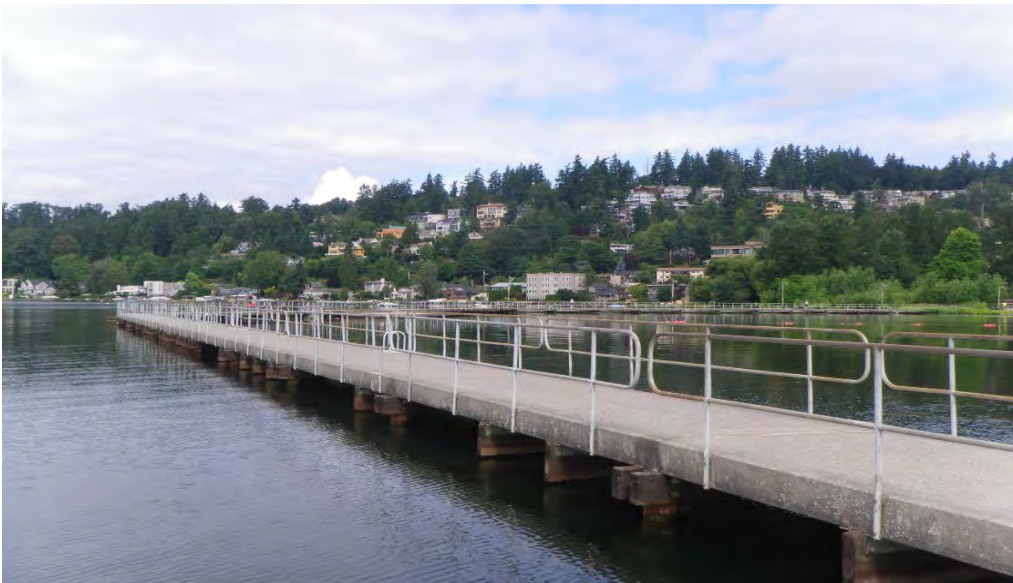
PHOTO No. 1: Juanita Beach Park, Looking West - The structure is built on treated piles with double cap timbers at each bent. Inspection noted that the piles have been notched on both sides to provide a ledger for the cap timbers. The structure has a concrete deck system, as well as an old deteriorated timber wave baffle system and diagonal steel tension rods located in areas underwater and in the plane of the deck.

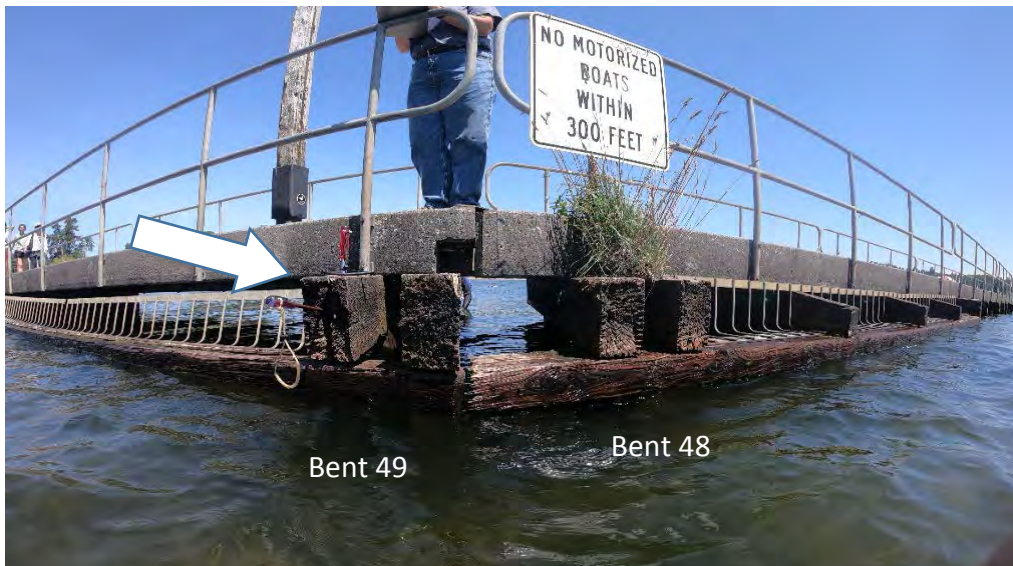
PHOTO No. 2: Bent 48-49, Row A, Looking Northeast - Note the vegetation growth located at the Bent 48, west cap. Inspection of these members found the pile top to have sustained an estimated 90% fungal decay and both cap timbers to have an estimated 50% loss of section also due to fungal decay. Inspection of the Bent 49 cap timbers also found significant damage. Note the screwdrivers inserted in the western cap (refer to arrow) which was found to have an estimated 75% fungal cavity.

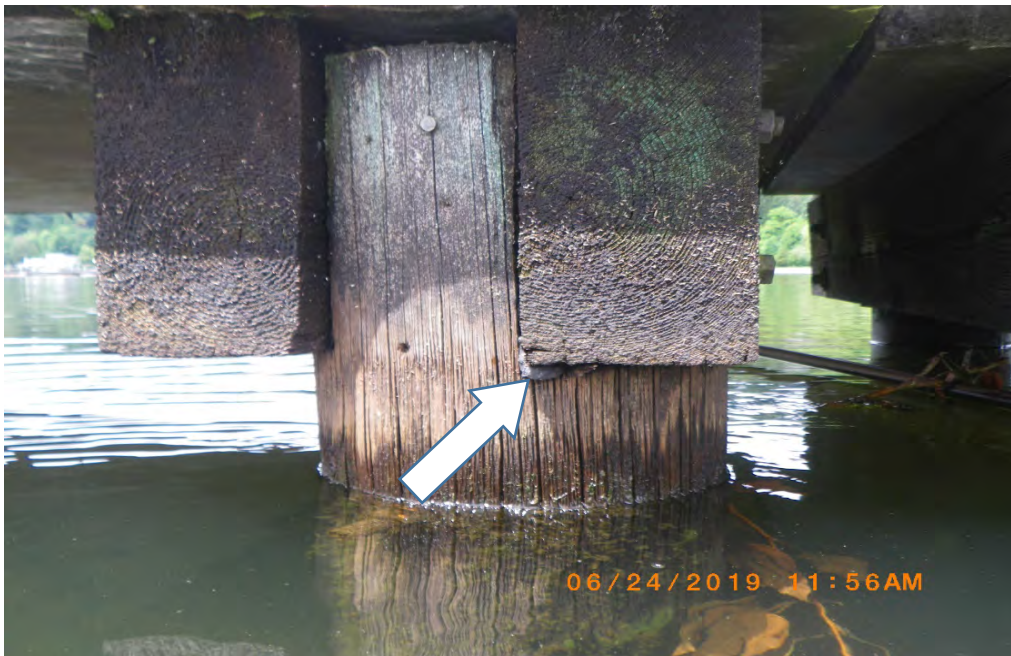
PHOTO No. 3: Bent 9, Row A, Pile / Cap Connection - Note the construction notches on both sides of the pile to provide a seat for the cap timbers. Also note the apparent field treatment of the pile at the notched areas (Refer to arrow). Inspection found that typically the piles have sustained weathering and/or minor biological degradation from the top down to low water.

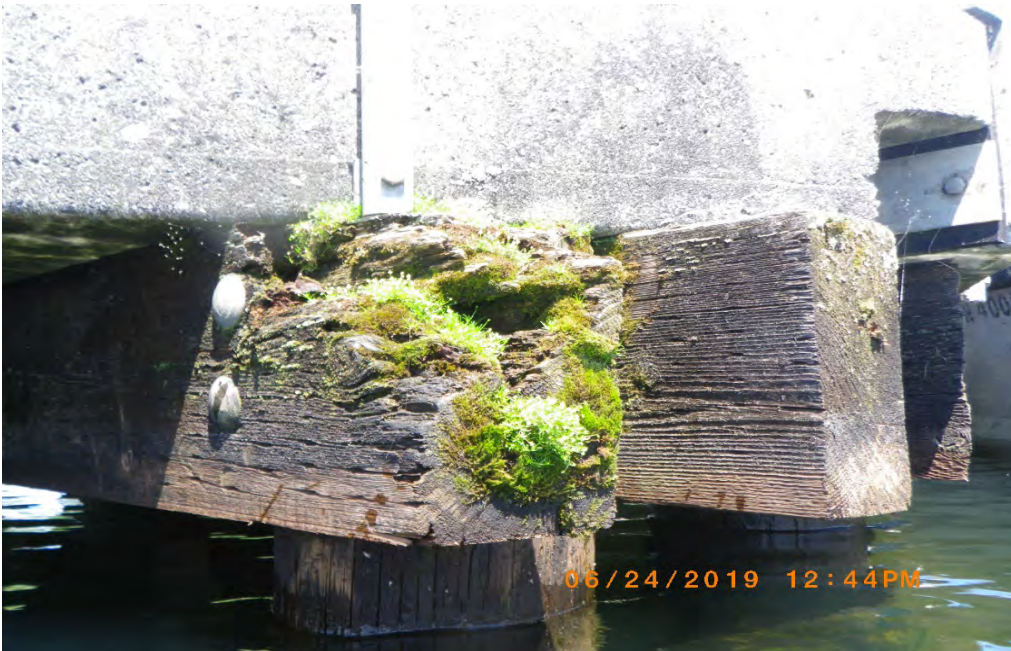
PHOTO No. 4: Bent 23, Row A - Note the 50% fungal / mechanical damage to the west cap which was found to extend from the end to the attachment bolts. Also note the overall good condition of the concrete deck panel above.

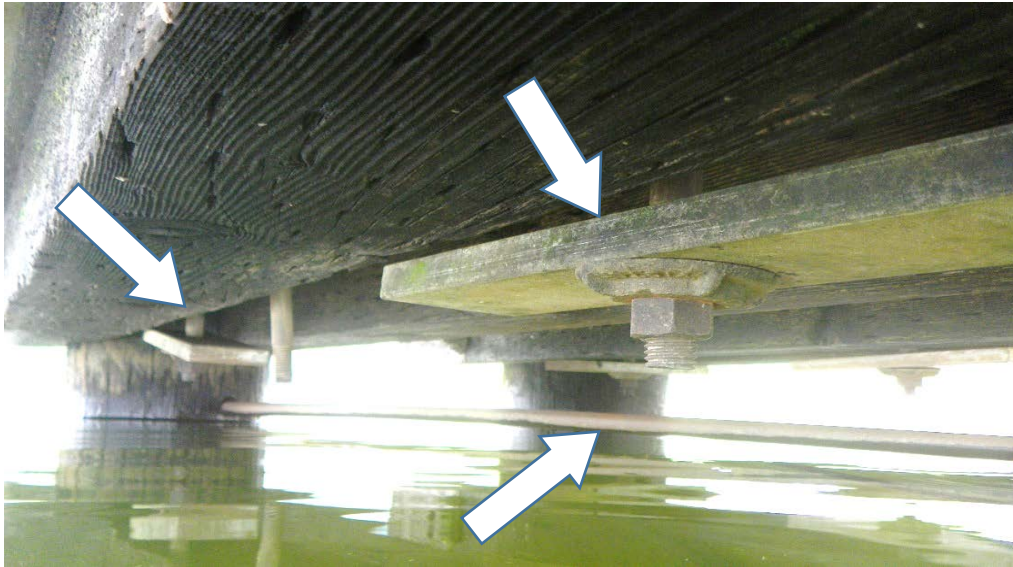
PHOTO No. 5: Bent 8 and 9, Pile Caps - Note the upper arrows indicating loose and misaligned brackets designed to secure the concrete deck panels to the timber caps. Inspection noted that throughout the structure, these brackets were found to be loose with missing components. Also note that the lower arrow indicating a set of horizontal tension rods securing the expansion joint at Bent 8-9. Investigation of these members found the general condition of the galvanized hardware is good with minimal surface corrosion.

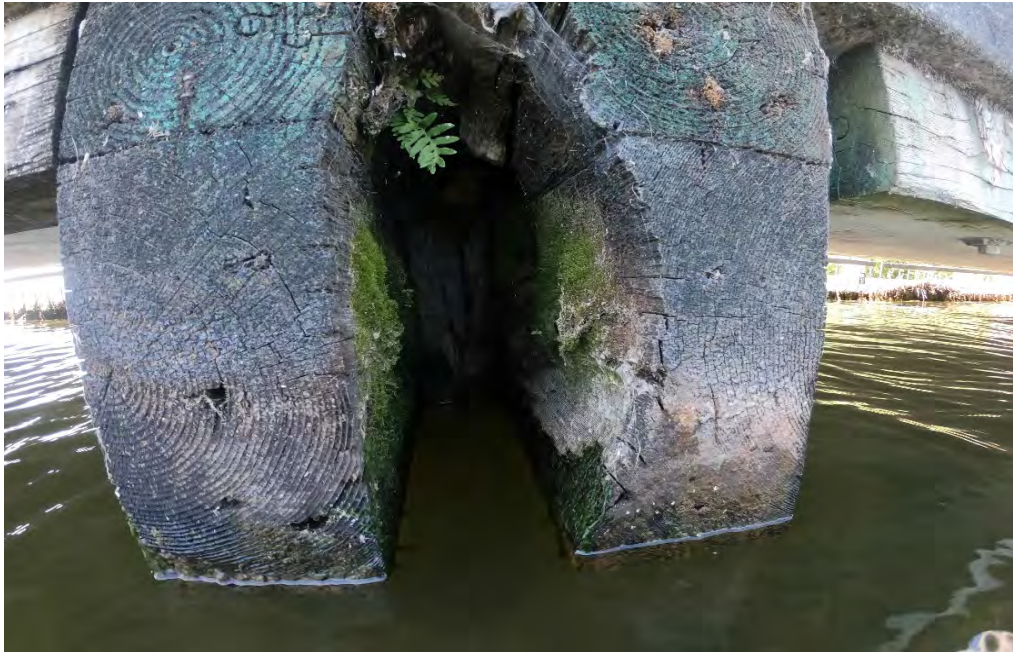
PHOTO No. 6: Bent 58, Row B, Cap Timbers - Note the fungal decay evident in the ends of these two cap timbers. Further inspection estimated the damage to be between 25-50%, with visible vegetation growth.

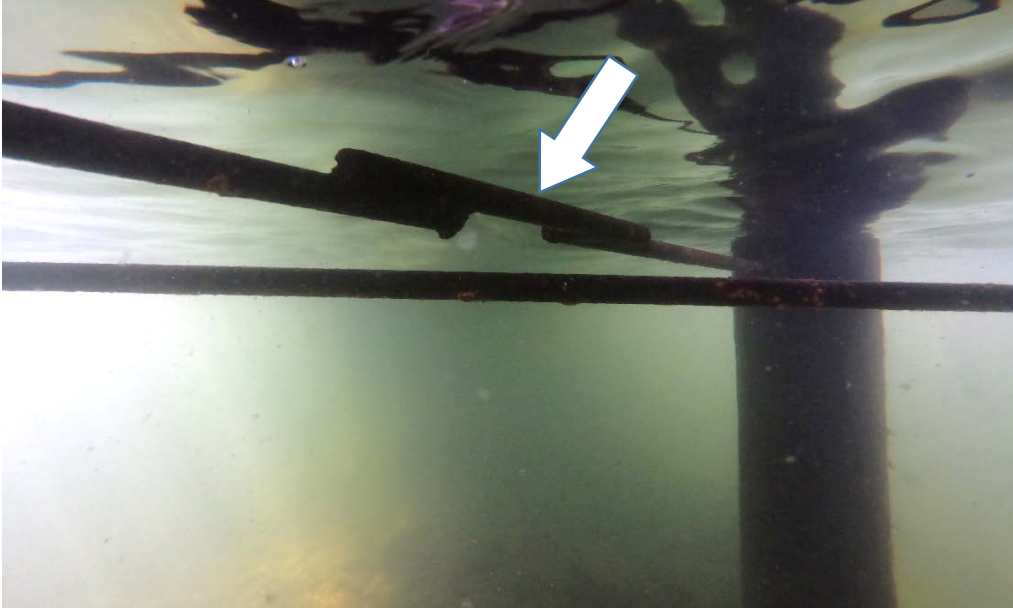
PHOTO No. 7: Bent 35 and 36, Expansion Joint Tension Rods - Inspection noted that one of the tension rods at this expansion joint has been spliced. No evidence of any damage associated with this condition was noted.

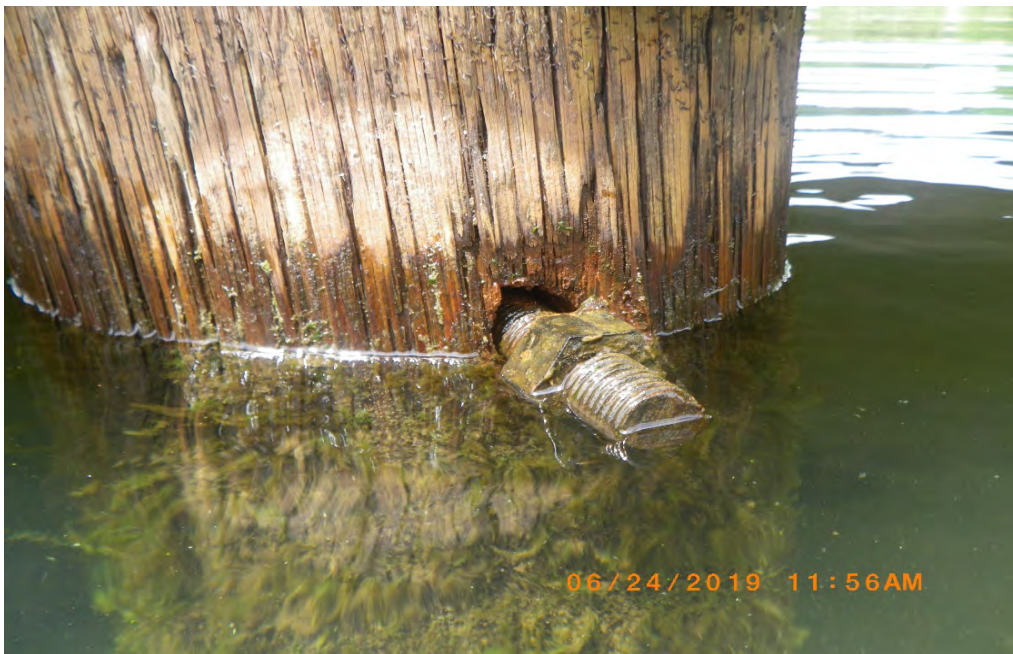
PHOTO No. 8: Bent 8, Row A Pile - Note the expansion joint tension rod connection has been reamed out due to movement over the life of the structure. This condition was found to be typical at the majority of the connections for the expansion joints. Also note that there is no washer and the pile has sustained a minor amount of weathering / biological degradation.

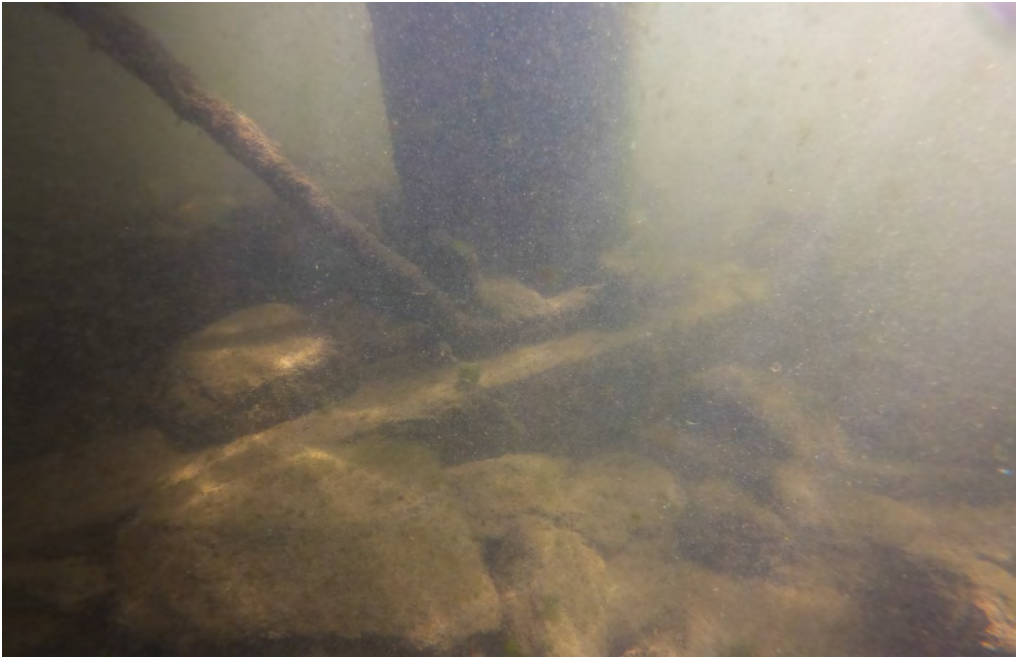
PHOTO No. 9: Bent 24, Row A Pile - Note the large dimension horizontal timbers at the mudline which appear to span between the piles. Also note the steel bracket at the base of the pile and the diagonal tension rod which extends up and is embedded in the poured in place concrete between the two cap timbers.

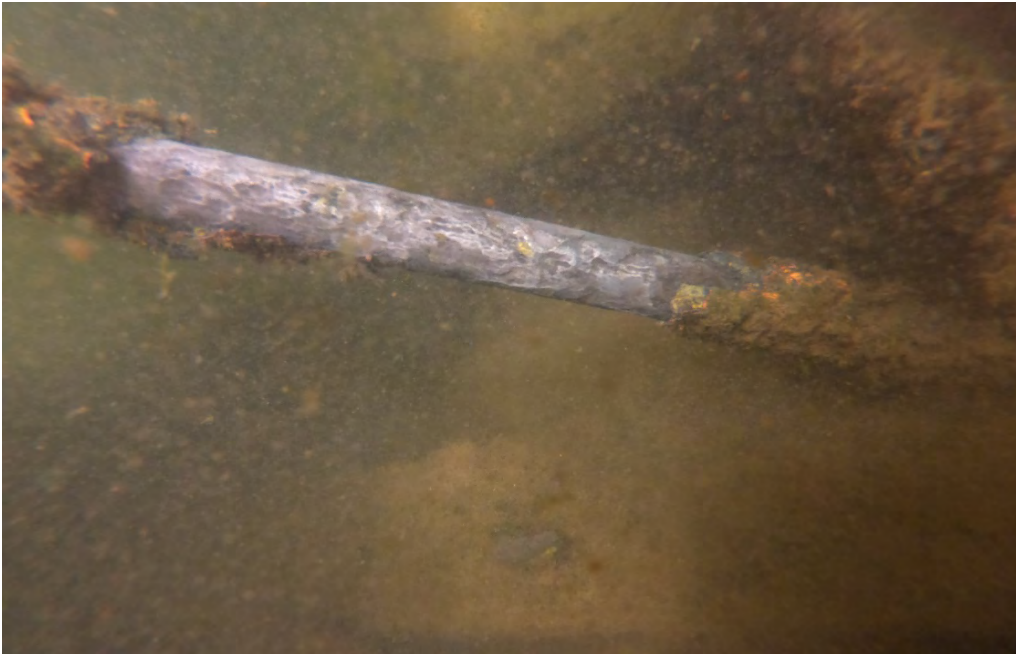
PHOTO No. 10: Bent 24, Row A-B Tension Rod - Note the overall fair condition of the steel tension rod at this location of Level II cleaning. overall, these rods were found to have sustained moderate to heavy surface corrosion with minimal visible section loss.

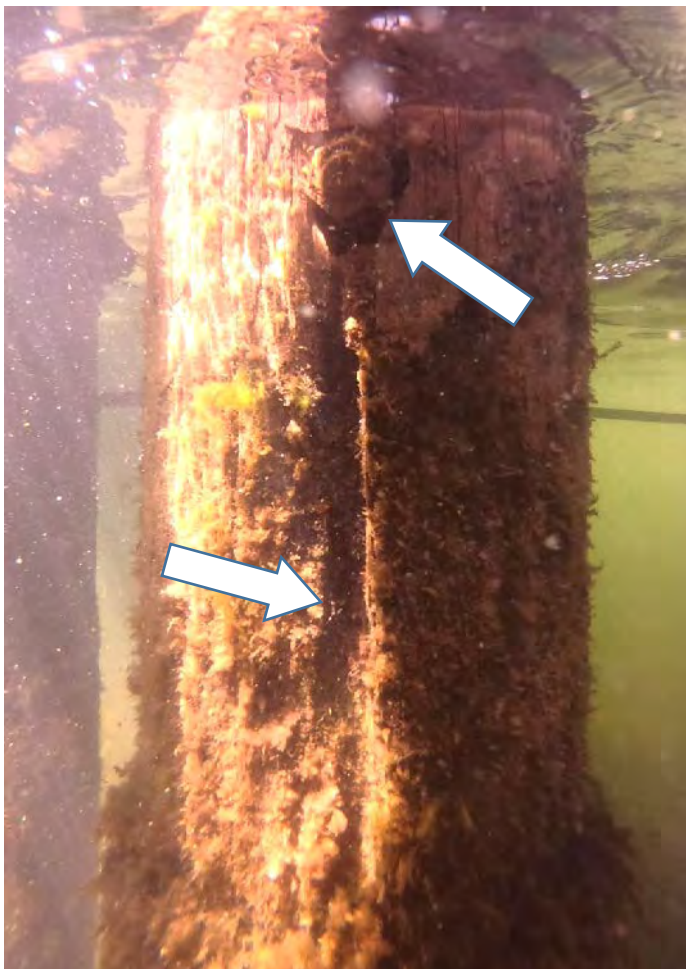
PHOTO No. 12: Bent 35, Row A Pile -
Note the reamed out connection for the expansion joint tension rod (upper arrow) and the minor mechanical damage extending vertically down the pile (lower arrows)

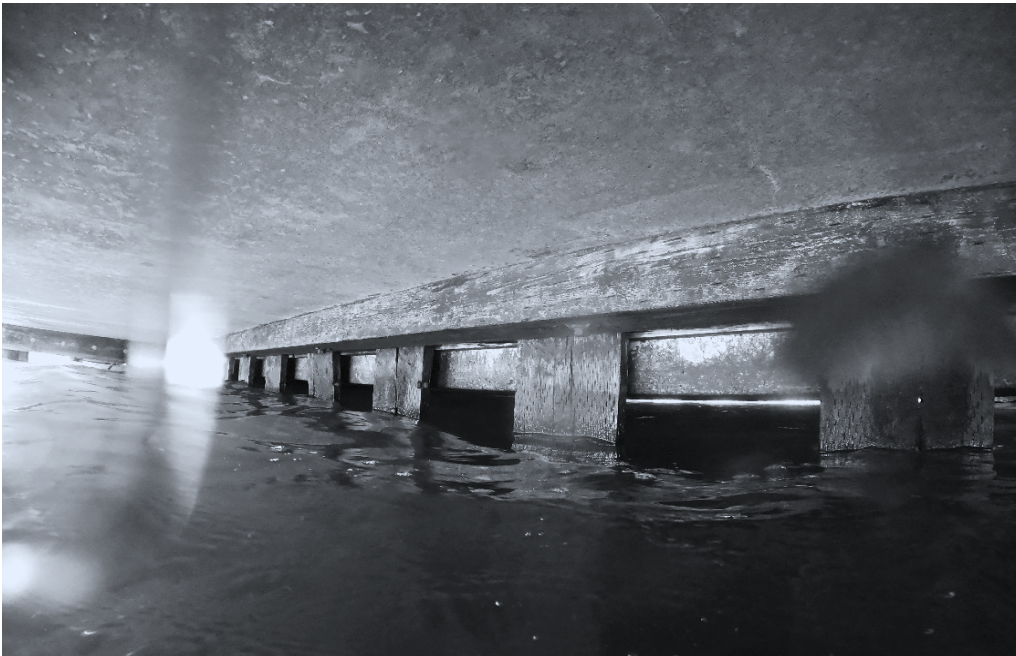
PHOTO No. 13: Bent 40 - 42, Row B, Looking West - Note the step-down in the concrete deck at the intersection of the water-walk and the swim platform along Row B. Also note the vertical boards, assumed to be a wave screen, which are secured to the underside of the deck. Investigation noted that a number of the boards appear to have gone missing or to have been removed.

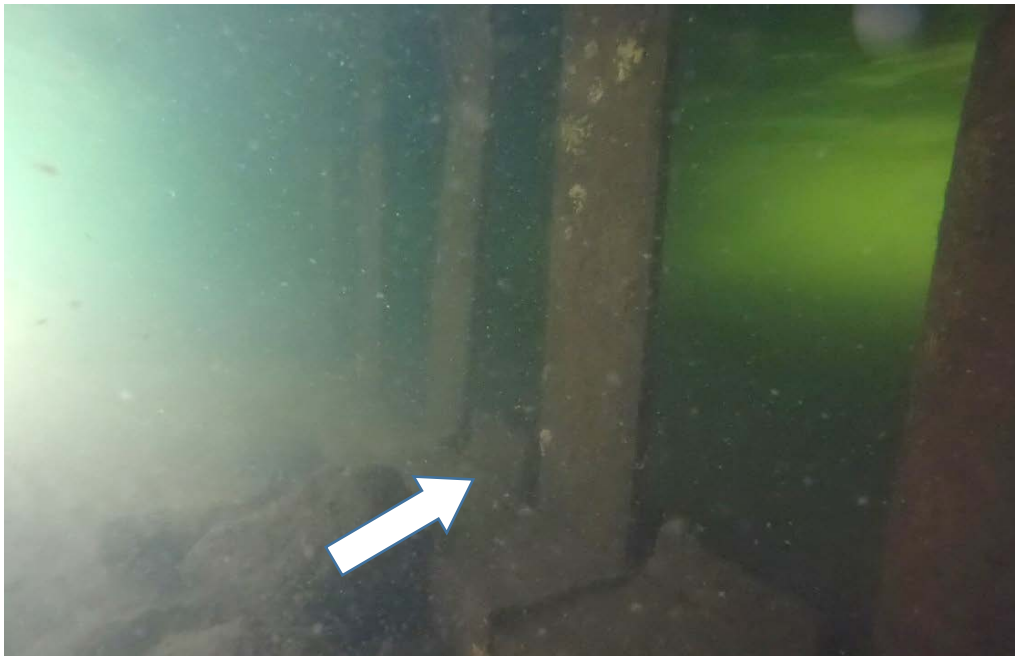
PHOTO No. 14: Bent 40 - 42, Row B, Looking West - Note the arrow indicating a missing or removed board. Inspection noted these 2x12's to be intermittent and to extend from the deck, down to the mudline.

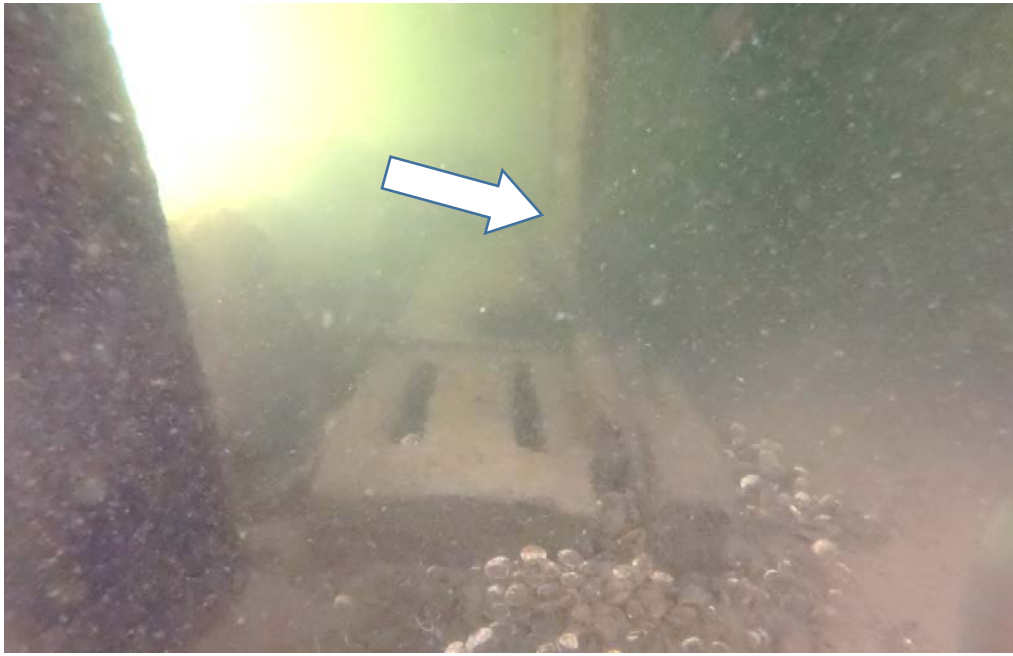
PHOTO No. 15: Bent 40 - 42, Bottom Wave Screen Connection - Note the arrow indicating a vertical 2x12 board. Also note the timber framing members embedded in the lake bottom that appear to secure the bottom ends of these boards.

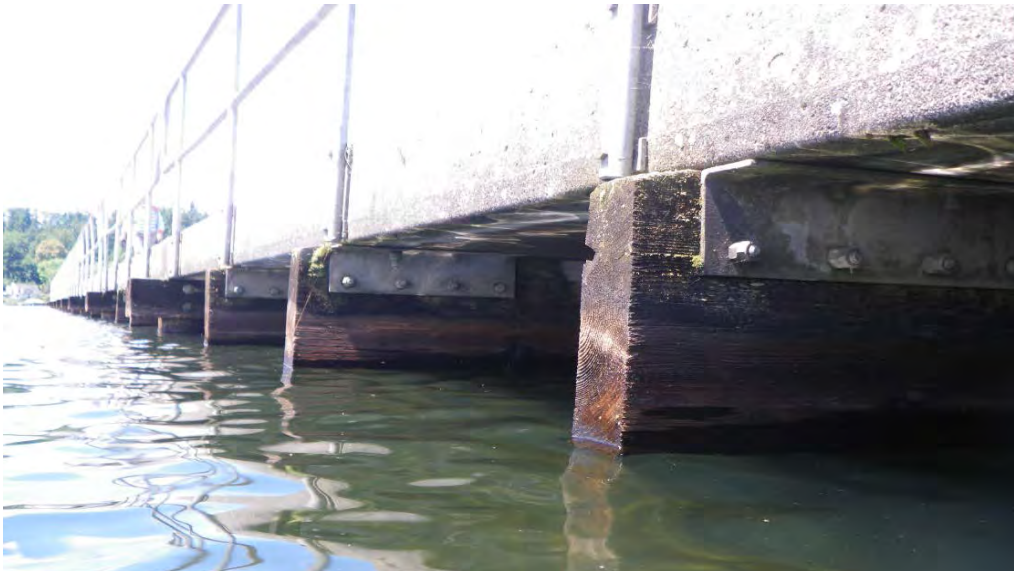
PHOTO No. 16: Bent 23, Row A, Looking West - Note the large baffle timbers attached to the underside of the concrete deck with galvanized angle brackets and hardware. Inspection found the timbers and the associated hardware to be in generally good condition. However, a number of the timbers appear to have gone missing. Inspection noted that these wave baffle board are located between Bent 22 through 48.

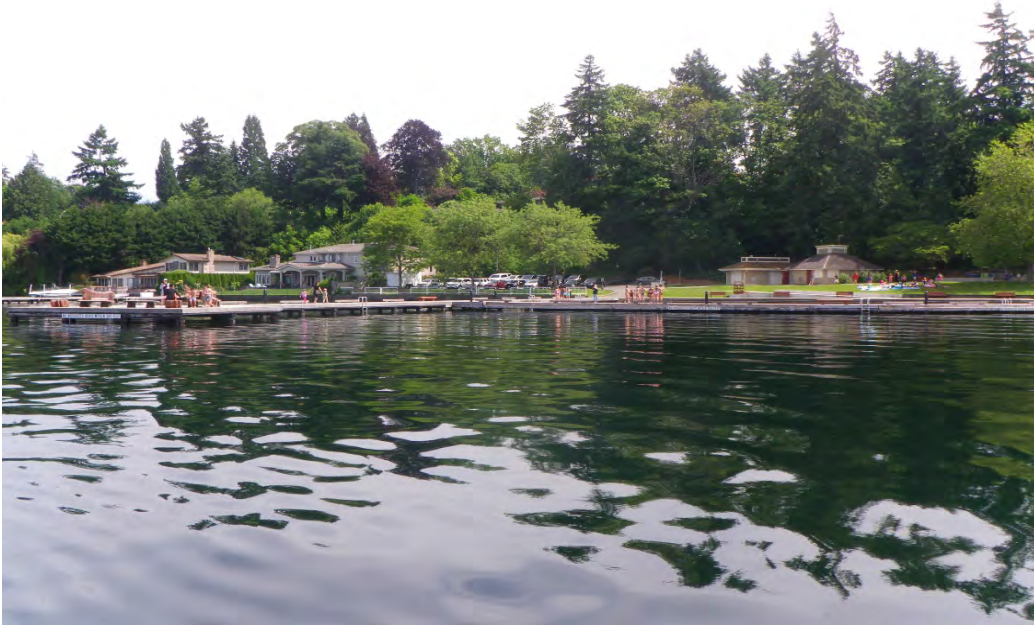
PHOTO No. 1: Waverly Park Pier, Looking Northeast - The pier is constructed on timber piling with timber caps, stringers and decking.

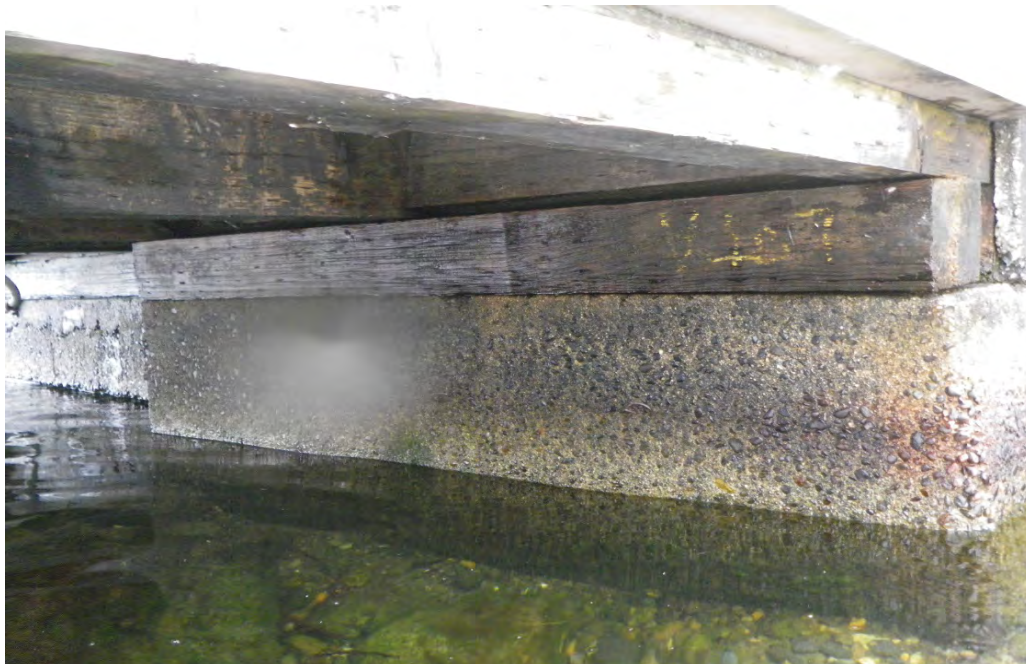
PHOTO No. 2: Shore Abutment - Note the overall good condition of the treated 6x6 cap, stringers, as well as the concrete abutment which has sustained minor loss of surface paste. Also note the rock and gravel that comprise the mudline near the shore.

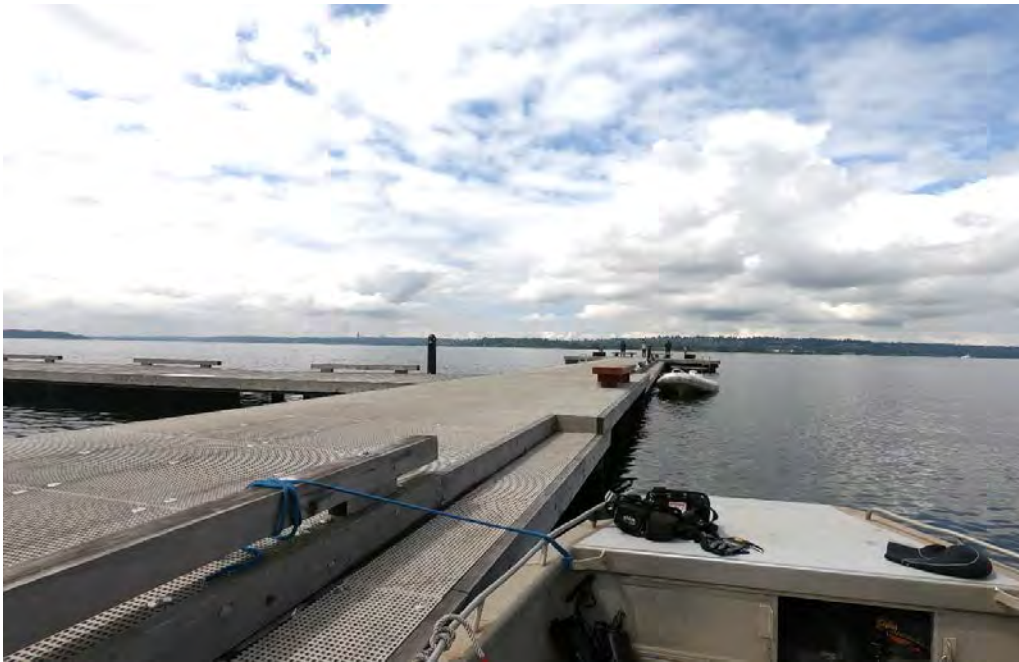
PHOTO No. 3: Main Approach, Looking West - Note the overall good condition of the composite / plastic deck used in the majority of the structure. Also note the secondary access which is decked with timber planks and extends to the south before curving to the east (shore).
