KIRKLAND PARKS & COMMUNITY SERVICES

Shoreline Structures Assessment Kirkland, Washington

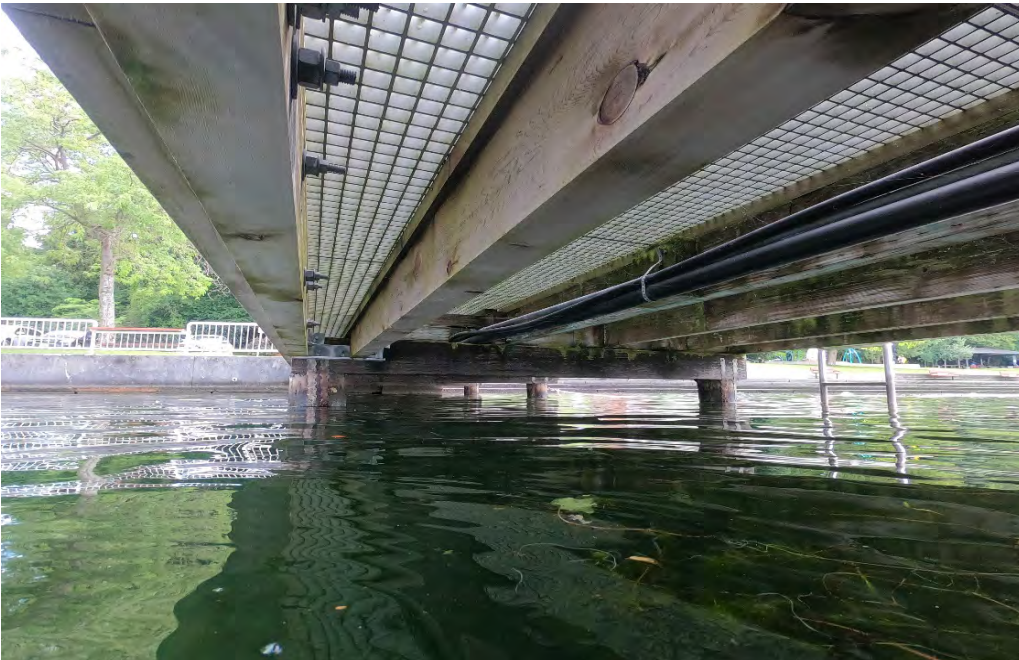
PHOTO No. 4: Main Approach, Looking West - Note the use of untreated stringers to support the lower elevation deck which runs along the perimeter of the structure. Also note the overall good condition of the utilities secured to the superstructure.

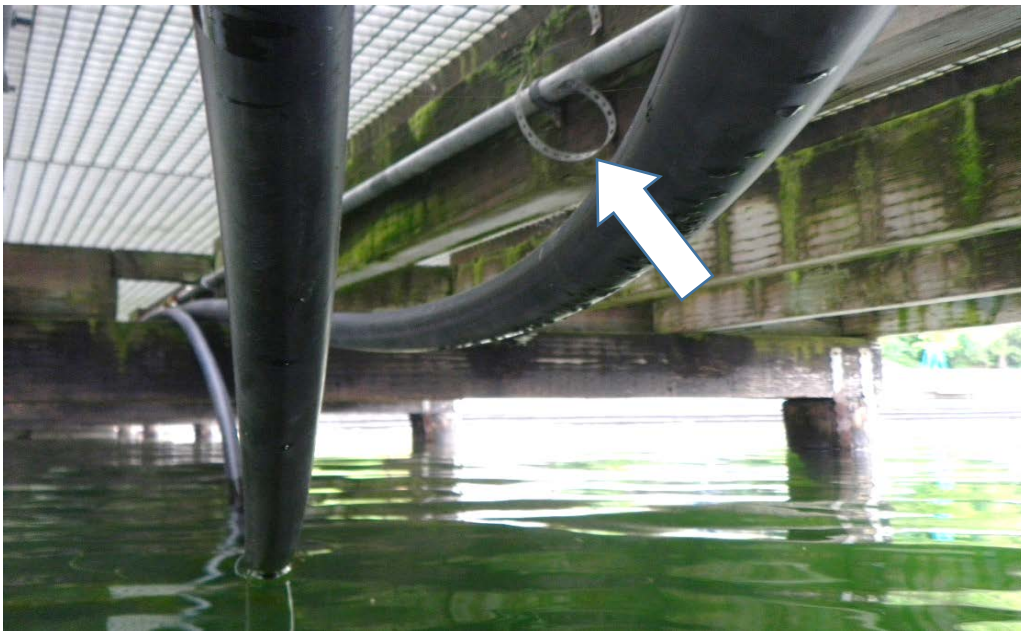
PHOTO No. 5: Bent 6-7, Unsupported Utilities - Note the arrow indicating a failed utility hanger. Also note the overall good condition of the treated stringers and pile caps which have visible algae growth and water staining, but no significant defects.

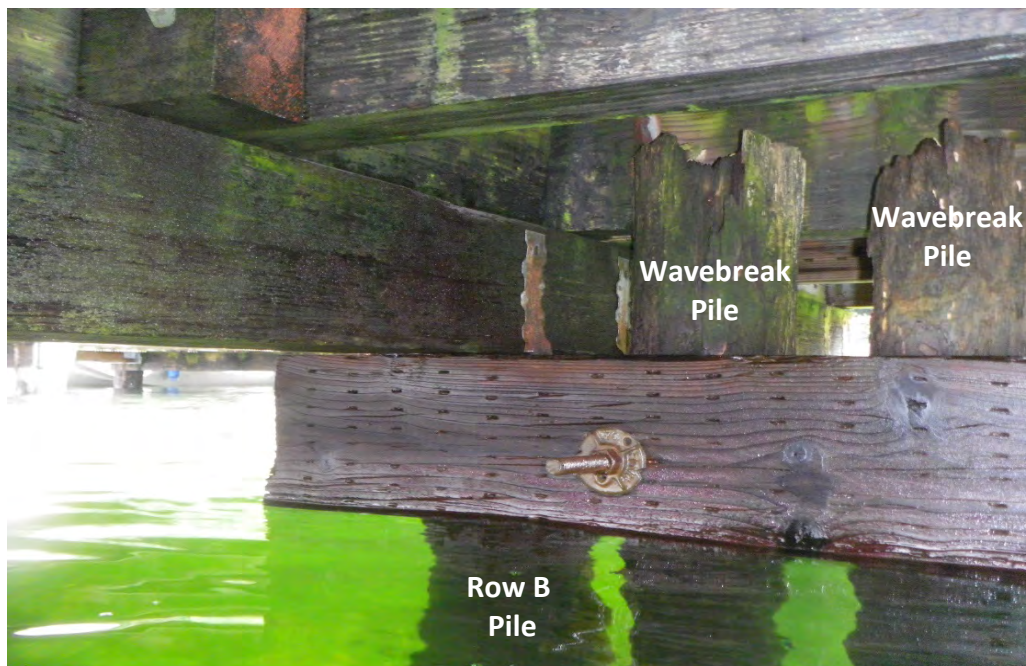
PHOTO No. 6: Bent 22, Row B, Wavebreak - Inspection found that a number of the wavebreak piles have been used to support the individual caps from Bent 22 - 37. Note the Row B pile in this Bent is bearing beneath the cap, and also functioned as a wavebreak pile. Also note the light corrosion of the Simpson ties used to secure the pile to the cap. The timber piles, to the right, appear to have been a wavebreak at some point in the past.

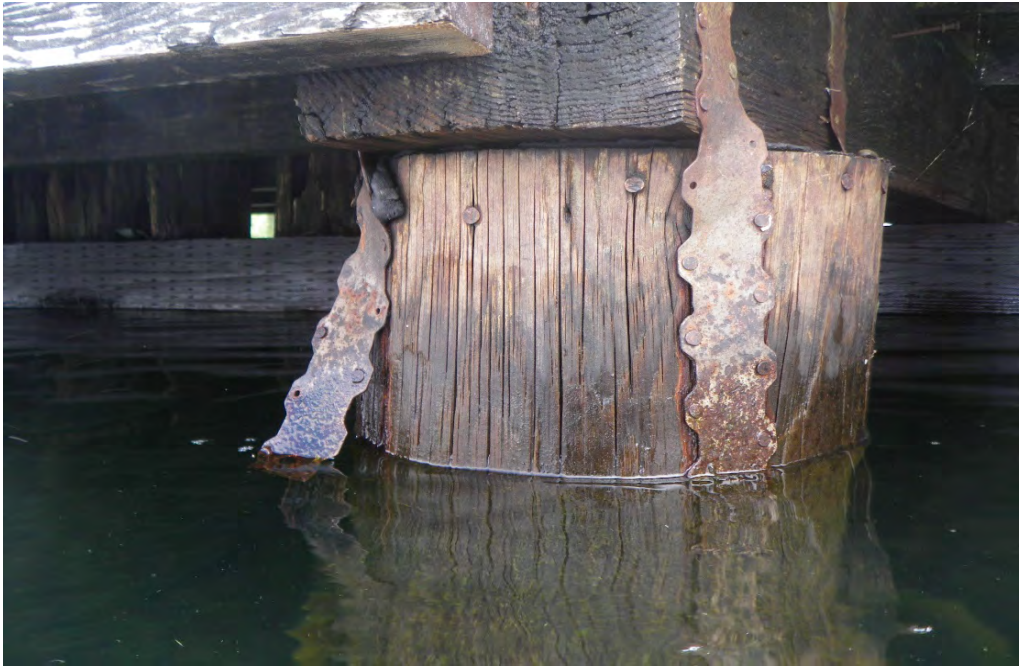
PHOTO No. 7: Bent 36, Row A Pile - Note the moderate to heavy corrosion of the Simpson ties used to secure the pile top / cap connection. Also note that the nails securing the straps are failing and the left strap is not secured. Inspection found the majority of the piles to be treated and to have sustained a minor amount of biological degradation or softening of the outer surface.

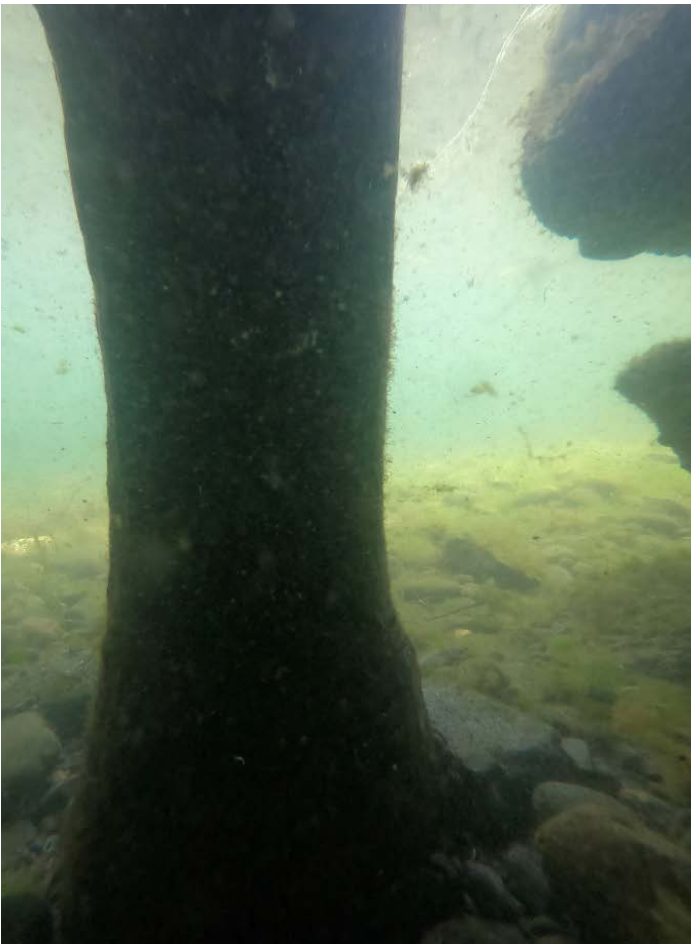
PHOTO No. 8: Bent 37, Row C Pile - Note the thinning of the pile near the mudline, which appears to have been caused by abrasion. Inspection of the timber found it to be generally sound with minor softening of the surface.

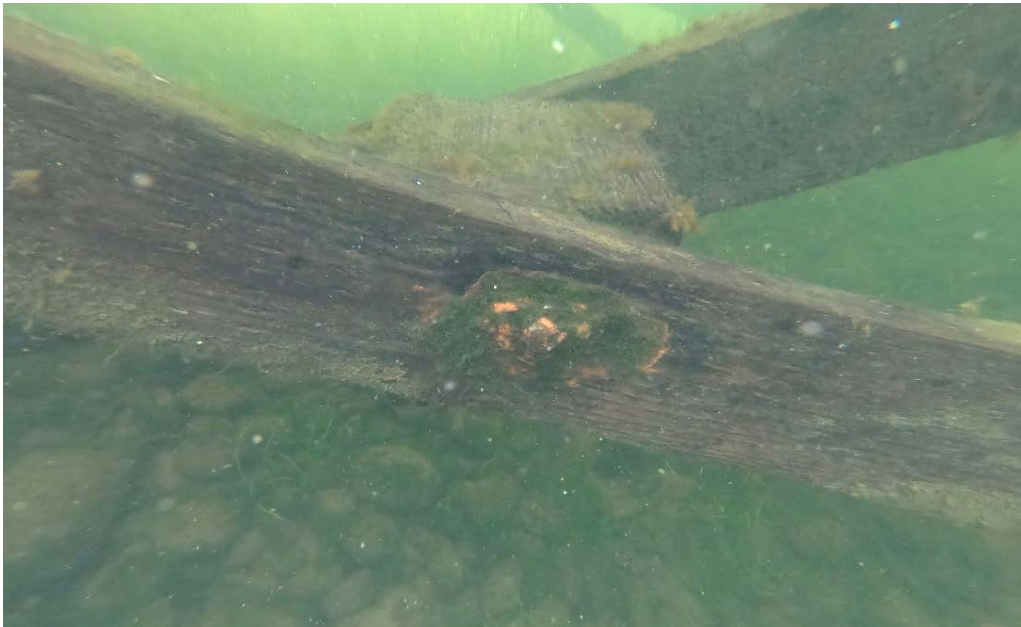
PHOTO No. 9: Bent 4 -5, Row A, Diagonal Bracing, Looking South - Note the moderate corrosion of the thru-bolt and the use of a center block at the mid-connection on this set of diagonal braces. Inspection found the bracing timbers to be in generally good condition with no evidence of any gross damage.

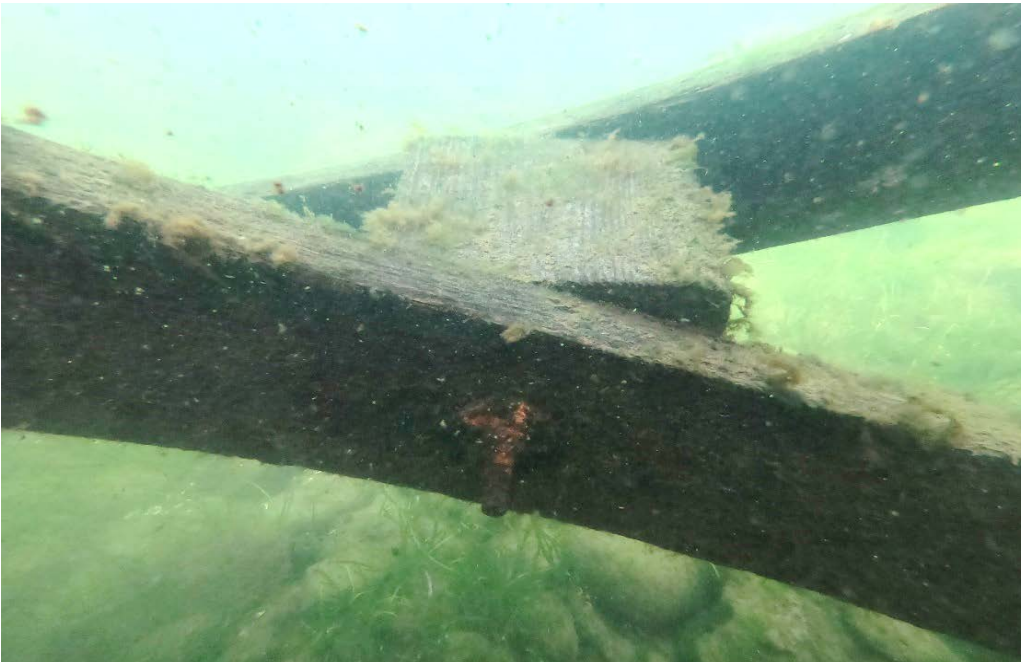
PHOTO No. 10: Bent 4 -Bent 5, Row A, Diagonal Bracing, Looking North - Note the overall good condition of the treated timber brace and center block. Also note the 2-4 inch rock that comprises the mudline in this shoreward area.

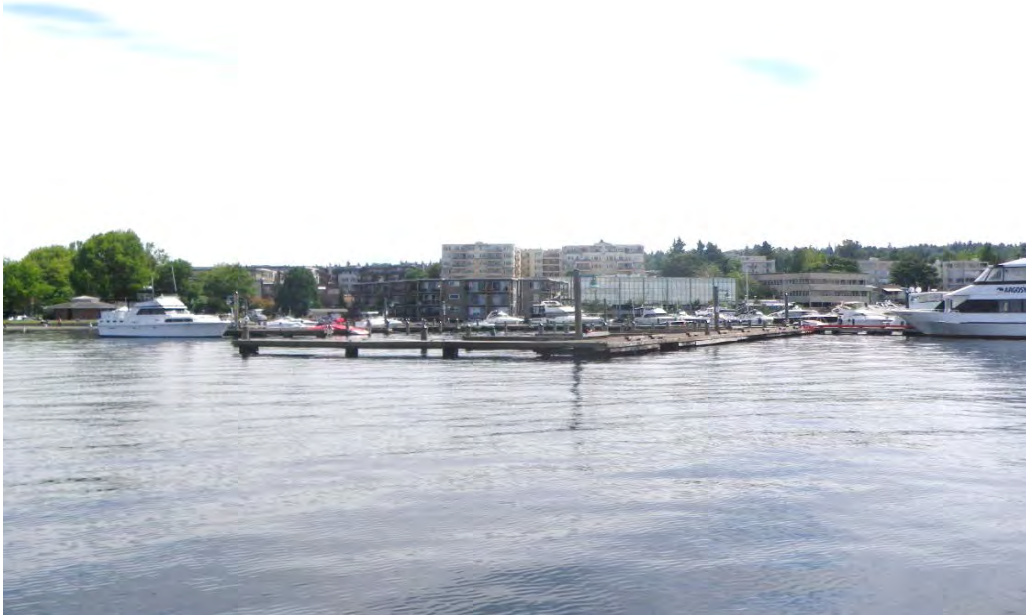
PHOTO No. 1: Marina Park, Main Pier, Looking Southeast - The structure is constructed using typical timber construction with treated timber piles, pile caps, stringers, and decking. Note that a number of the piles extend above the elevation of the deck.

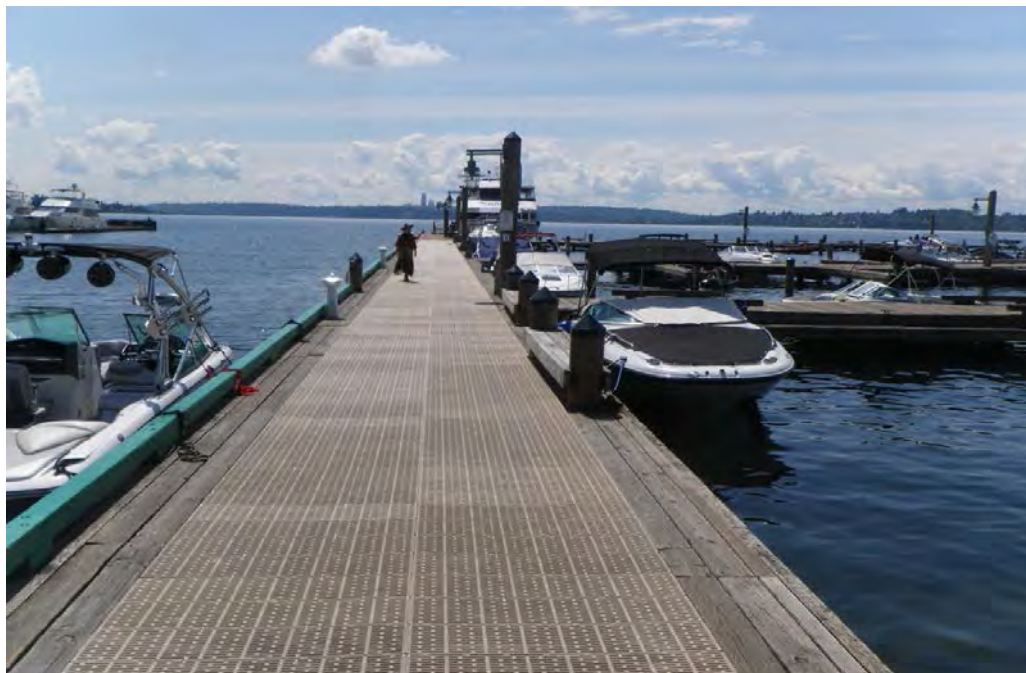
PHOTO No. 2: Main Approachway, Looking West - Note the overall good condition of the composite / plastic decking, the bull rail and the various benches along the structure. Also note the multiple piles which extend up above the deck elevation.

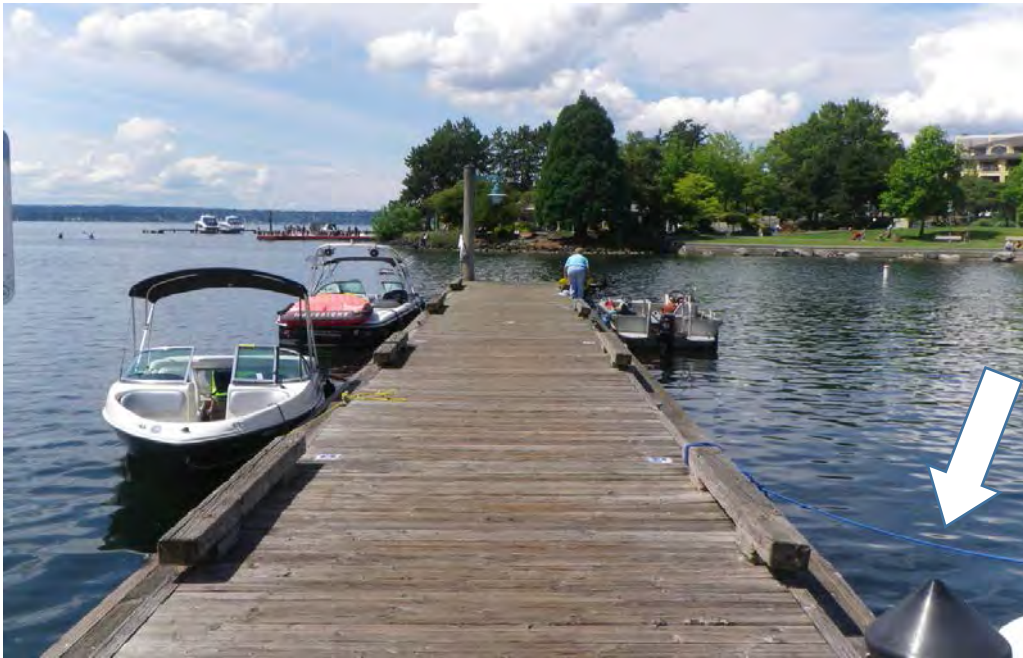
PHOTO No. 3: Eastern Finger, Looking North - Note the generally good condition of the timber decking and the arrow indicating a plastic pile cap located on the Bent 5, Row A Pile.

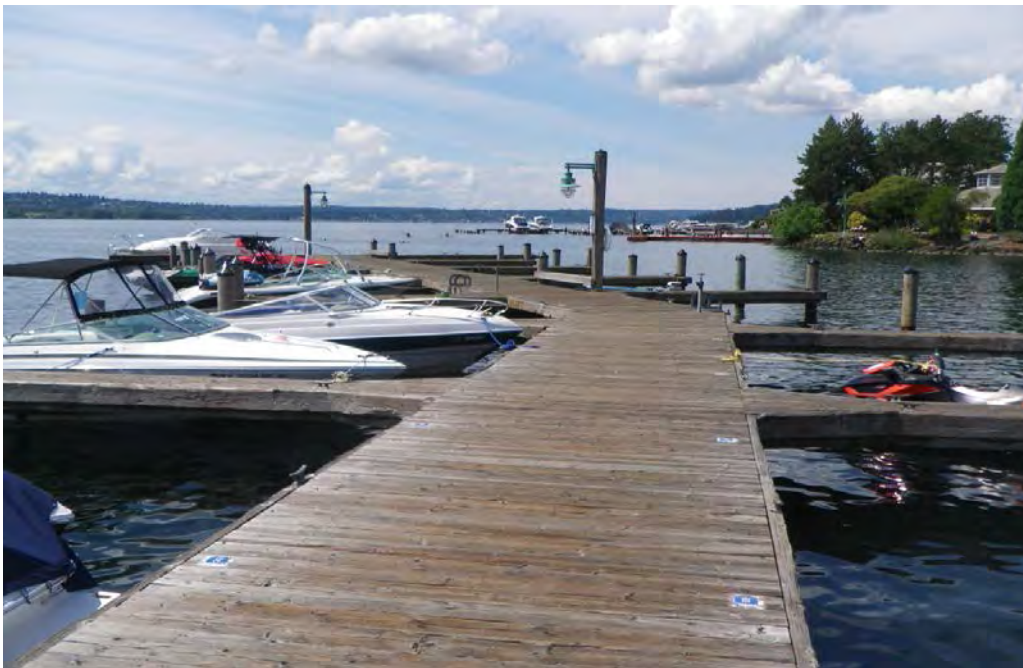
PHOTO No. 4: Center Mooring Finger, Looking North - Note the two light posts which were found to be driven timber piles, and the Row D piles to the right which extend up above the elevation of the deck and serve as mooring piles. Also note the majority of these piles are capped with a plastic cap to prevent accelerated damage to the pile tops due to fungal decay.

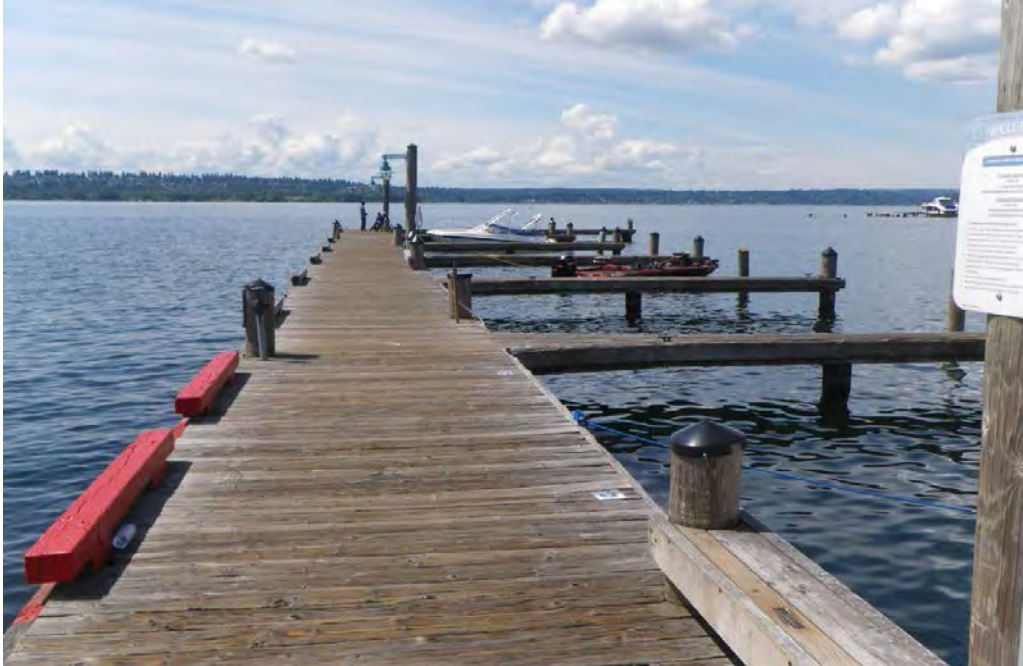
PHOTO No. 5: Western Mooring Finger, Looking Northwest - Note the overall good condition of the timber decking, bull rail, and bench. Also note the piles that extend above the elevation of the deck and the plastic caps covering the pile top end grain on the majority of the piles.

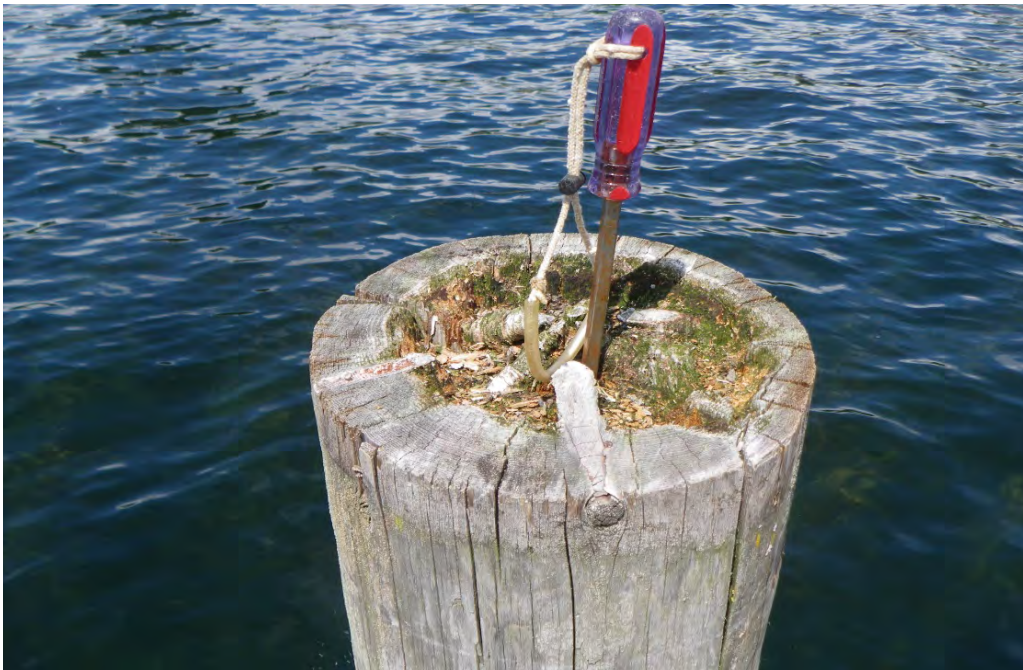
PHOTO No. 6: Bent 56, Row D Pile - Inspection found that is pile has sustained an estimated 75% fungal damage extending from the pile top down approximately 1 ft. This pile was also noted to not have a plastic cap protecting the end grain of the pile.

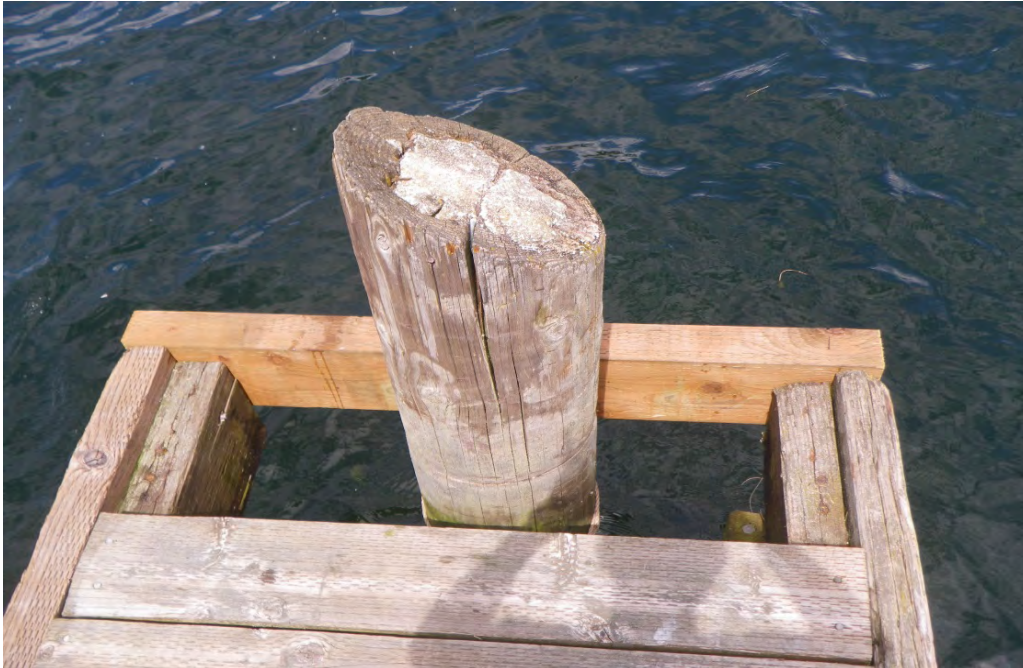
PHOTO No. 7: Bent 88, Row E Pile - Note the center of the pile has been filled with concrete grout. Inspection of the pile estimated that the pile has internal fungal damage below the concrete which extends down several feet. Also note the missing plastic cap and the new edge member indicating on-going maintenance of the framing and decking at this location.

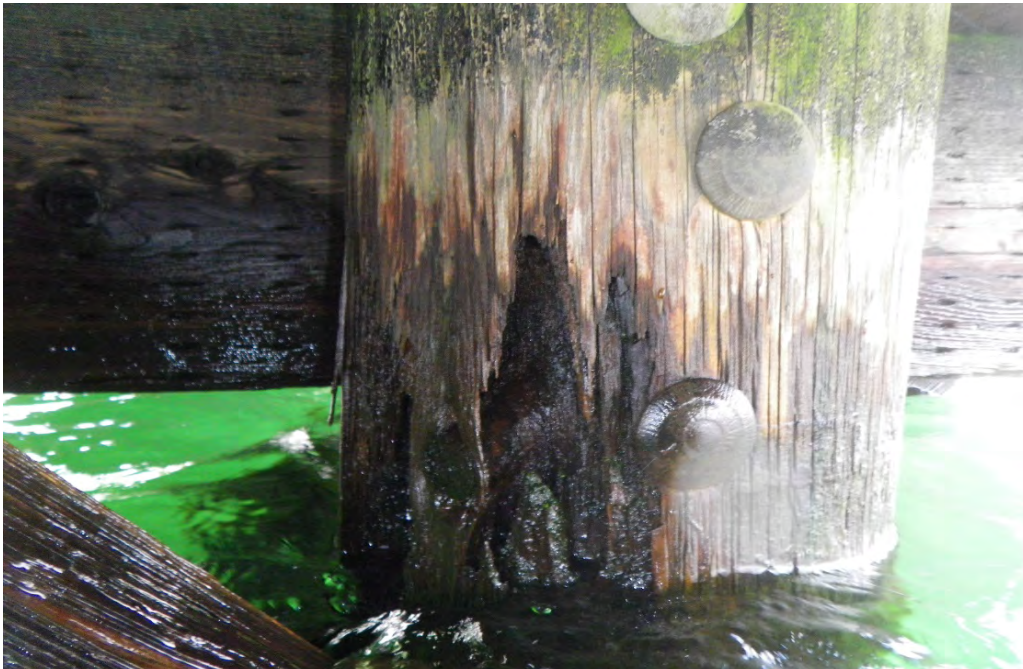
PHOTO No. 8: Bent 60, Row B Pile - Note the fungal damage at the waterline of this pile. Inspection found this decay to be localized at this location resulting in an estimated 10% loss of section. Also note the generally good condition of the cap timber which is bolted to the pile.

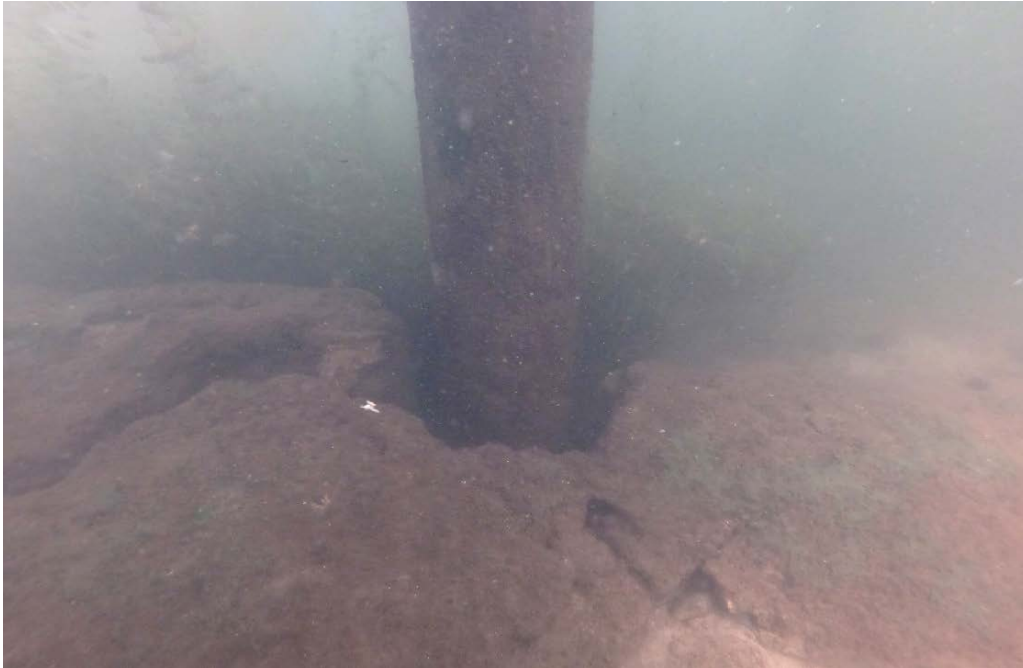
PHOTO No. 9: Bent 46, Row C Pile - Note the generally good condition of the pile, as well as the algae growth covering the surface in the submerged zone. This was found to be typical of the piles throughout the facility in the submerged zone.

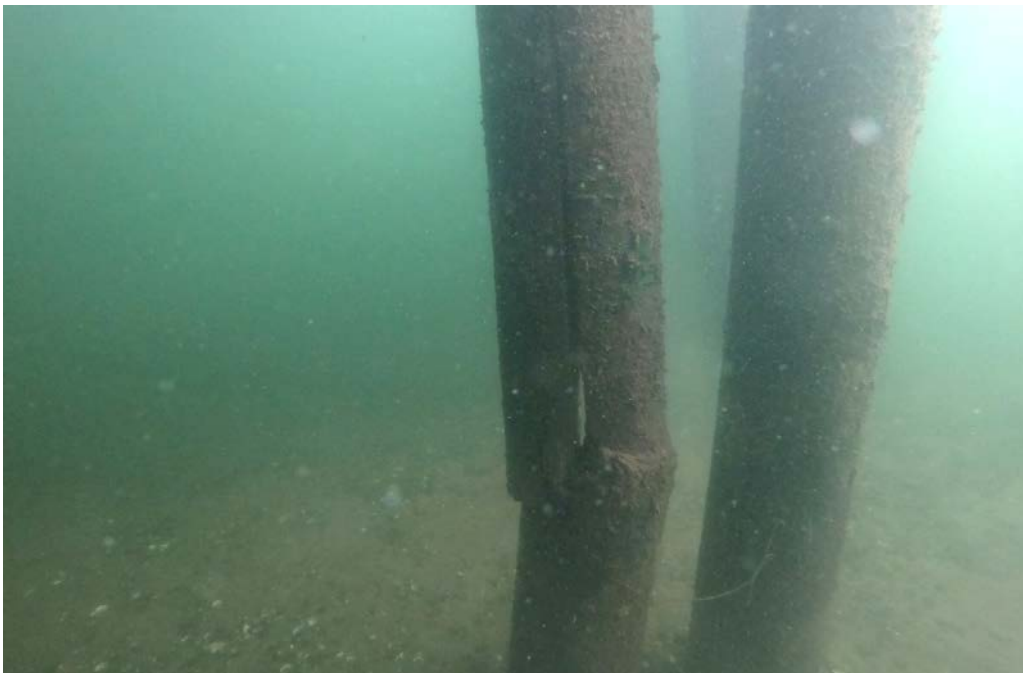
PHOTO No. 10: Bent 30, Row A Pile - Inspection found this pile to have failed near the mudline. Note that the pile is split vertically and broken at this elevation. Also note the good condition of the adjacent Bent 29.8, Row A pile which functions as a light post.

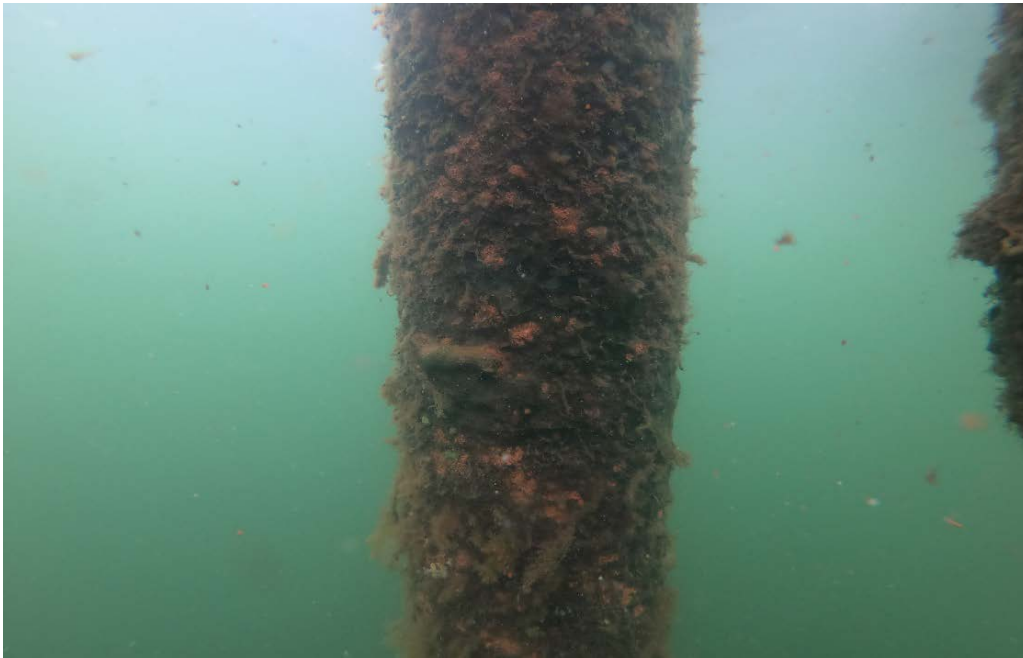
PHOTO No. 11: Bent 88, Row D, Steel Sleeved Pile - Note the algae growth, surface corrosion and rust nodules visible on the steel pipe pile sleeve which appears to have been installed over the top of the original timber pile. No apparent lag bolts or other hardware was noted securing this sleeve to the timber stub.

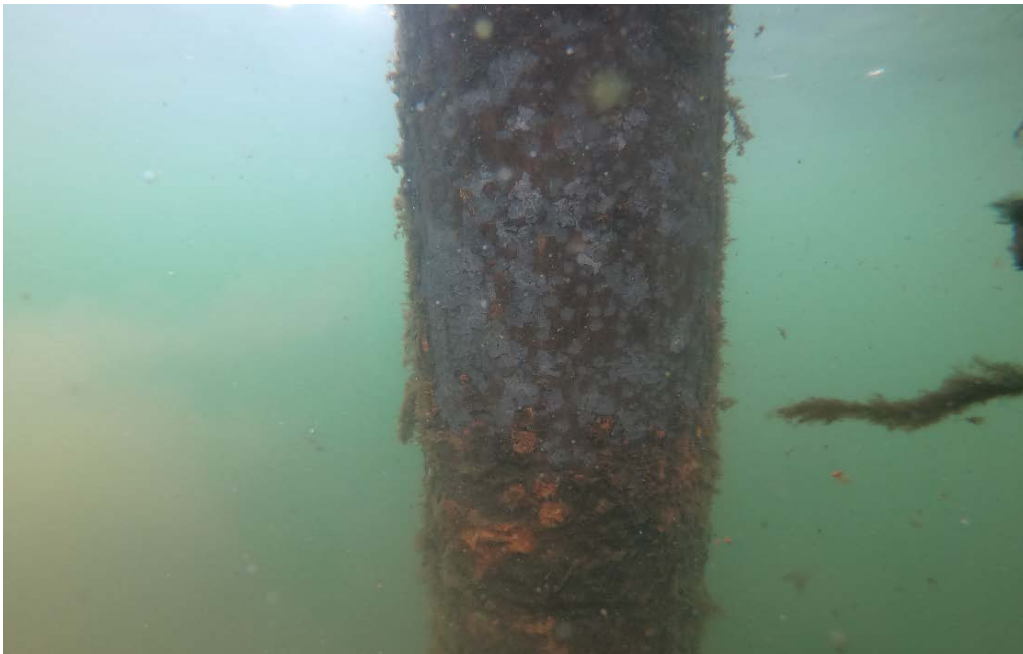
PHOTO No. 12: Bent 88, Row D, Steel Sleeved Pile - Note the rough surface of the steel sleeve in this area of Level II cleaning. Although pitting of the base metal was visible, no areas of significant section loss or perforation were noted.

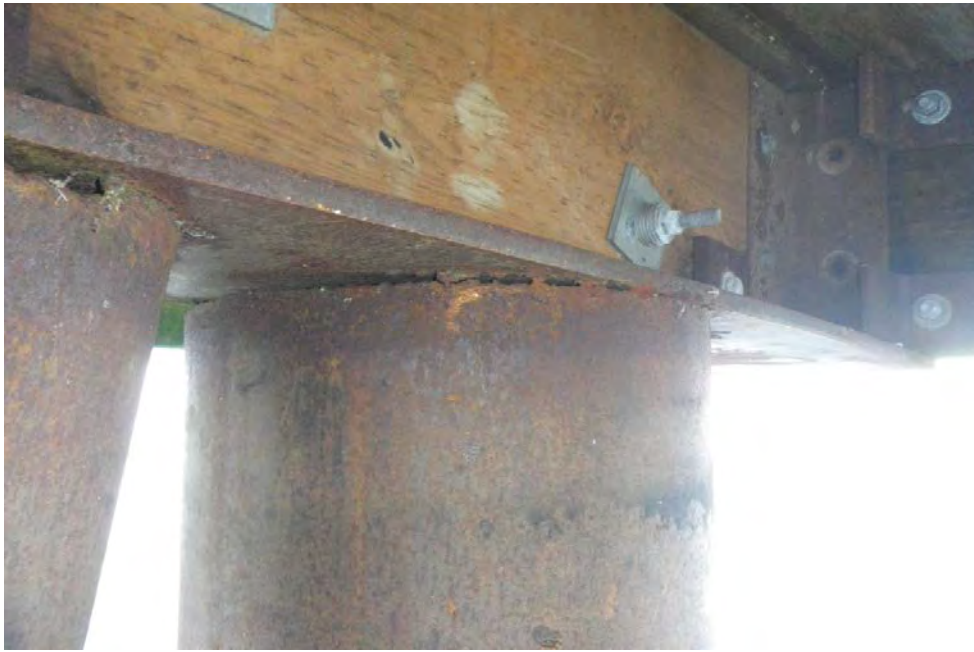
PHOTO No. 13:
Bent 88, Row D,
Steel Sleeved Pile -
Note the minimal
amount of tack welds
securing the top of
this steel pipe pile
sleeve to the steel
plate on the
connection bracket.
Also note the minor
surface corrosion of
the uncoated steel
above water.

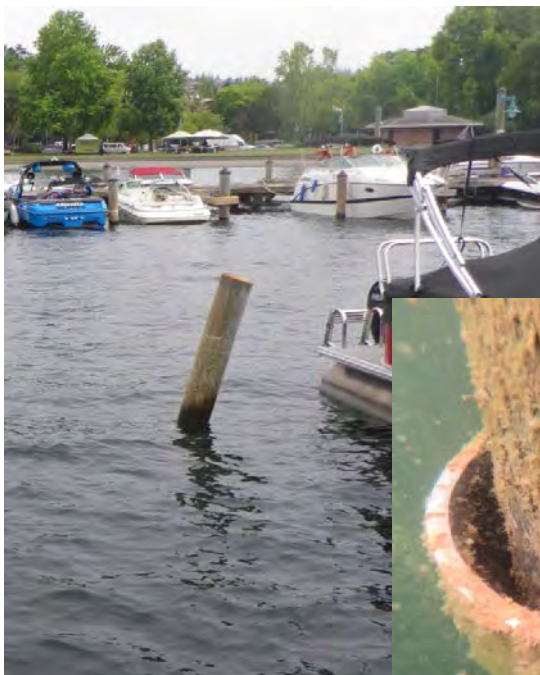
PHOTO No. 14: Bent 72, Row D Pile -
Note the significant list of
the pile which is due to a
loose splice connection
on this timber pile posted
pile. The submerged
splice is secured with a
steel pipe pile sleeve that
is thru-bolted to the upper
post and lower timber
stub. Investigation found
that the sleeve is
oversized allowing the
upper post to move. Also
note the light corrosion
on the galvanized steel
sleeve and the
attachment hardware, as
well as the good
condition of the steel
brace system located
near the mudline (arrow)
which runs along the Row
D piles in this mooring
finger.

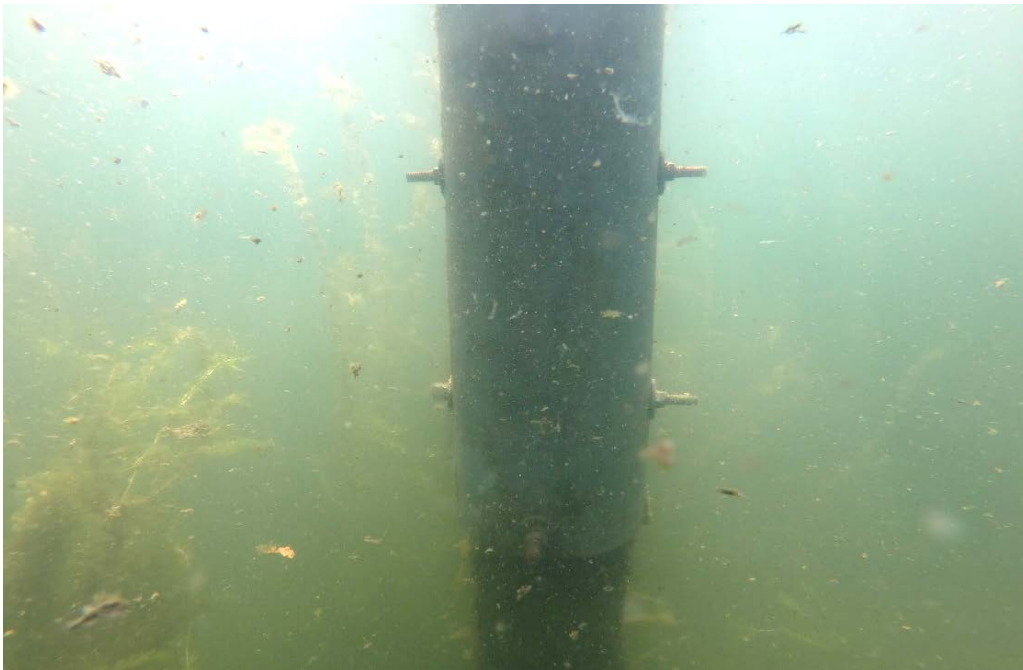
PHOTO No. 15: Bent 51, Row D, Pile Post - Note the overall good condition of the steel sleeve and connection hardware used to secure the splice connection. Inspection of the steel found it to have sustained light to moderate surface corrosion and to be tight.

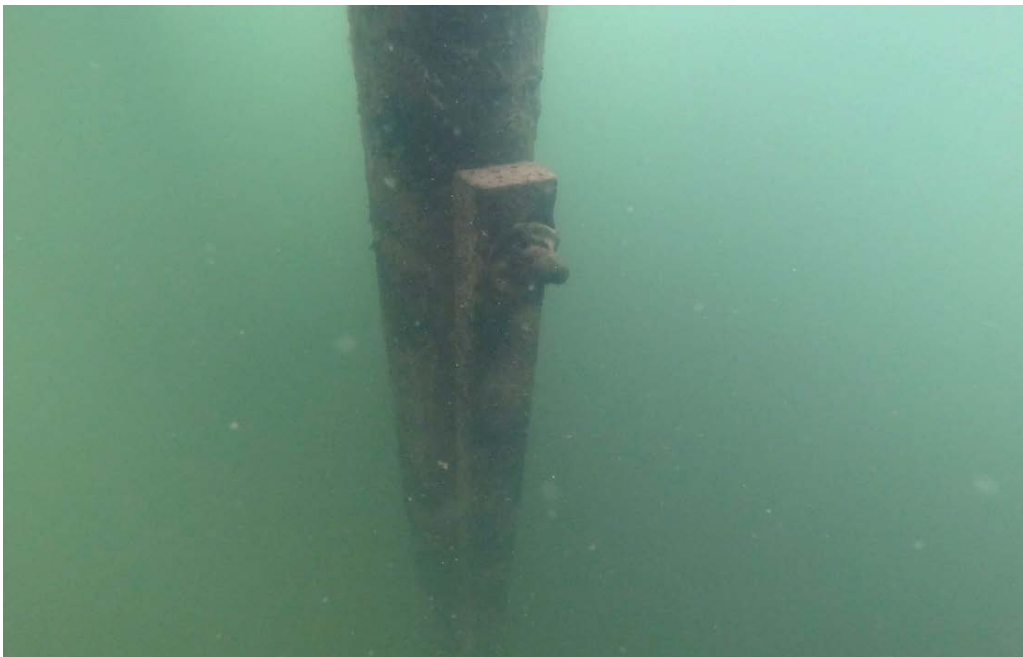
PHOTO No. 16: Bent 82, Bow B Pile - Note the brace timber which originally spanned from the Bent 82, Row A Pile to the Row B Pile is no longer secured to the Row A pile and is hanging from its lower bolted connection. Investigation found that the timber has failed at the upper connection on the Row A Pile.

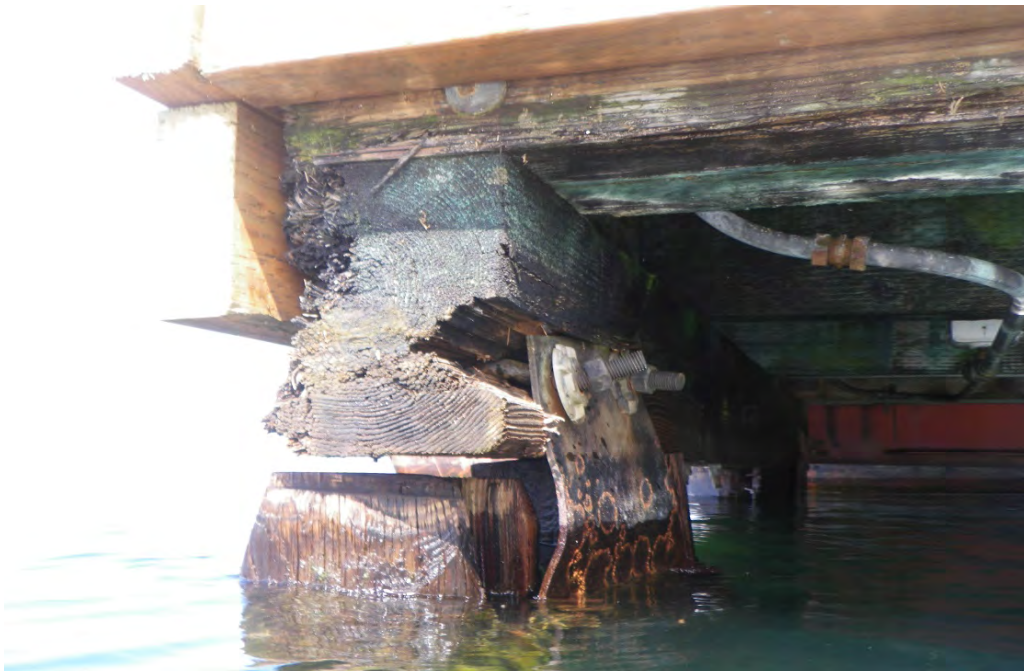
PHOTO No. 17: Bent 35, Row B Pile - Inspection noted this mechanical damage to the end of the cap which has been estimated at 25% loss. The structure has apparently sustained impact damage resulting in damage to the steel bracket securing the batter pile, as well as exposing the attachment bolts.

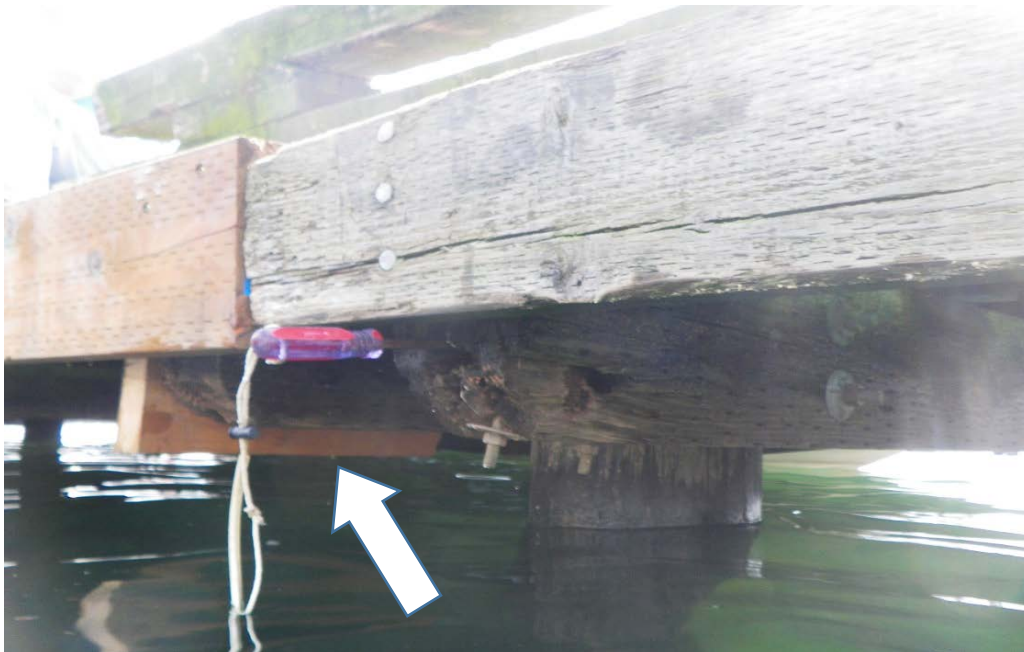
PHOTO No. 18: Bent 43, Row B Pile - Note the combined mechanical damage and fungal decay to the north cap. Also note the new fascia board and the arrow indicating a scabbed repair timber on the southern cap timber.

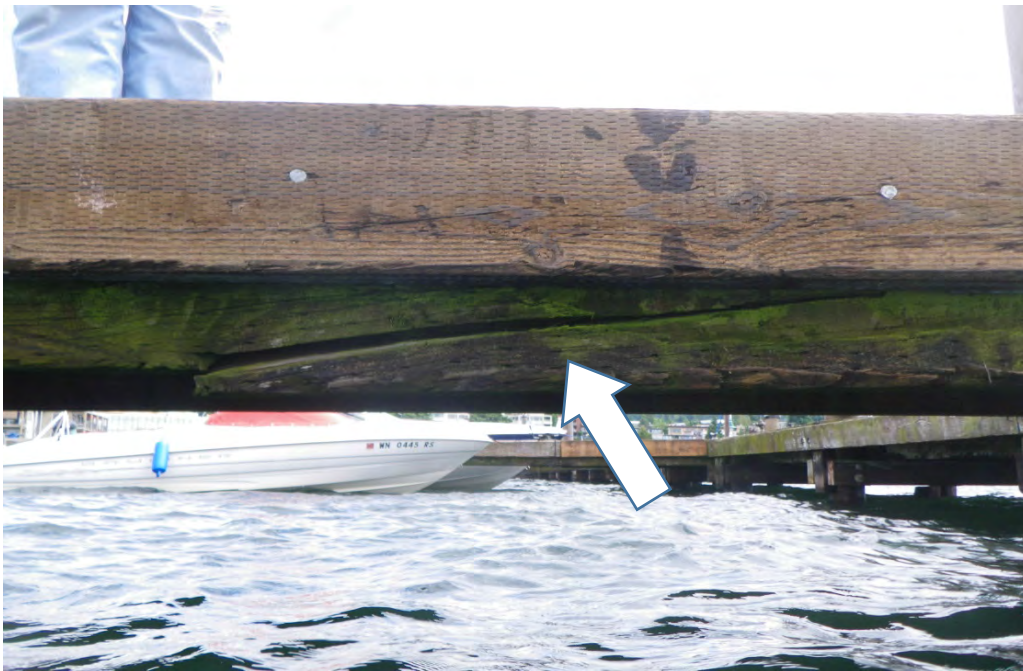
PHOTO No. 19: Bent 88, Row B-C, North Perimeter Stringer - Note the failure of this perimeter stringer, which is one of two stringers providing support for the deck. Inspection also noted the newer members sistered to and secured to the damaged stringer.

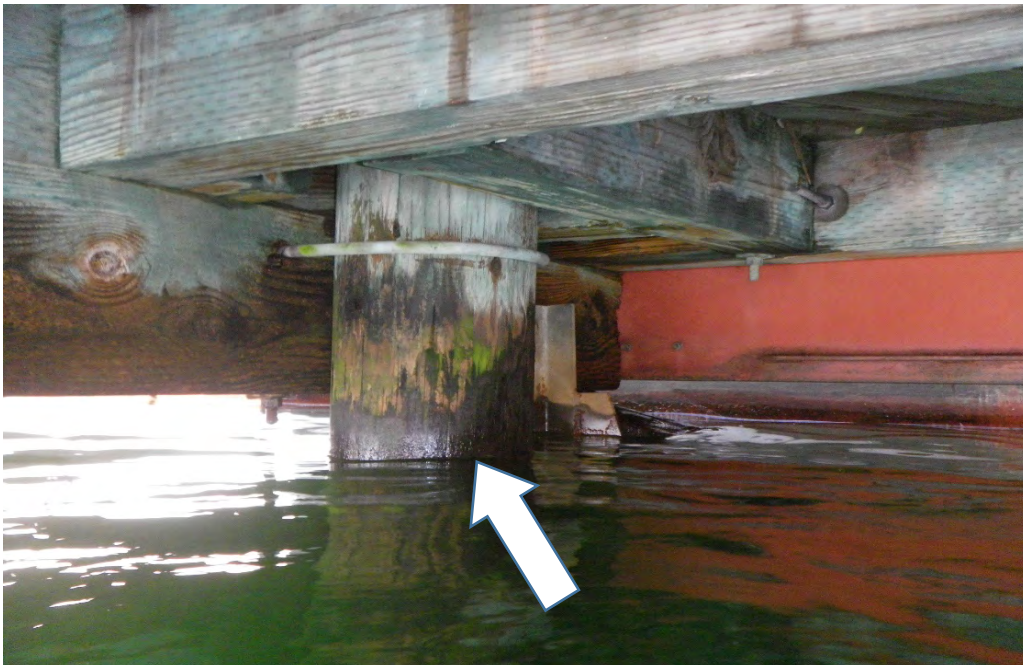
PHOTO No. 20: Bent 32.8, Row A, Light Post - Inspection found the light posts throughout the facility to be driven piles. Note the post is offset slightly from the cap and secured with framing, as well as with a galvanized hoop. Also note the good condition of the treated superstructure timber at this location.

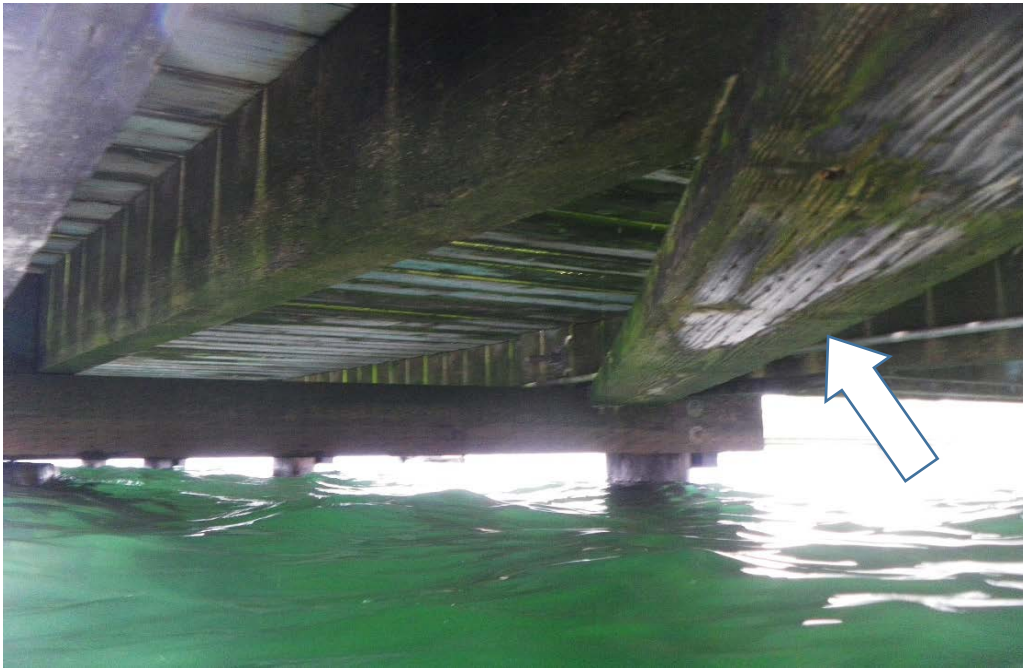
PHOTO No. 21: Bent 82 to Bent 83, Superstructure - Note the diagonal brace located at the elevation of the cap (refer to arrow) and extending diagonally from the Row A Pile to the Row B Pile. Also note the overall good condition of the cap, stringers, and the under-surface of the deck timber.

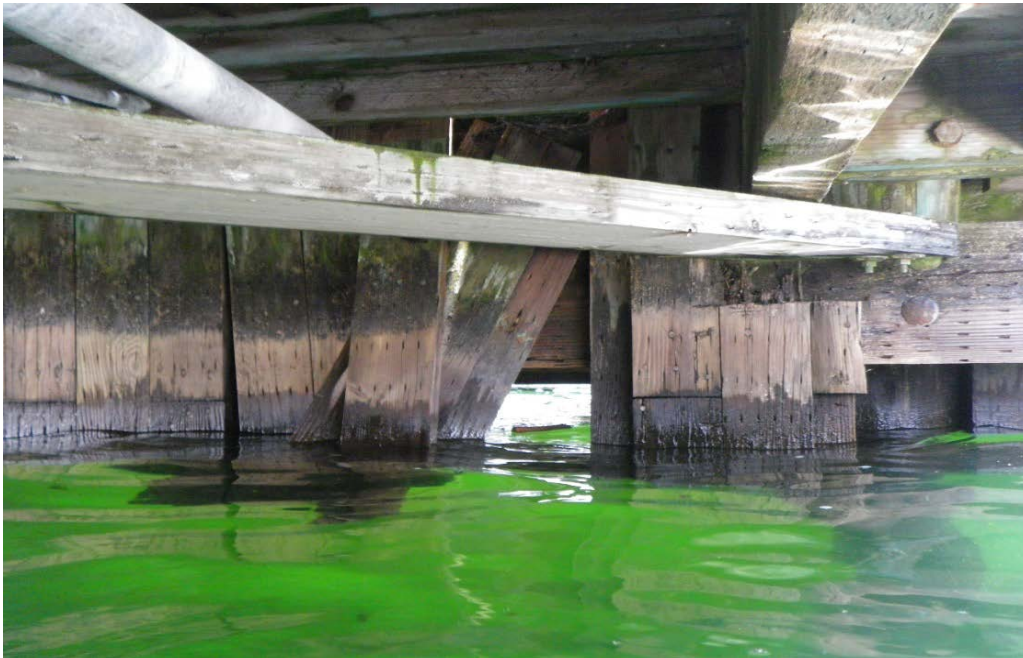
PHOTO No. 22: Bent 45, Firewall - Inspection found a number of firewalls throughout the facility. Inspection of this firewall found it to be in poor condition with several loose and missing boards.

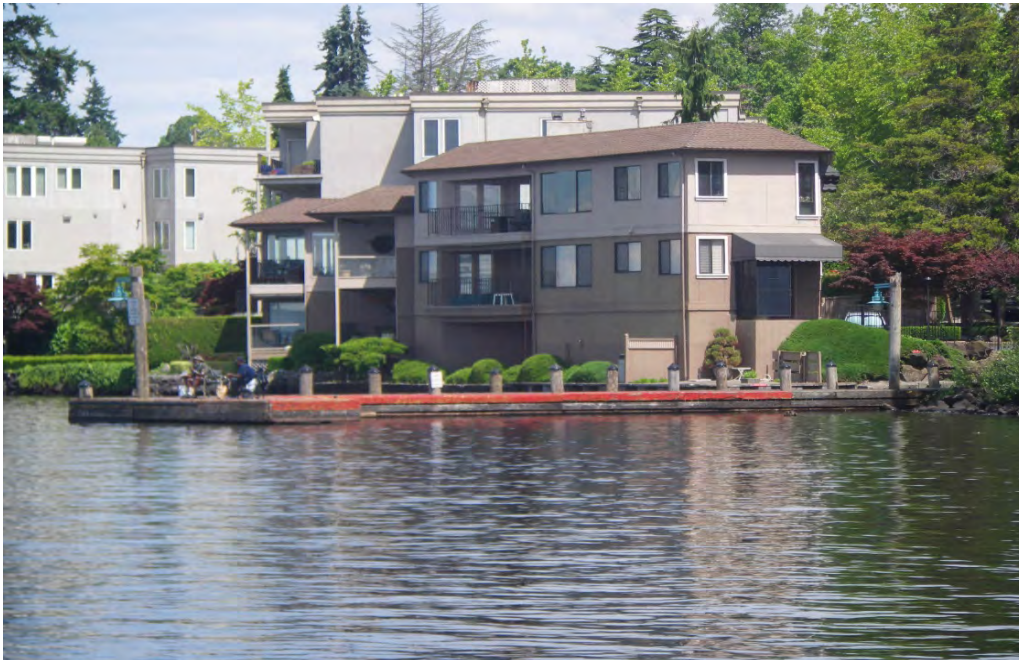
PHOTO No. 1: Marina Park, Small Pier, Looking North - The pier is constructed using treated members, including timber piles, pile caps, stringers and decking. A large diameter concrete storm sewer is located beneath the structure running to the west from the shore. See Photo No. 5 and 7.

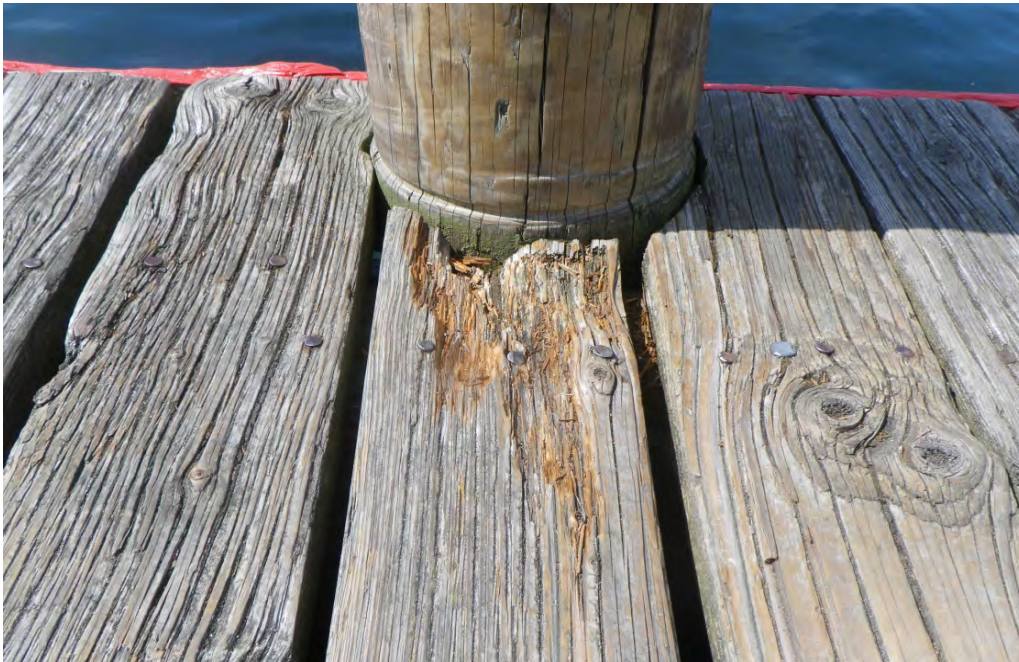
PHOTO No. 2: Bent 16, Row A Pile - A number of piles were found to extend above the deck providing a place to moor vessels. Note the good condition of the timber pile at this elevation.
