KIRKLAND PARKS & COMMUNITY SERVICES

Shoreline Structures Assessment Kirkland, Washington

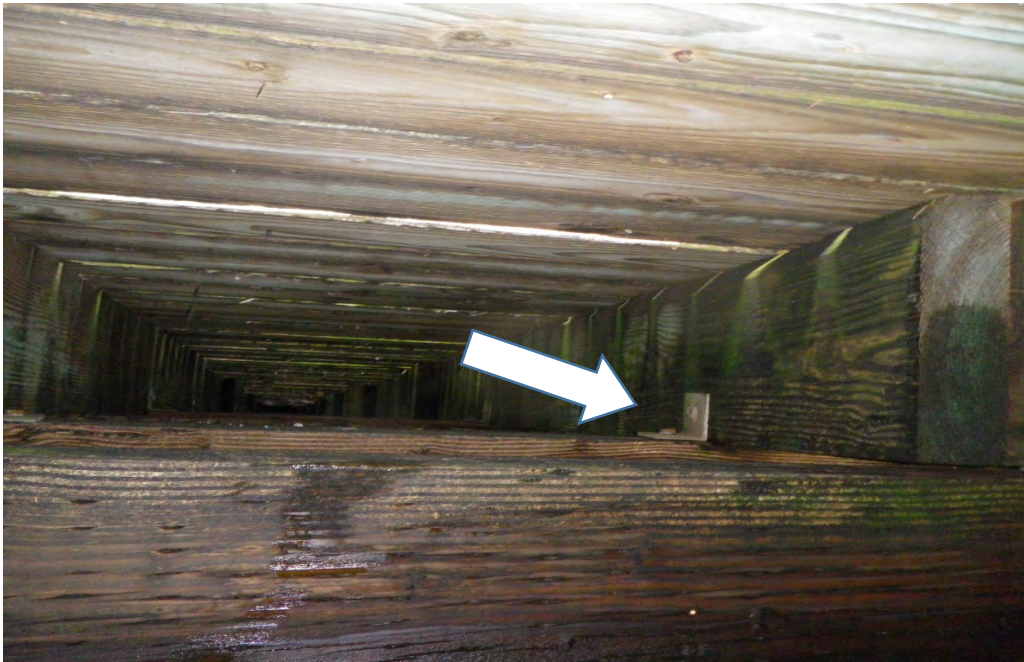
PHOTO No. 3: Bent 17 Superstructure - Note the overall good condition of the pile cap, stringers, and the underside of the decking within the pier. Also note the good condition of the galvanized angle bracket securing the stringer to the cap.

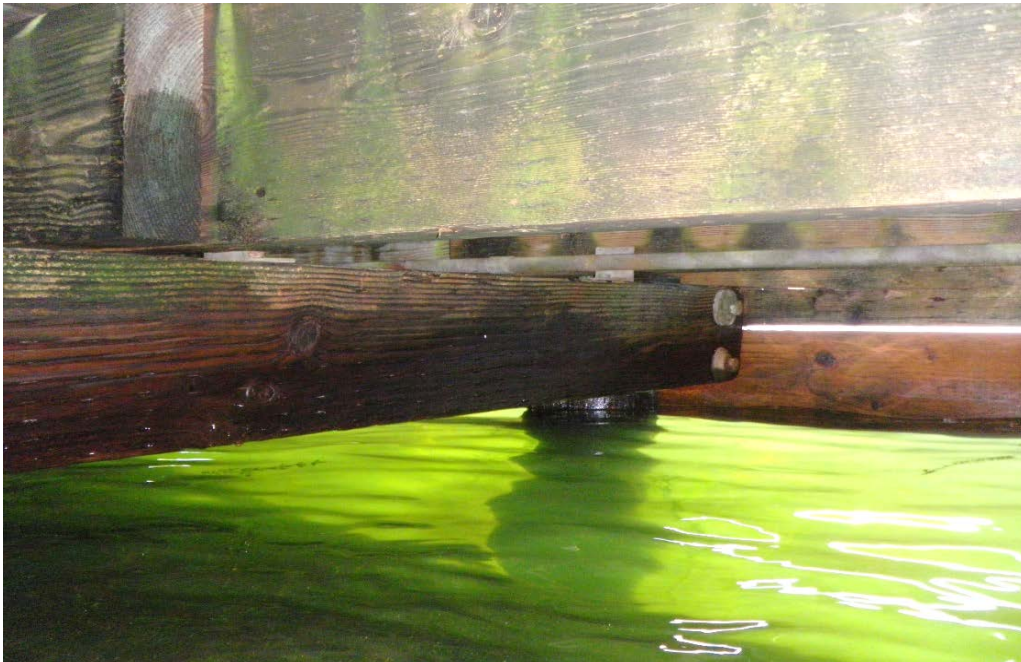
PHOTO No. 4: Bent 17, Row A Pile - Note the good condition of the treated cap and stringers in this area. This good condition was found to be typical throughout the structure. Also note the generally good condition of the horizontal members of the fender system in the background.

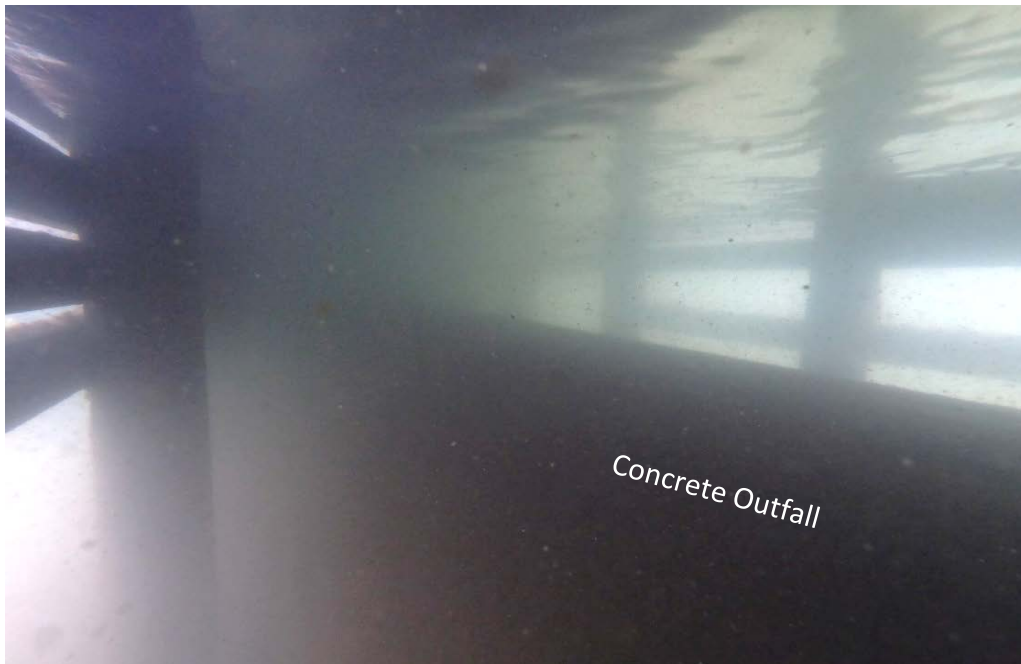
PHOTO No. 5: Bent 16, Looking East - Note the large concrete storm sewer outfall which runs the length of the structure. Also note the fender system running along the north and south perimeter of the pier. The presence of the outfall resulted in limited access to the piles and superstructure members.

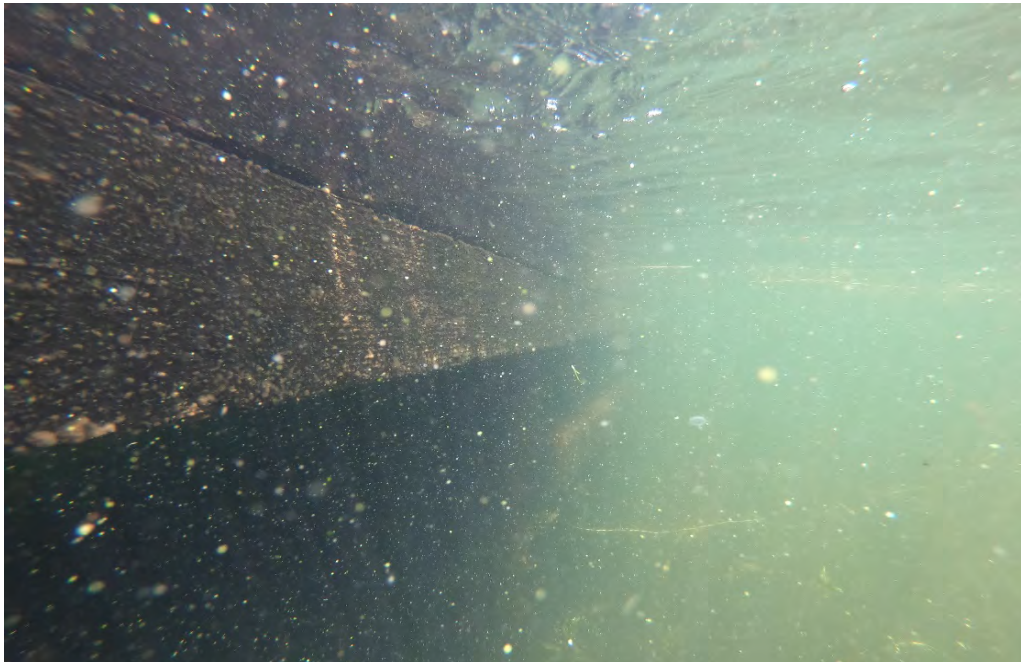
PHOTO No. 6: Bent 17, South Side, Fender System - Note the typical good condition of the horizontal timbers in the fender system timbers. Several members were noted to be missing throughout the length of the pier.

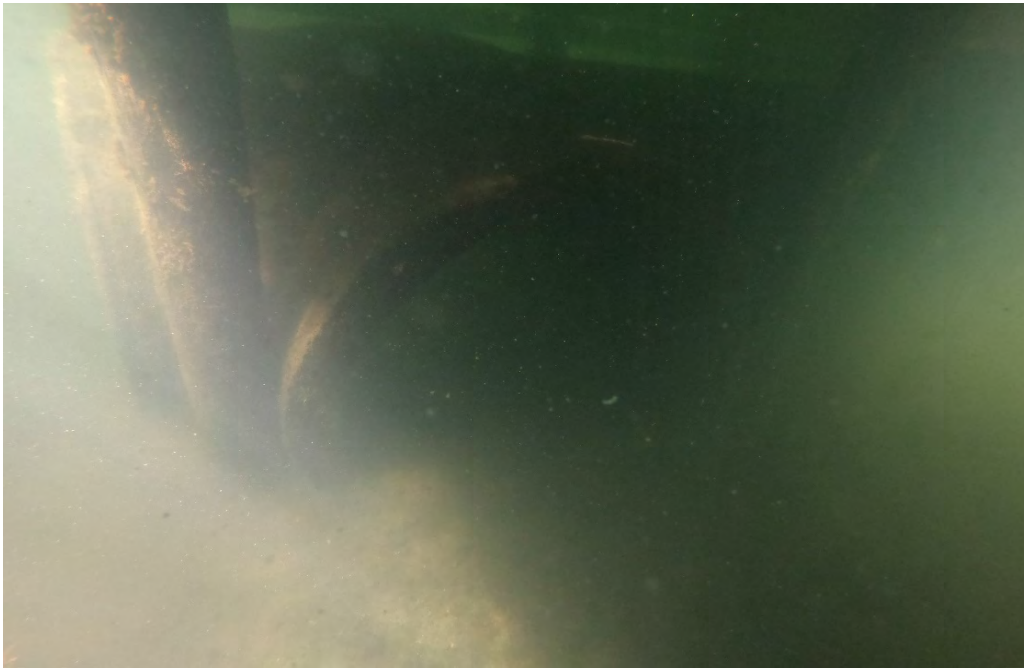
PHOTO No. 7: Bent 18, Row A, Looking East - Note the discharge end of the storm sewer outfall which is located between the Row A and B piles. Inspection found the concrete to be in overall good condition with sharp well defined edges and minor loss of cement past on the outer surfaces. Also note the typical good condition of the pile in the submerged zone.

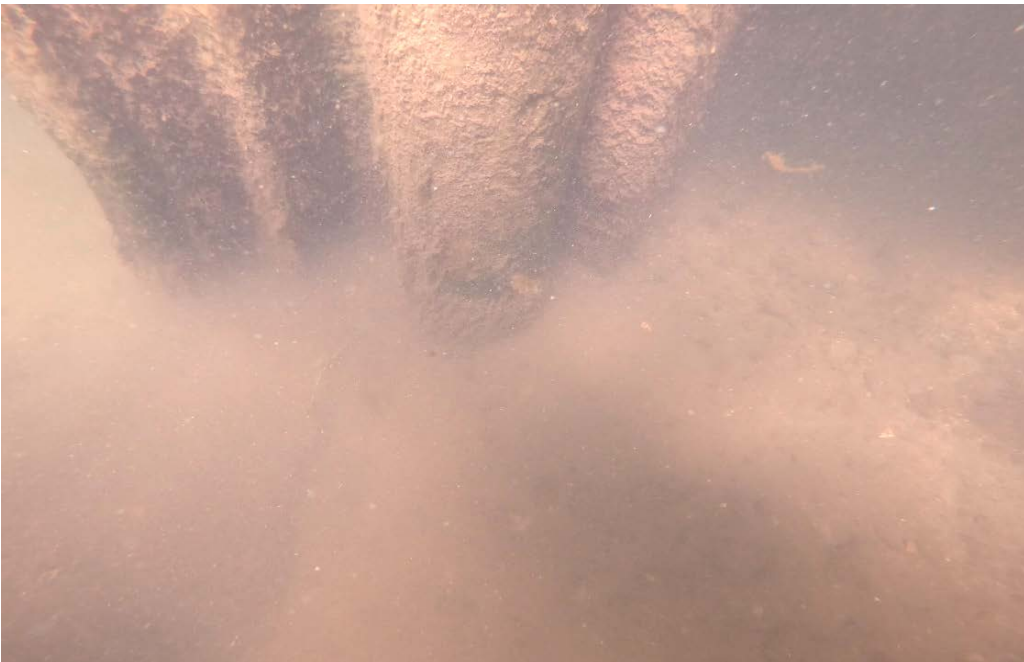
PHOTO No. 8: Bent 18, Row A Pile, Looking South - Note the coating of algae and the typical good condition of the pile near the mudline. Also note the discharge end of the outfall and the typical soft mud and silty sediment composition of the lake bottom.

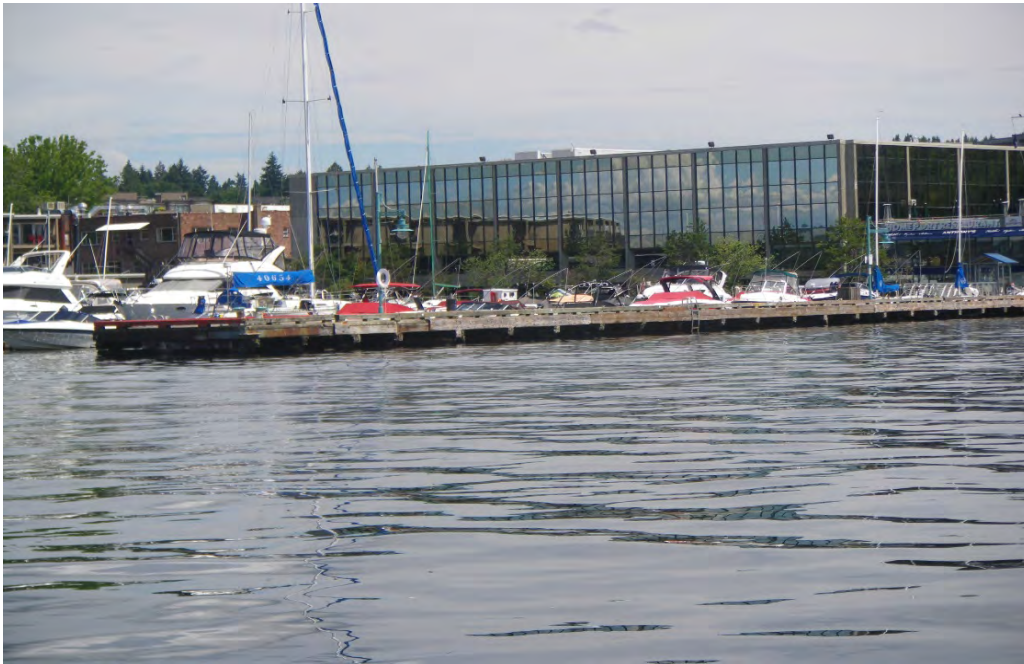
PHOTO No. 1: Second Avenue South Pier, Looking Northeast - The structure is constructed on timber piles with treated caps and stringers, supporting a galvanized sub pan and poured in-place concrete deck. Note that pleasure craft moored along the north side of the pier.

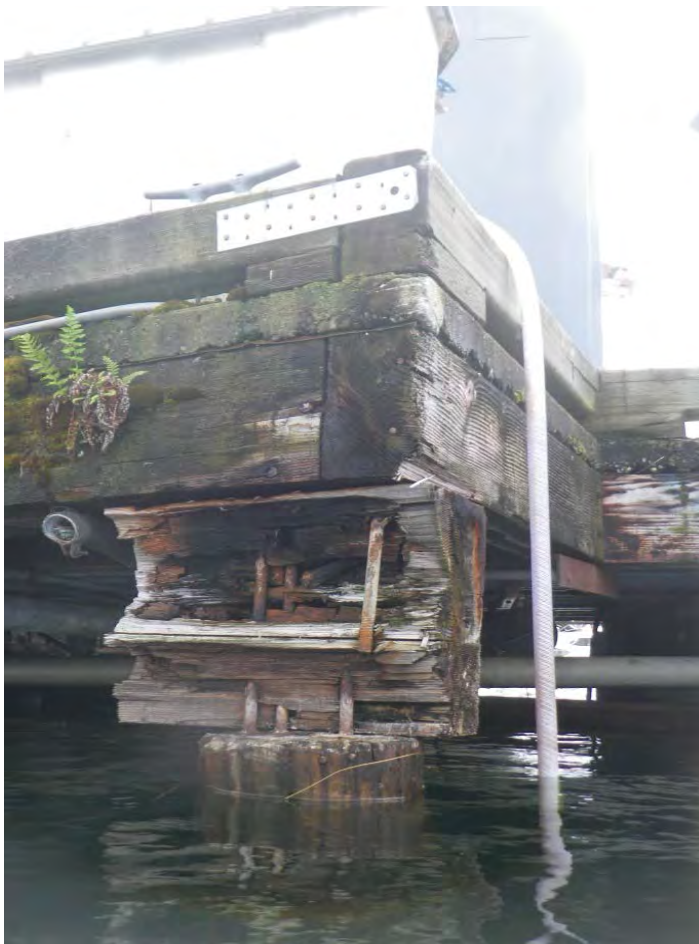
Bent 46, Row A,
Looking Southeast -
Note the heavy
fungal damage in the
ends of the sub-caps
over the pile (refer to
arrow). Inspection of
these members
found them to have
sustained an
estimated 25-90%
fungal decay.

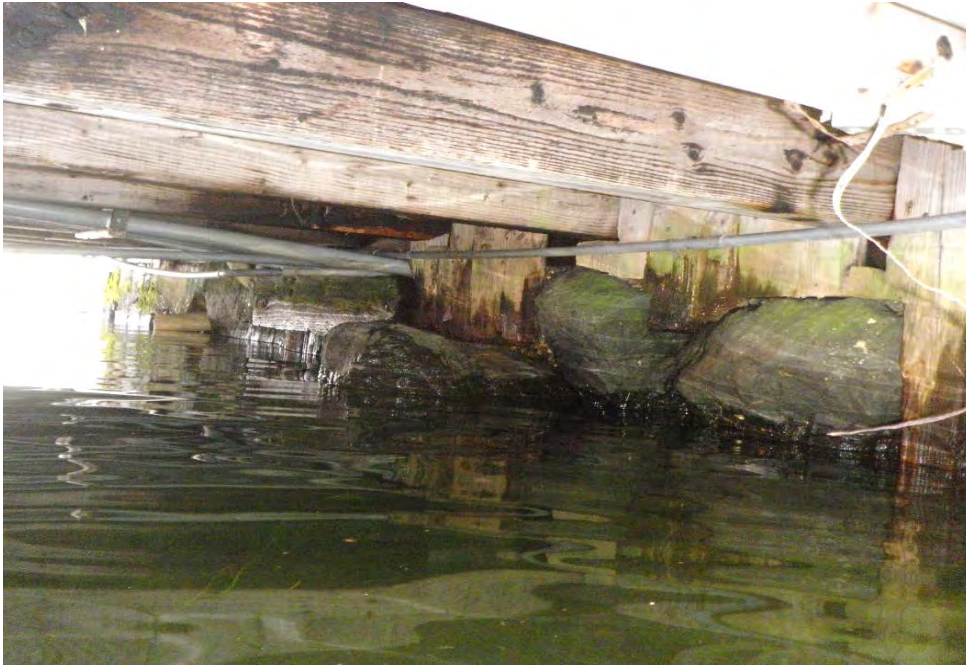
PHOTO No. 5:
Shore Abutment,
Looking North - Note
the deterioration of
the vertical lagging
timbers used as a
backwall to contain
the shoreward soils.
Inspection did not
identify any apparent
loss of back fill.

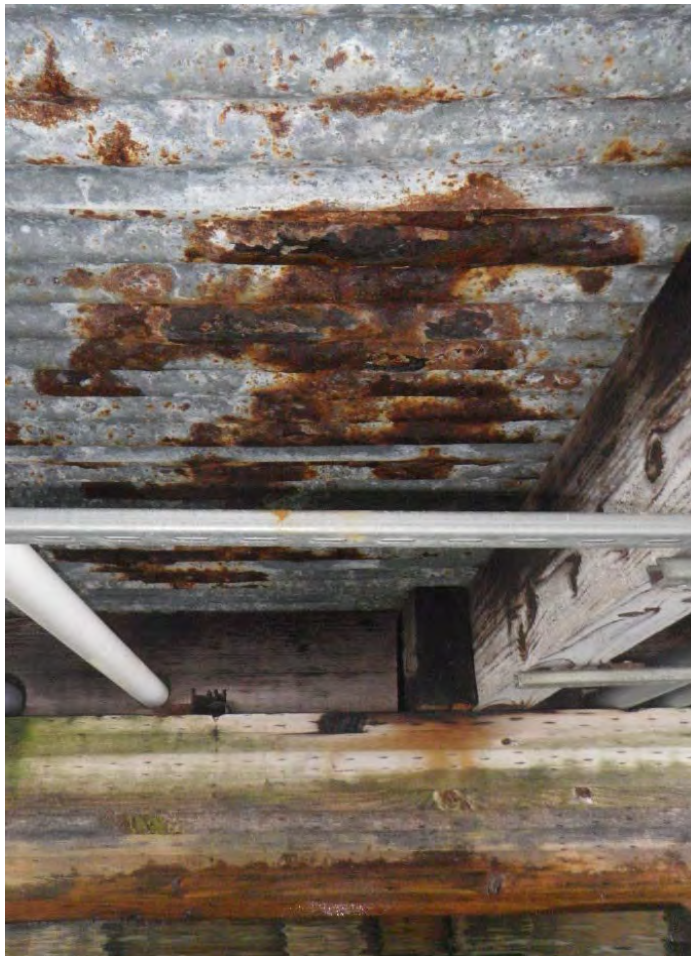
PHOTO No. 6: Bents 39-40, Corrugated
Deck Pan - Note the
corrosion of the
galvanized sub pan at this
location. Overall, the
condition of the sub-pan
was found to be generally
fair with an estimated 20-
25% of the surface found
to have localized surface
corrosion with areas of
perforation.

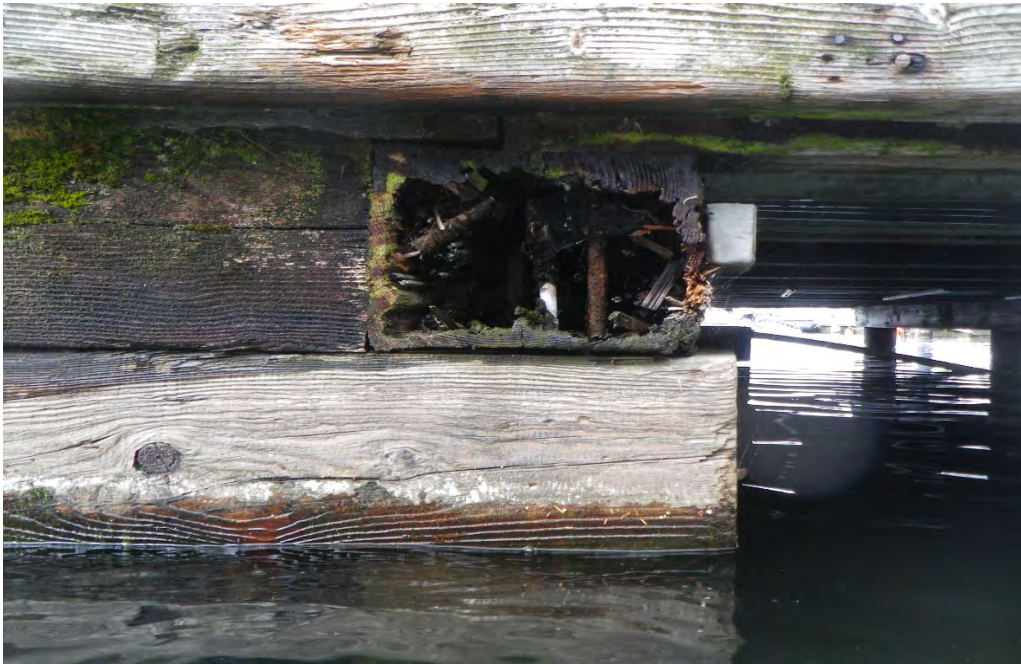
PHOTO No. 7: Bent 3, Row A, Looking West - Note the extensive section loss and visible compression that has resulted from fungal damage of the cap timber.

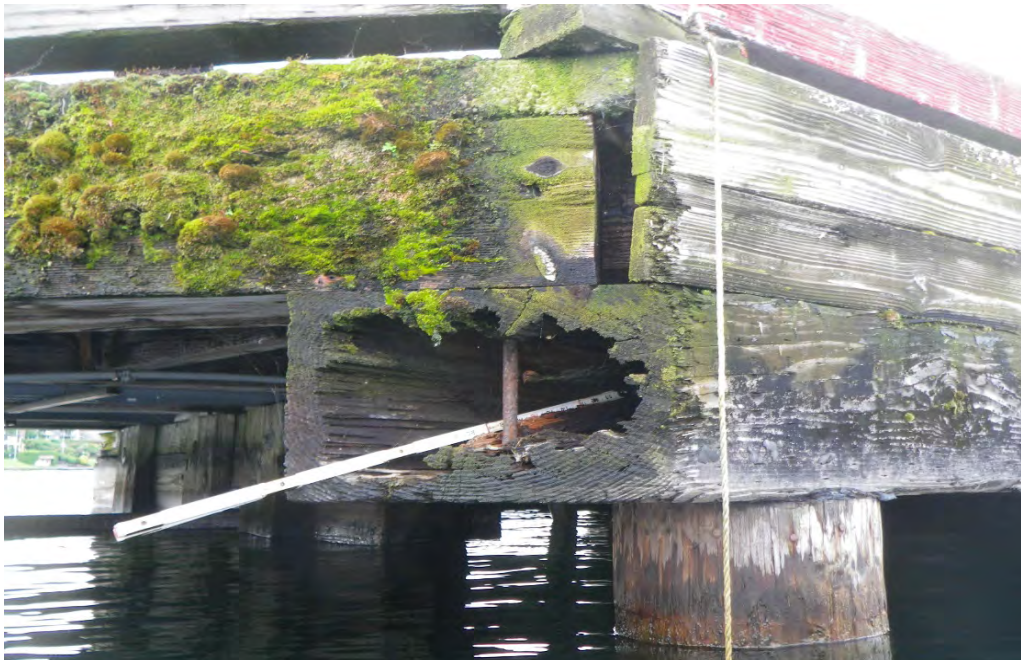
PHOTO No. 8: Bent 46, Row E Pile, Looking West - Note the folding ruler inserted in a large fungal cavity in the end of the sub-cap. Inspection found that the damage, estimated at 90%, has progressed along the timber and over the pile.

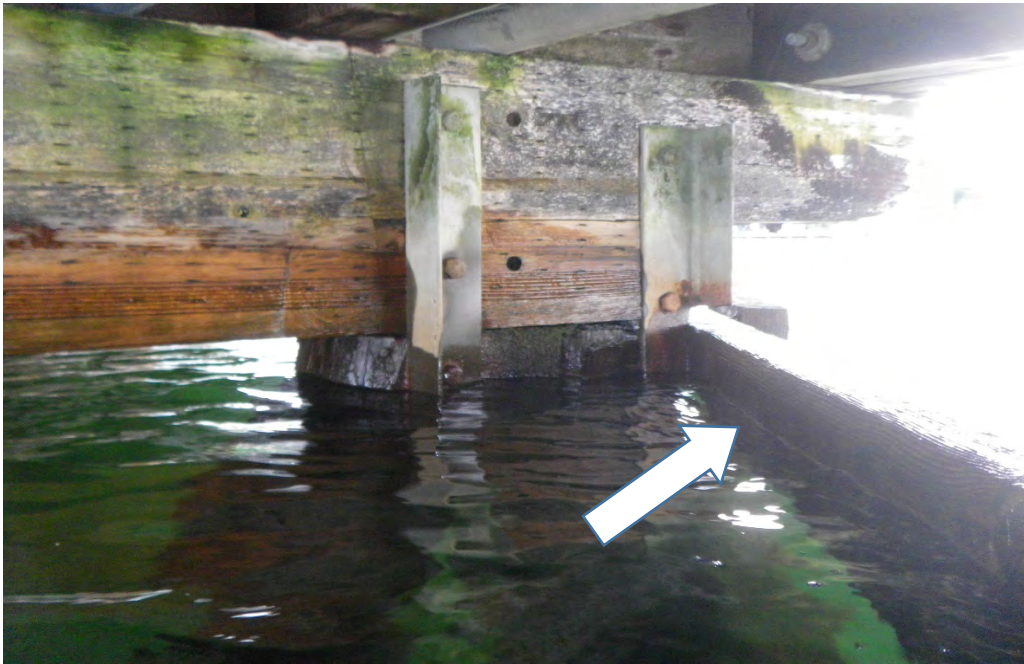
PHOTO No. 9: Bent 38, Row A Vertical and Batter Pile - Note the galvanized angle brackets used to connect the batter pile top (left), and the vertical pile top (right) to the glu-lam cap. Also note the diagonal wavebreak which is attached to the vertical pile (refer to arrow) and the algae and water staining on the glu-lam cap.

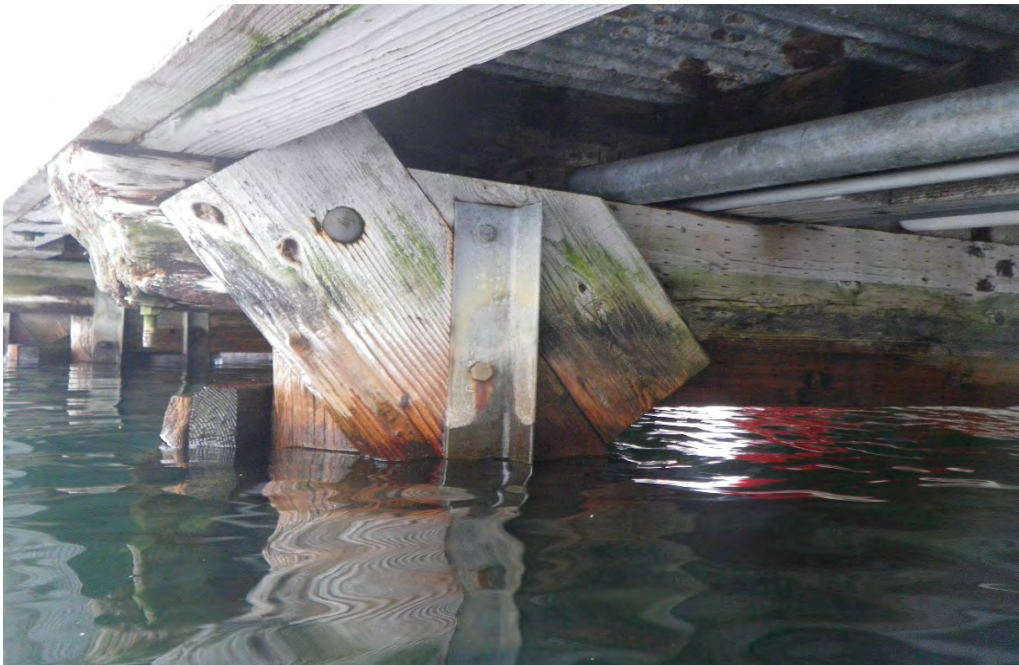
PHOTO No. 10: Bent 37, Row A Pile - Note the diagonal brace timber secured to the cap and the galvanized bracket attachment. Also note the condition of the corrugated sub-pan and the utilities that run over the cap.

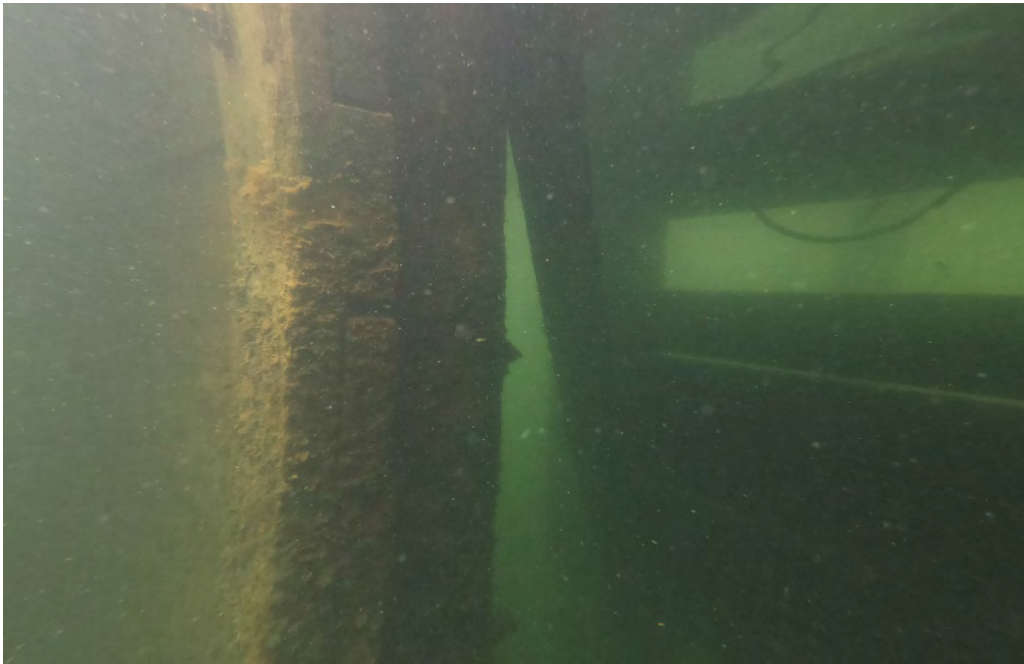
PHOTO No. 11: Typical Wave Break Connection To Row A Pile - Note the missing boards in the damaged wavebreak on the right side of the pile. Also note the horizontal timbers are secured to the pile with a vertical timber and thru-bolts.

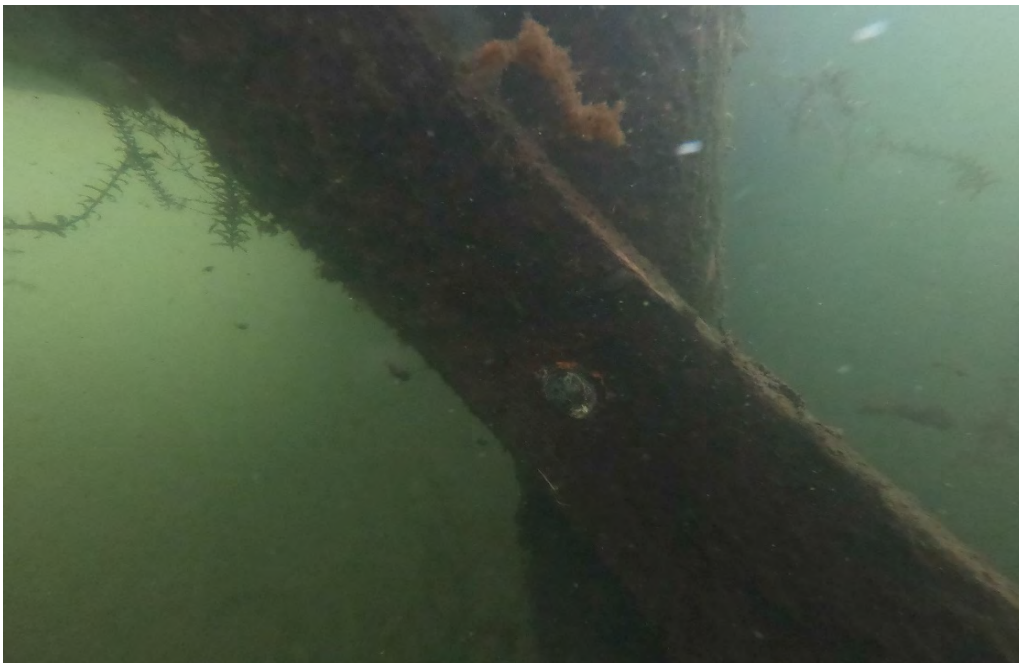
PHOTO No. 12: Bent 16, Row B Pile - Note the lower diagonal brace connection located near the mudline. Inspection of the brace timbers found them to be in generally good condition with moderated corrosion of the connection hardware. Also note the typical good condition of the pile in the submerged zone which was noted to be typical throughout the structure.

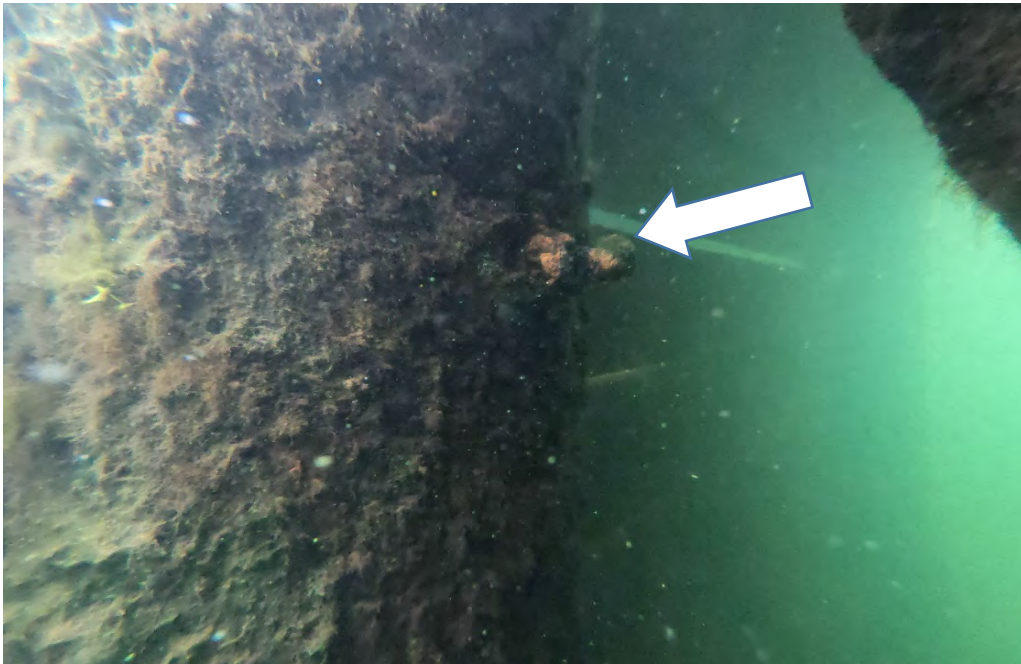
PHOTO No. 13: Bent 18, Row A Pile - Note the moderate corrosion evident on the surface of this thru-bolt that secures a diagonal wavebreak. Also note the typical algae growth and the typical good condition of pile in submerged zone.

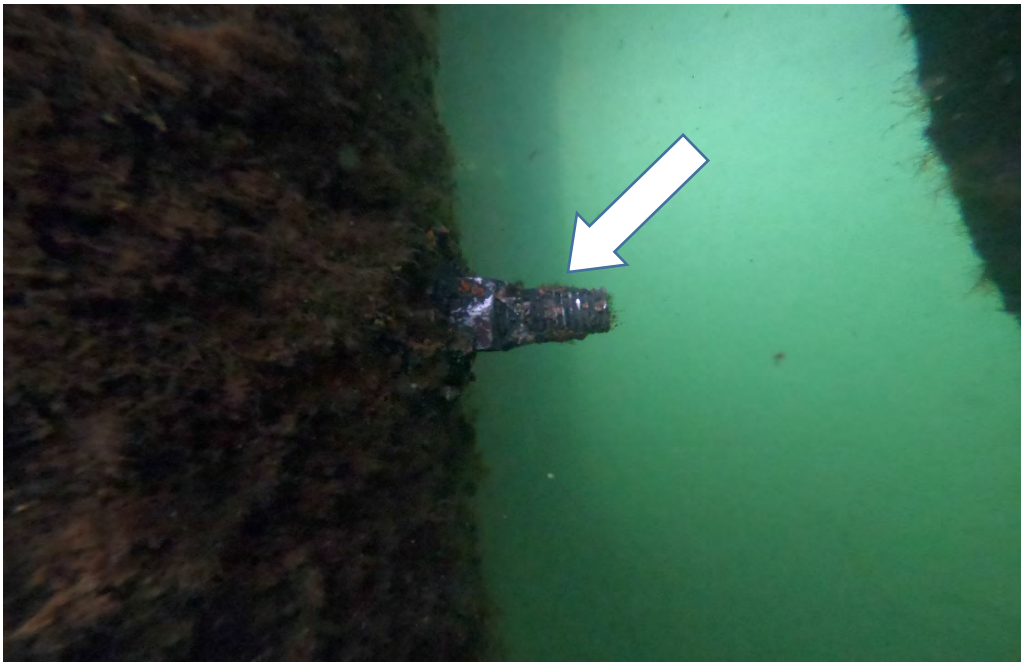
PHOTO No. 14: Bent 18, Row A Pile - Note the Level II cleaned condition of this thru-bolt. Inspection of the bolt found it have visible loss of section due as a result of corrosion, particularly in the threads.

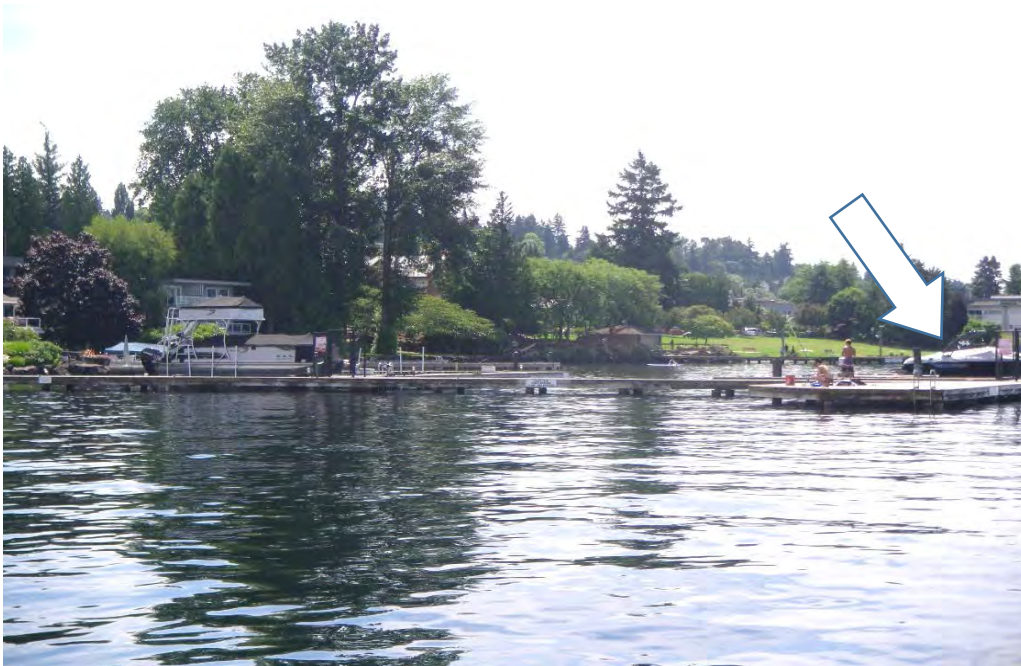
PHOTO No. 1: Settler's Landing Pier, Looking Southeast - The pier is constructed with treated timber piles, and superstructure, including pile caps, stringers, and decking. Note the boat moored to one of two privately owned moorage piers that extend to the south and were not included in the investigation.

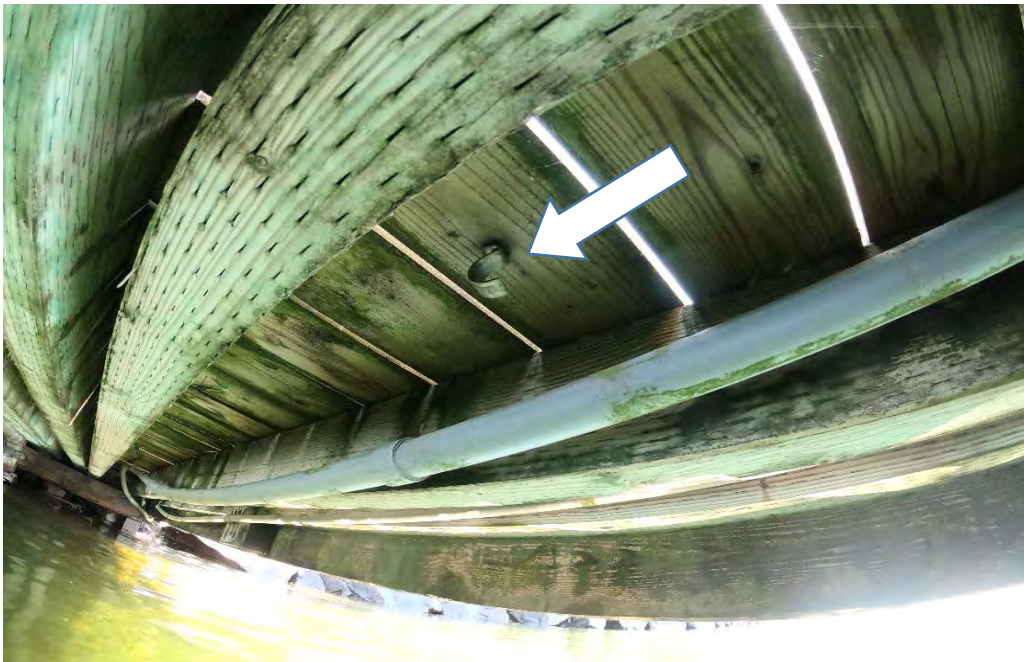
PHOTO No. 2: Bent 1 - 2, Looking East - Note the good condition of the Chemonite treated stringers and the under-surface of the deck planks which was typical throughout the pier. Also note the arrow showing a failed utility hanger.

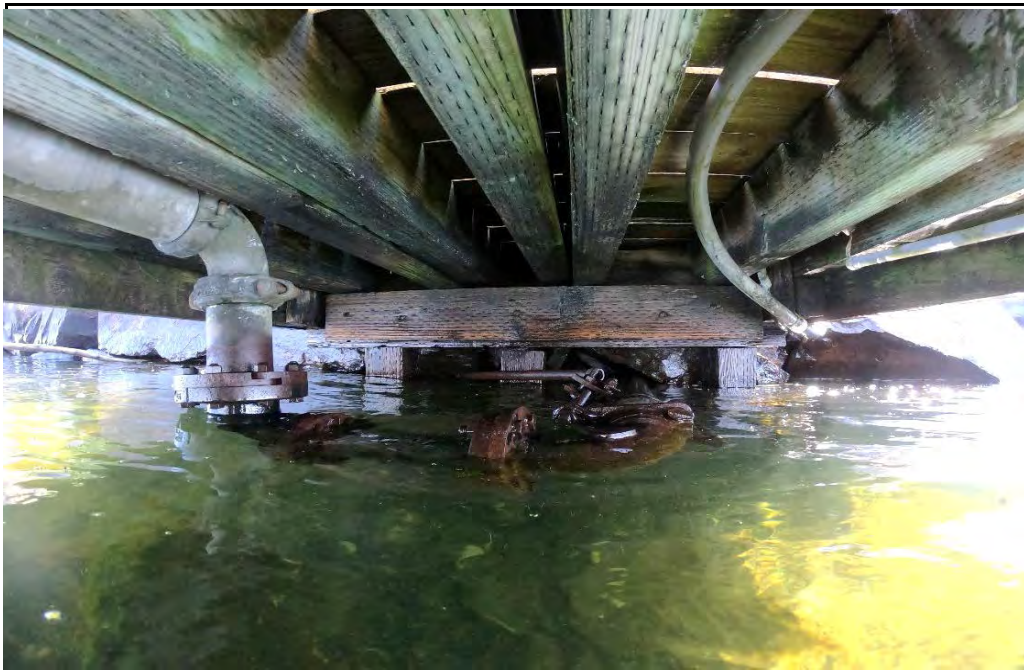
PHOTO No. 3: Bent 1, Looking East - Note the three 6x6 posts supporting Bent 1 and the overall good condition of the superstructure members. Inspection of the posts found them to be in generally good condition but noted that all three are bearing directly on large rock. Additionally, the center, Row B post, was found to be non-bearing beneath the cap.

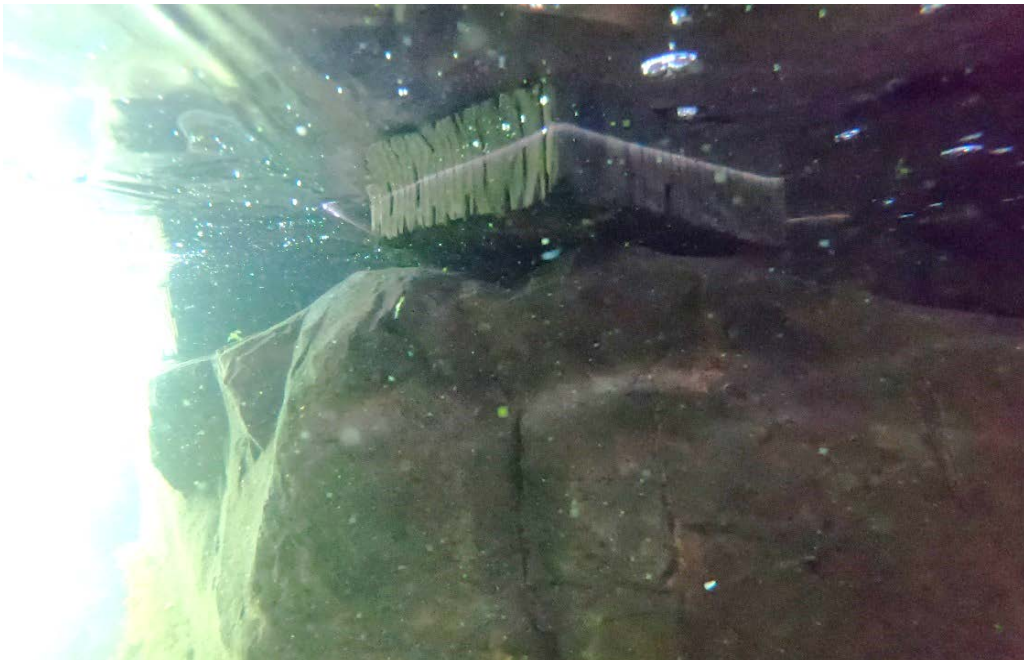
PHOTO No. 4: Bent 1, Row B Post - Note the post is only partially bearing on the shore protection rock. Also note the overall good condition of the post.

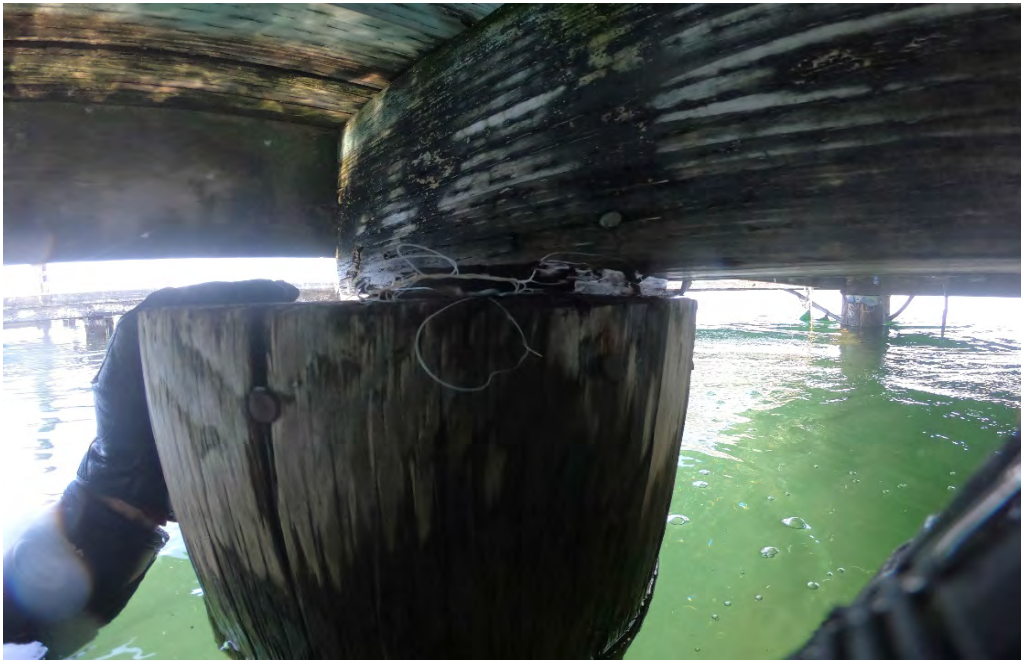
PHOTO No. 5: Bent 15, Row B Pile - Note partial bearing condition of the pile beneath the cap. Inspection noted that the protective metal cover on this pile is missing and the bearing has been estimated at 10%.

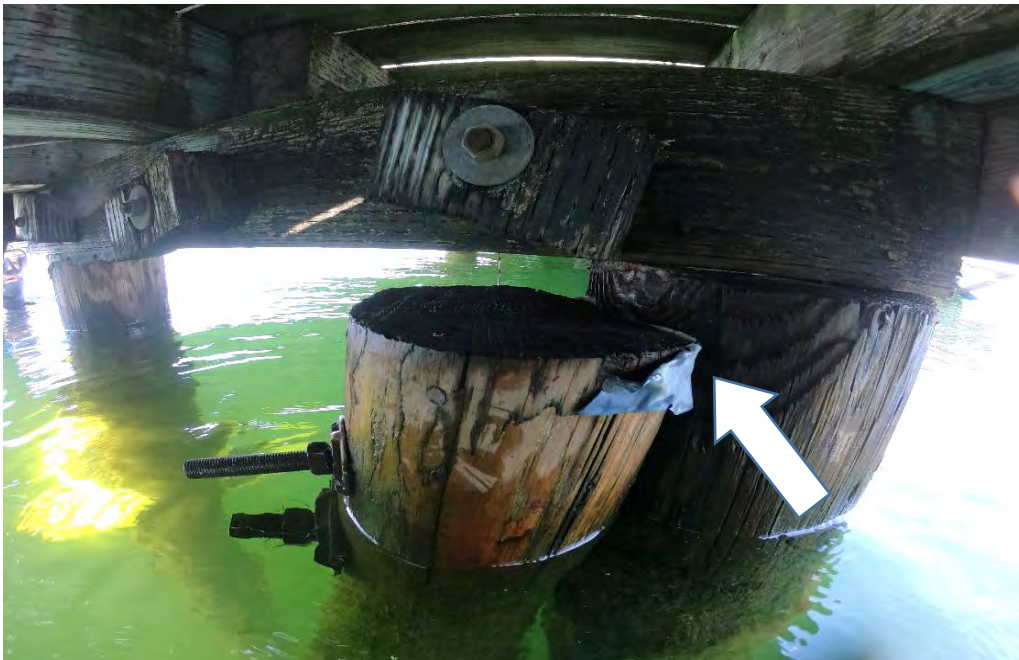
PHOTO No. 6: Bent 10, Row A Vertical and Batter Piles - Inspection noted the hardware securing the batter pile to the vertical pile to be in overall good condition with minor surface corrosion. Also note the arrow indicating remnants of the protective metal cover on the batter pile.

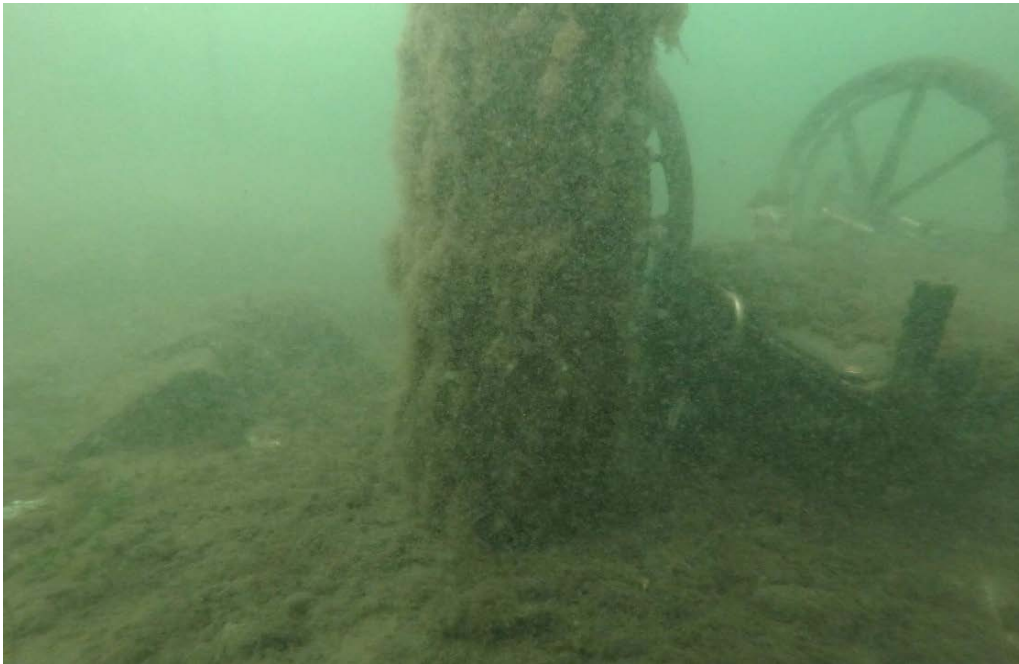
PHOTO No. 7: Bent 16, Row A Pile - Note moderate accumulation of algae on the pile, and the mudline. Also note the wheelchair which has been dumped off the pier. Investigation of the bottom found the bottom to be composed primarily of soft mud and silt at this location.

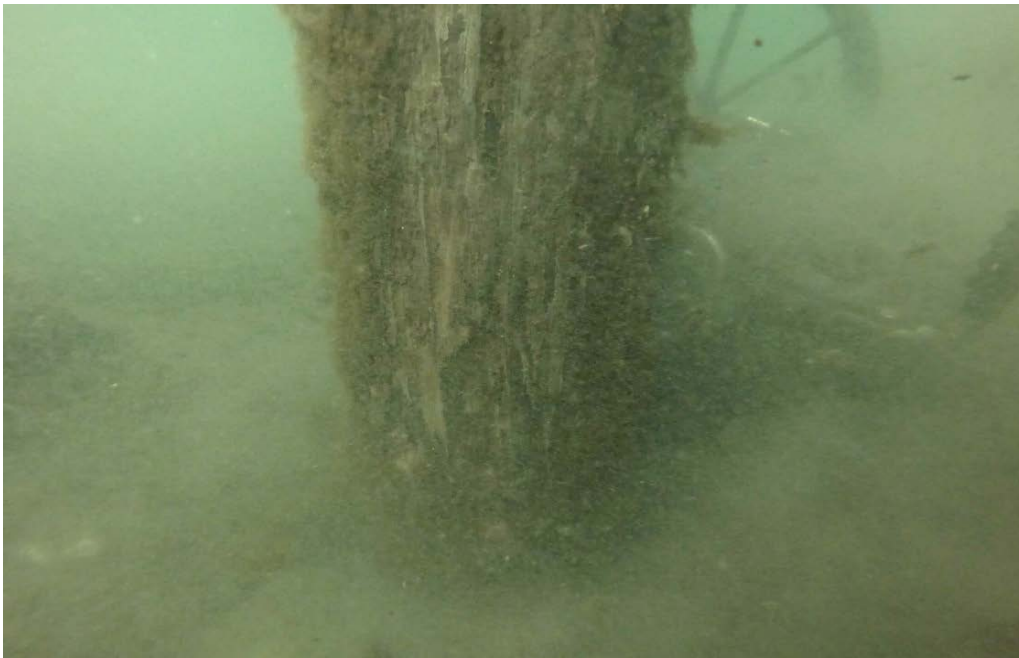
PHOTO No. 8: Bent 16, Row A Pile - Note the area of Level II cleaning which revealed an estimated 5% loss of section due to biological degradation. This type of minor section loss was found to be typical of the piles within the submerged zone.

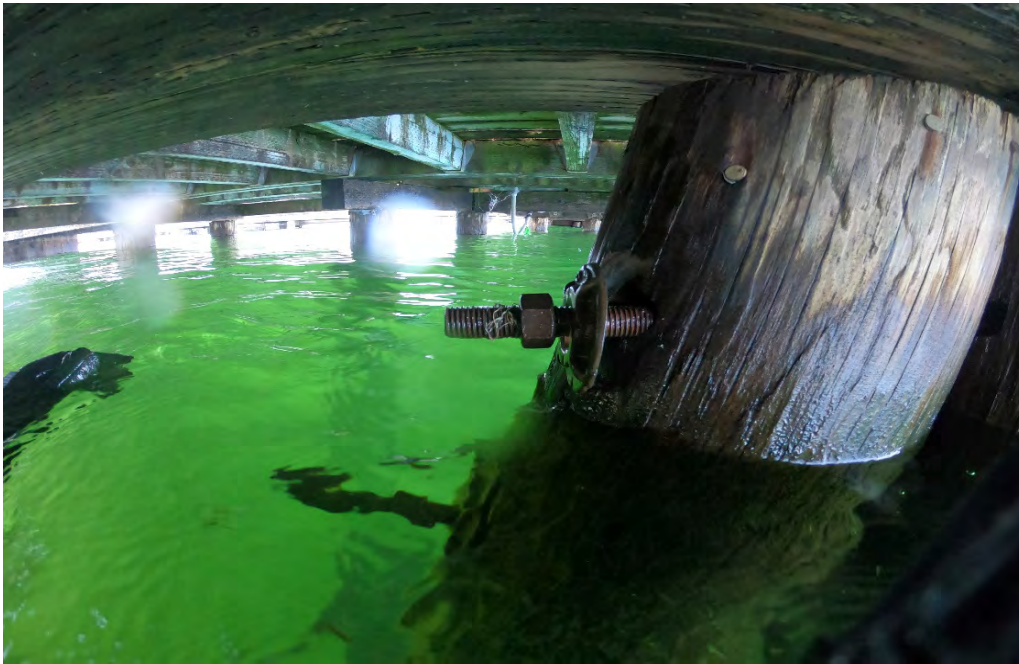
PHOTO No. 9: Bent 18, Row A Batter Pile - Inspection noted this loose hardware securing the batter pile to the vertical pile. Several loose batter pile connections were identified throughout the structure. Additionally, no blocking was found on any of the batter piles throughout the pier, between the top of the piles and the superstructure.

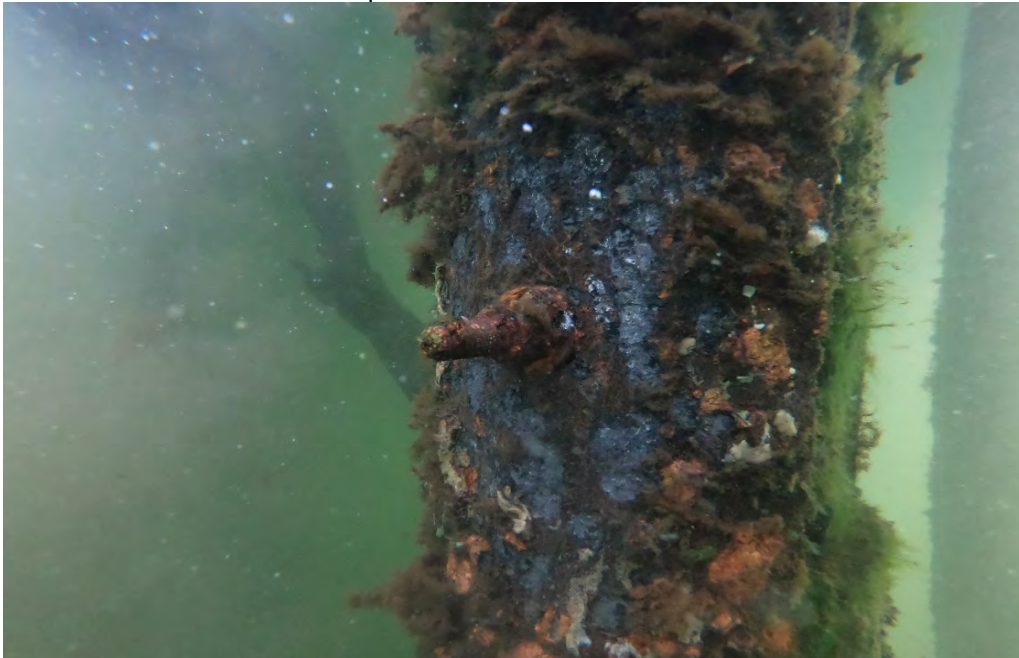
PHOTO No. 10: Bent 16, Row A Pile Post Splice - Note the surface corrosion and pitting on the steel splice plate which secures the pile post connection. Overall, the plates and connection hardware were found to be tight and in overall fair condition.

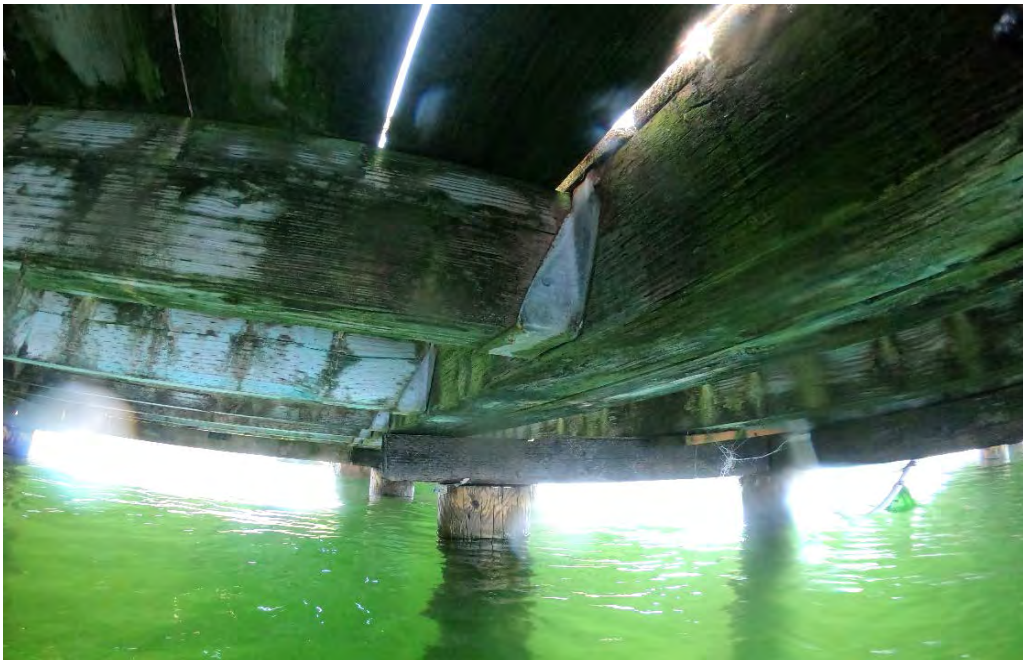
PHOTO No. 11: Pierhead Framing, Looking North - Note the good condition of the treated superstructure timbers supporting the pierhead portion of the structure. Also note the good condition of the galvanized joist hangers used to secure the stringers.

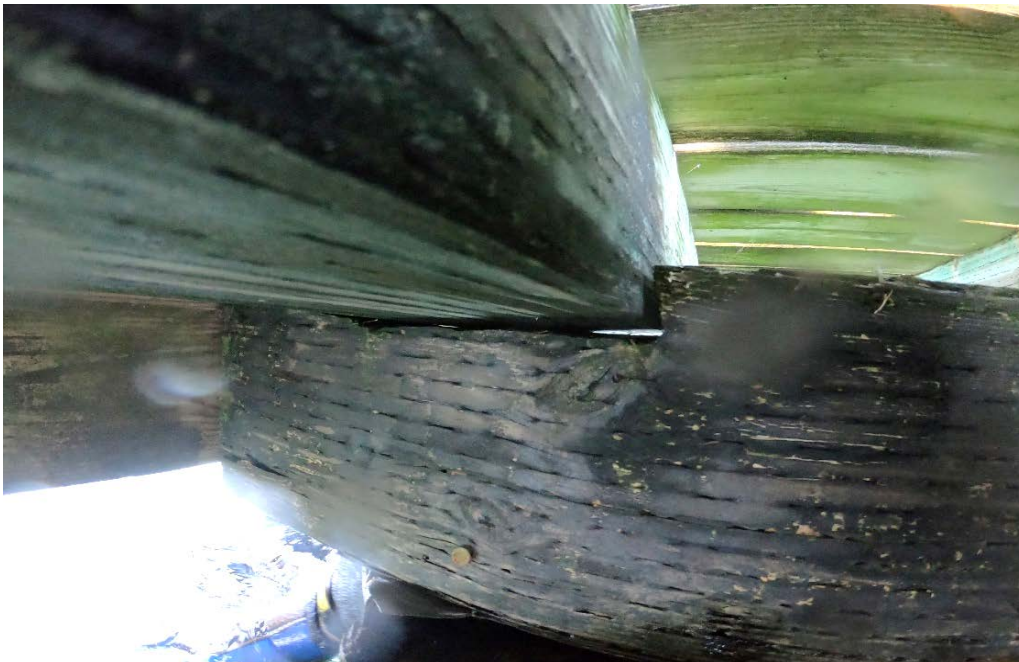
PHOTO No. 12: Bent 15, Row A Cap - Note the notch in the cap to accommodate the perimeter stringer and maintain a constant deck elevation. The member was found to be in overall good condition with no evidence of any significant deterioration or damage.

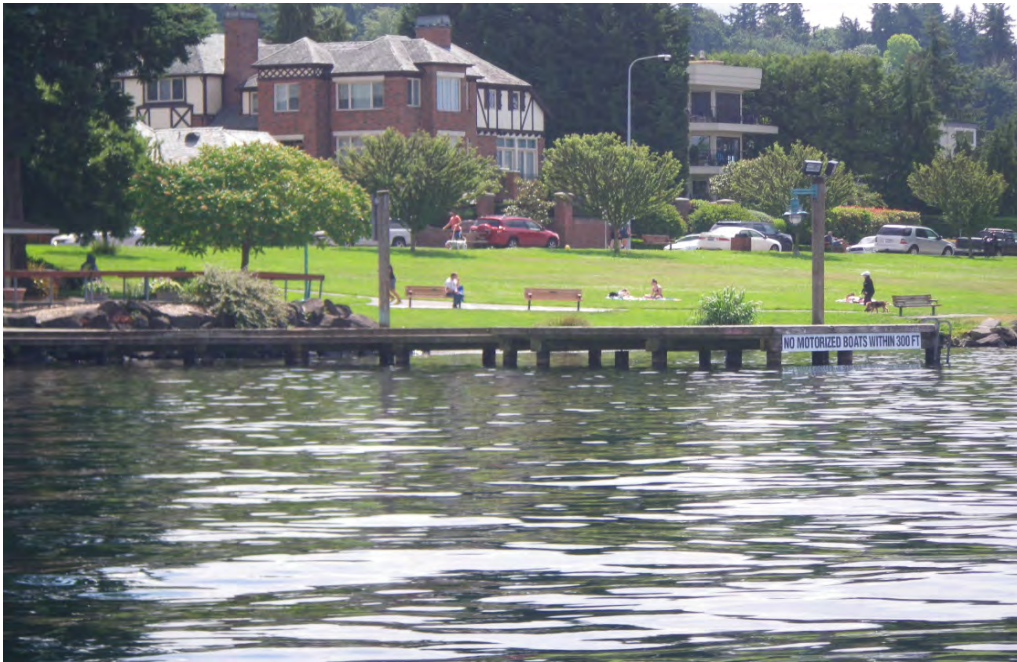
PHOTO No. 1: Marsh Park Pier, Looking Southeast - The structure is supported by treated timber piles and treated superstructure members. Note the two piles which extend above the deck. These are driven piles which act as a light post and sign post.
