KIRKLAND PARKS & COMMUNITY SERVICES

Shoreline Structures Assessment Kirkland, Washington

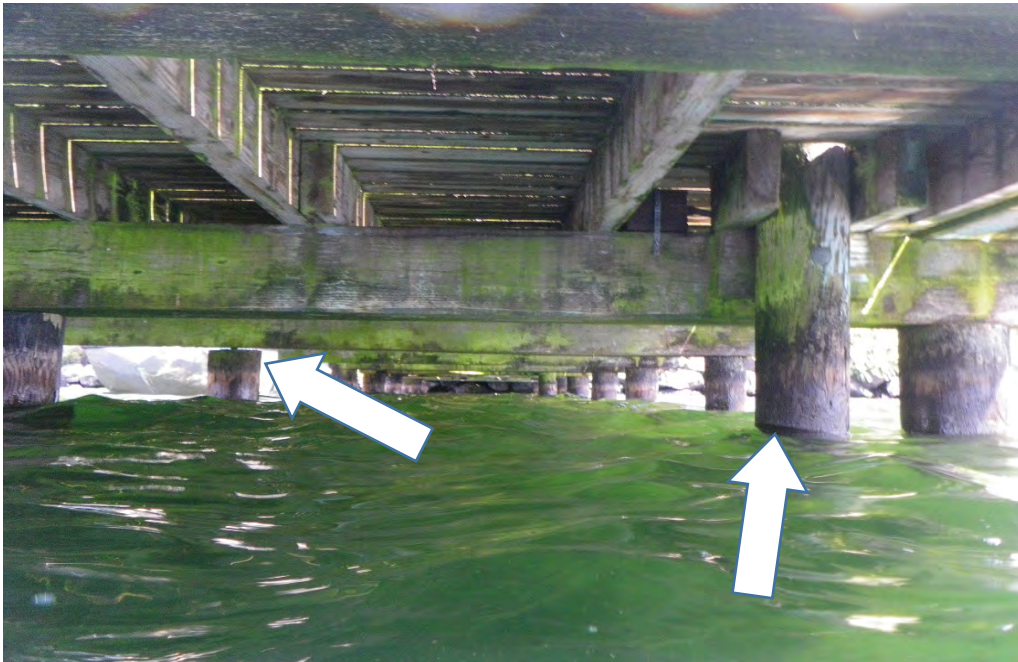
PHOTO No. 3: Bent 10, Looking East- Note the overall good condition of the piles and superstructure members, with minor water staining and algae growth. Also note the right arrow indicating the Bent 9.1 light post and the left arrow indicating the non-bearing condition of the Bent 8, Row B pile.

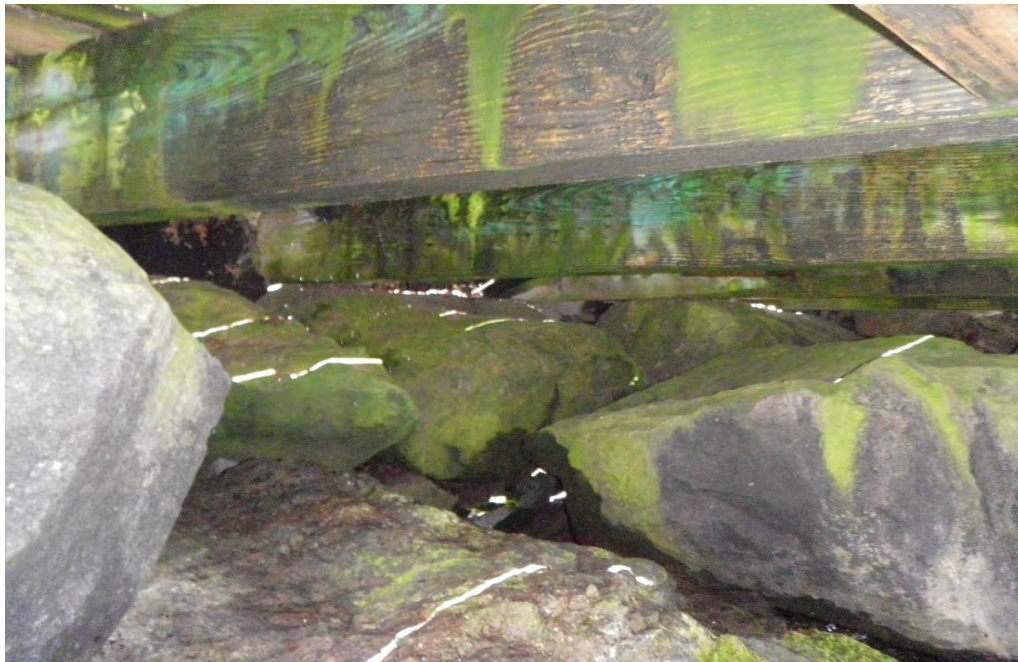
PHOTO No. 4: Bent 1-2, Looking Southeast - Inspection of the shore support was limited due to the rip rap along the shore. The accessible stringers and underside of the deck timbers were found to be in overall good condition with minor algae growth and water staining.

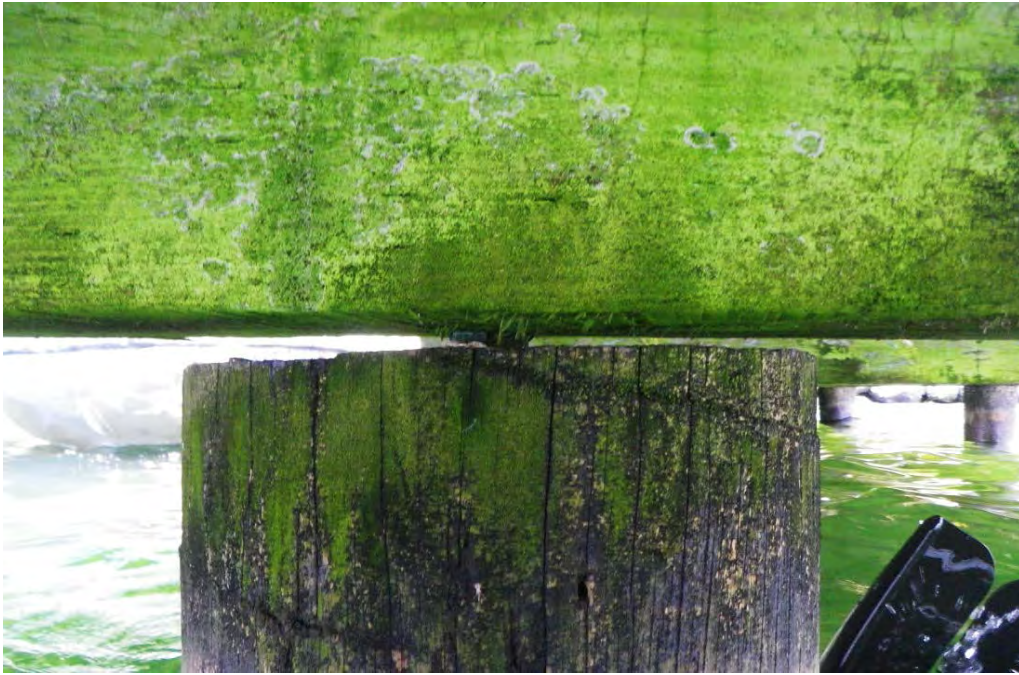
PHOTO No. 5: Bent 8, Row B Pile - Note the gap between the pile top and the cap, as well as the drift pin which is visible. Also note the algae growth on the pile top and cap. Level II cleaning of representative areas found the underlying timber to be in overall good condition with weathering and minor biological degradation.

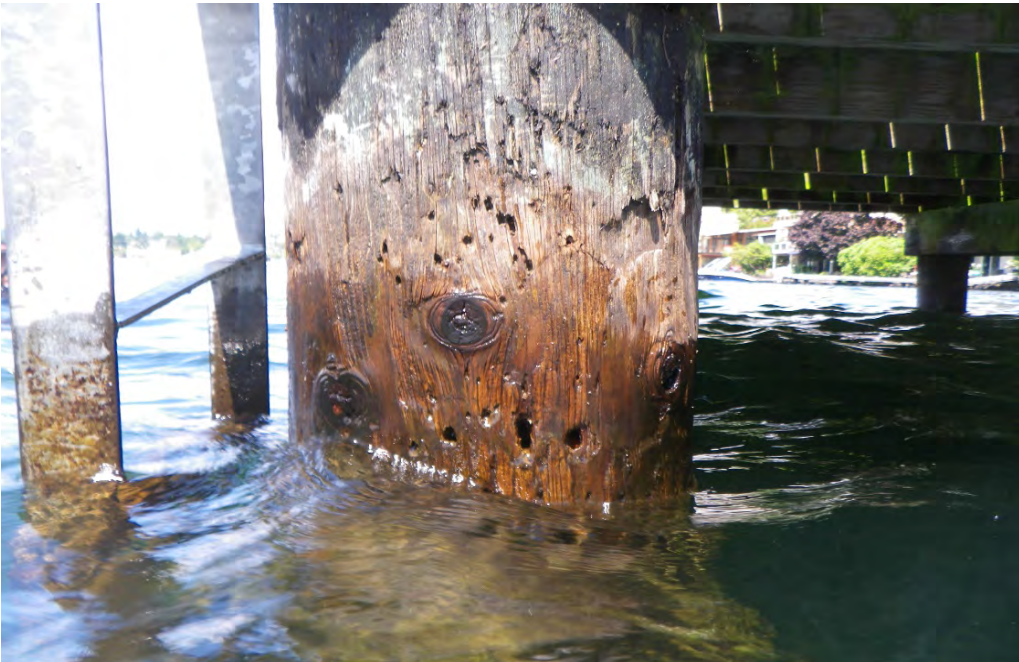
PHOTO No. 6: Bent 10, Row C Pile - Note the insect damage which was found to extend from the top of the pile down to low water. Minor biological degradation of the pile surface was also noted. This deterioration was found to extend from the pile top to the mudline. Also note the swim ladder to the left of the pile which is attached to the end of the pier.

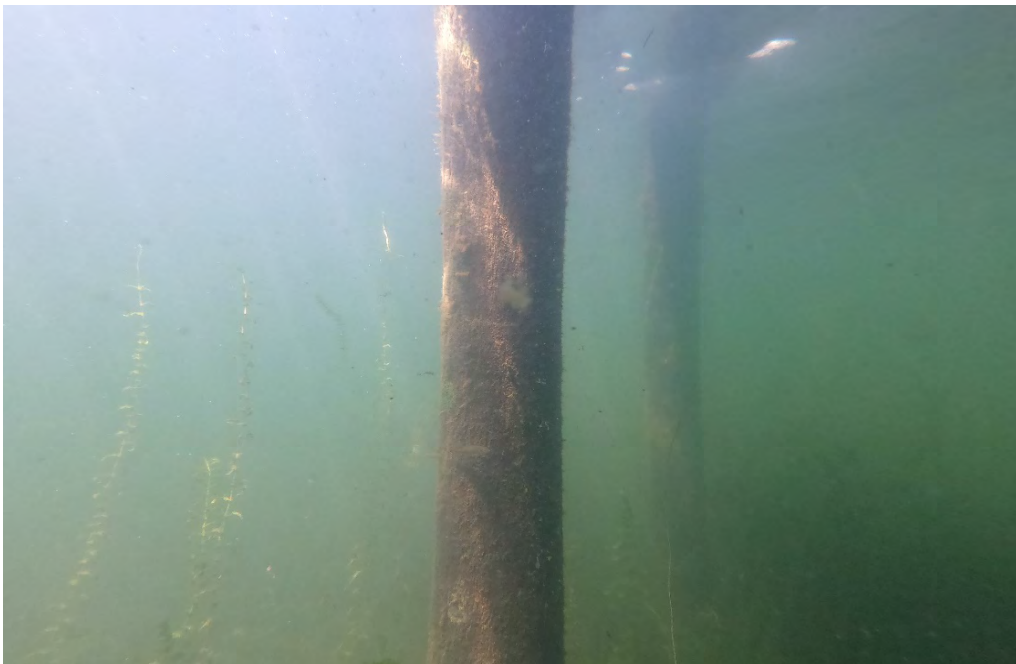
PHOTO No. 7: Bent 10, Row B Pile - Note the overall good condition and light algae growth on the pile in the submerged zone. This was found to be typical of the piles supporting the structure.

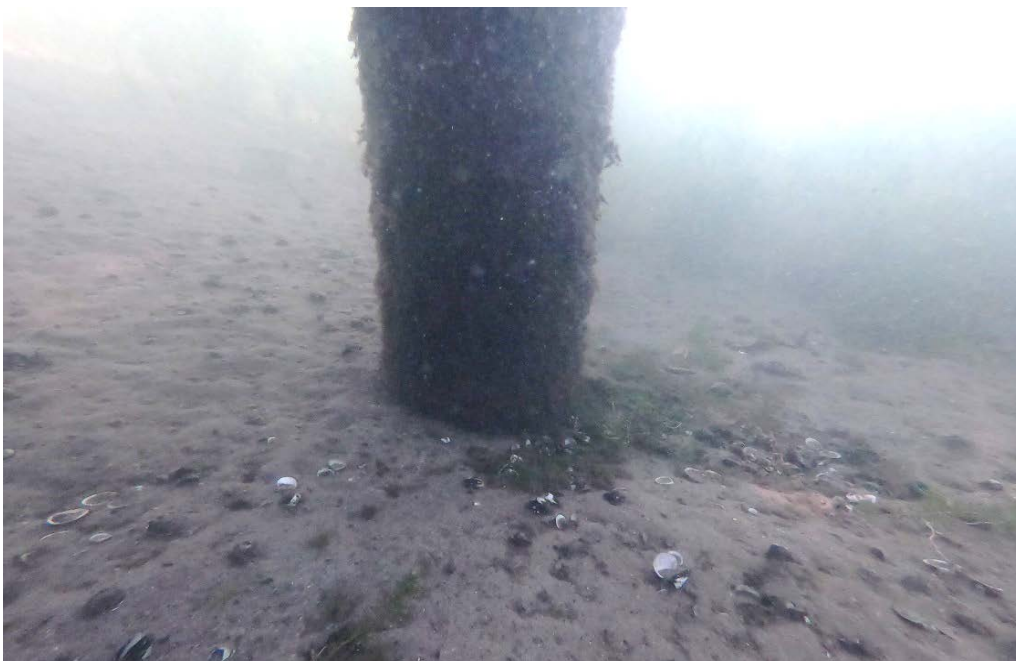
PHOTO No. 8: Bent 9, Row B Pile - Note the overall good condition of the pile with light algal growth. Level II cleaning of the pile found the timber to be in overall good condition with minor biological degradation of the surface. Also note the fresh water clam shells and the soft, silty sand which comprises the lake bottom in the vicinity of the pier.

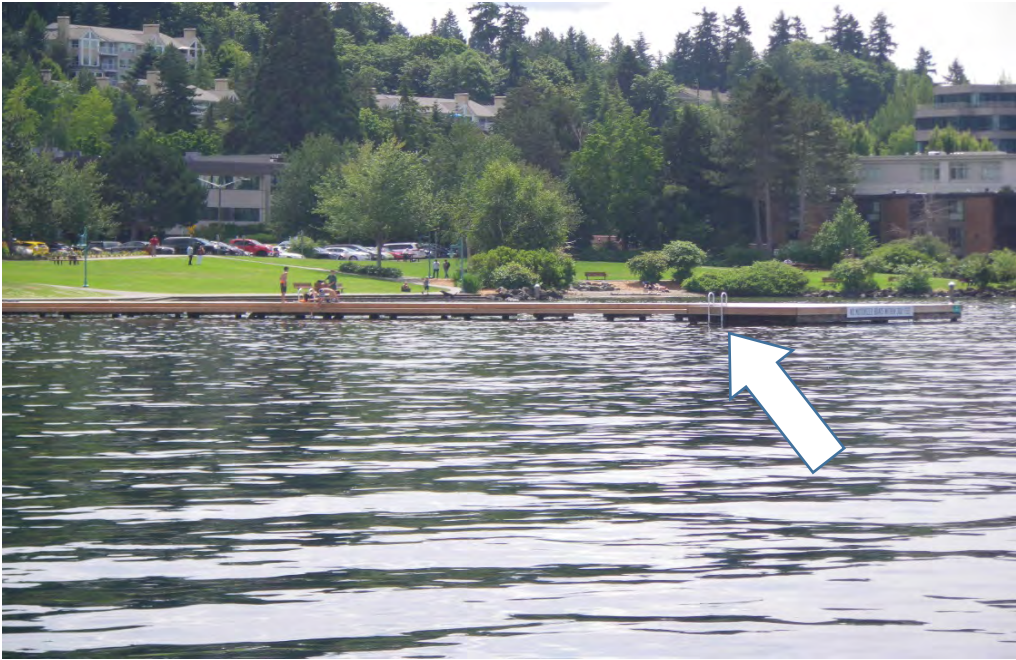
PHOTO No. 1: Houghton Beach Pier, Looking Southeast - Note the swim ladder located on the north side of the on the Pierhead. The structure is constructed using timber substructure piles, caps and stringers with a plastic grate decking.

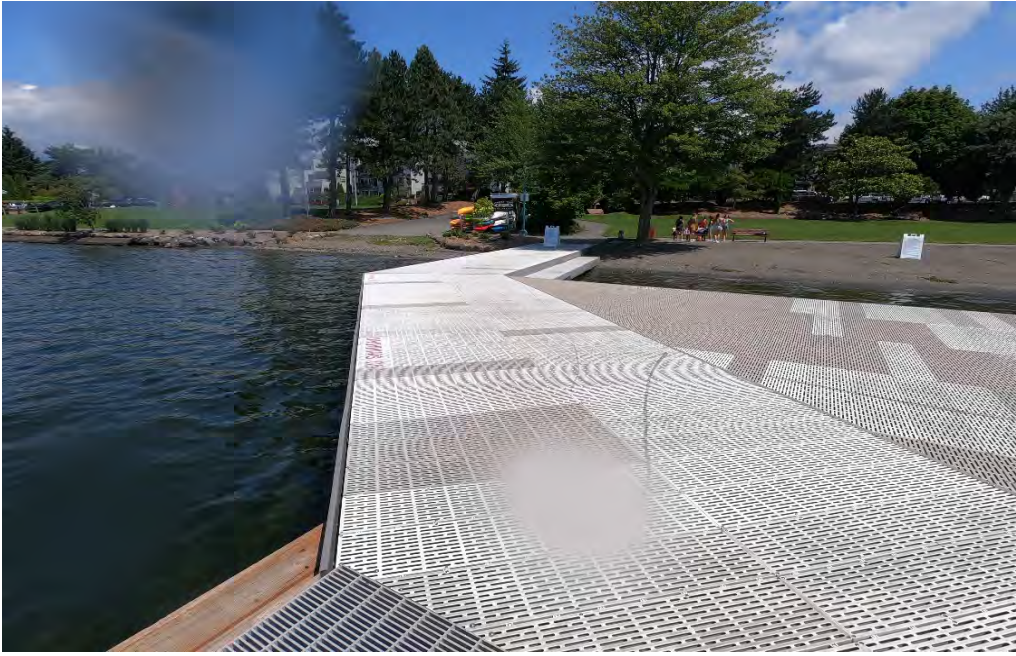
PHOTO No. 2: Approachway, Looking East - Note that use of plastic grate decking and the differing colors. Also note the overall good condition of the deck.

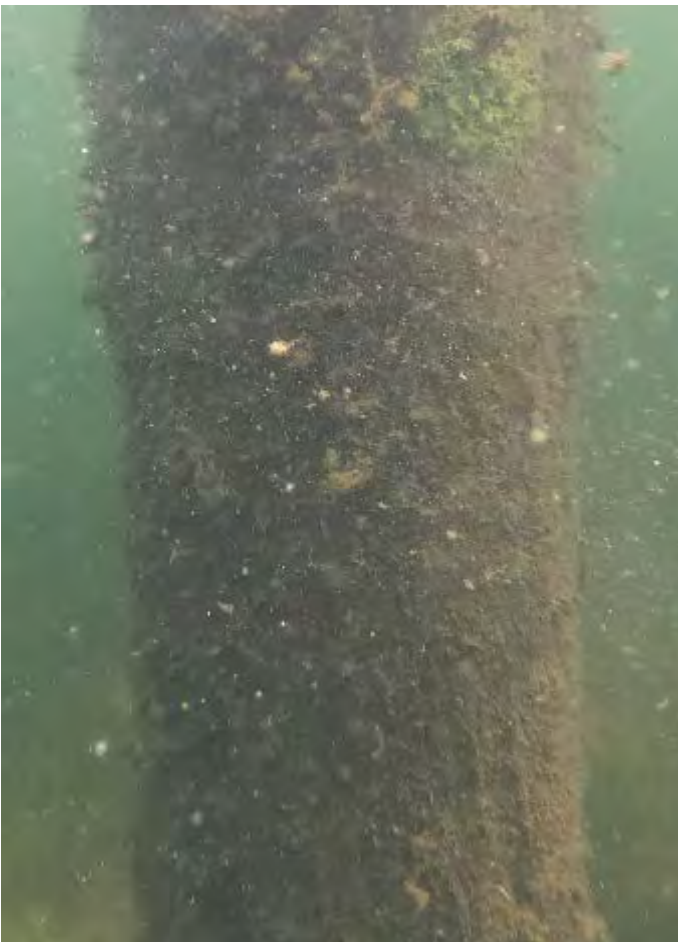
PHOTO No. 4: Bent 33, Row A Pile - Note overall good condition of the pile in the submerged zone. Also note the light algae growth on the pile's surface. This was found to be typical of the piles supporting the structure.

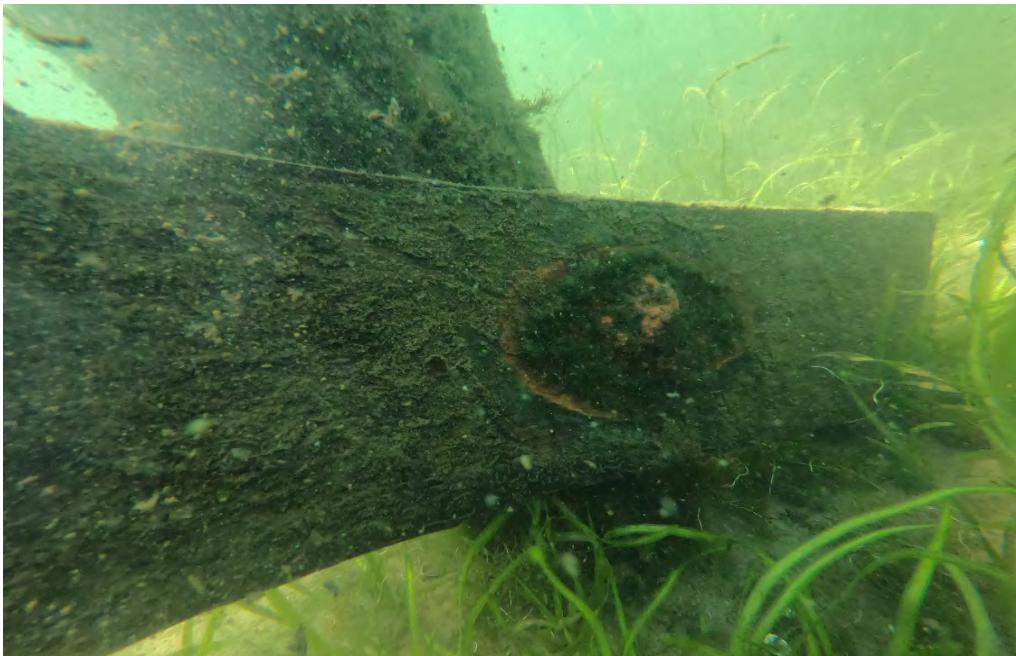
PHOTO No. 5: Bent 15, Row A Pile - Note the 3x10 treated diagonal brace timber attached to the pile at the mudline. Inspection found the brace timbers to be in generally good condition with minor biological degradation of the timber surface and minor to moderate corrosion on the attachment hardware.

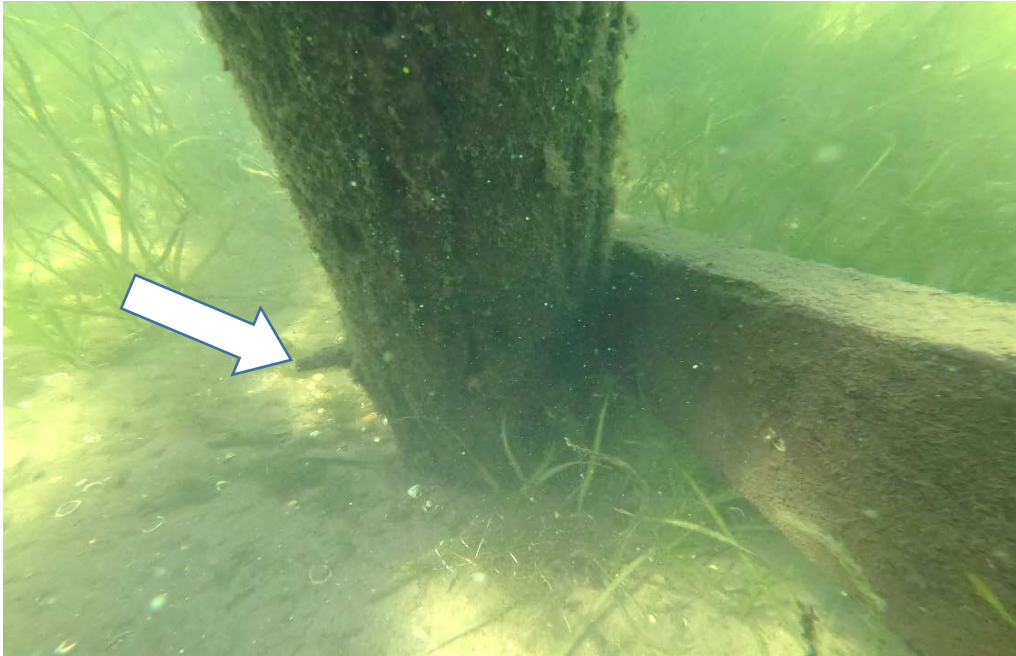
PHOTO No. 6: Bent 15, Row A Pile - Note the overall good condition of the timber pile and diagonal brace. Also note the arrow indicating the end of the thru-bolt securing the brace to the pile which was note to have minor to moderate surface corrosion.

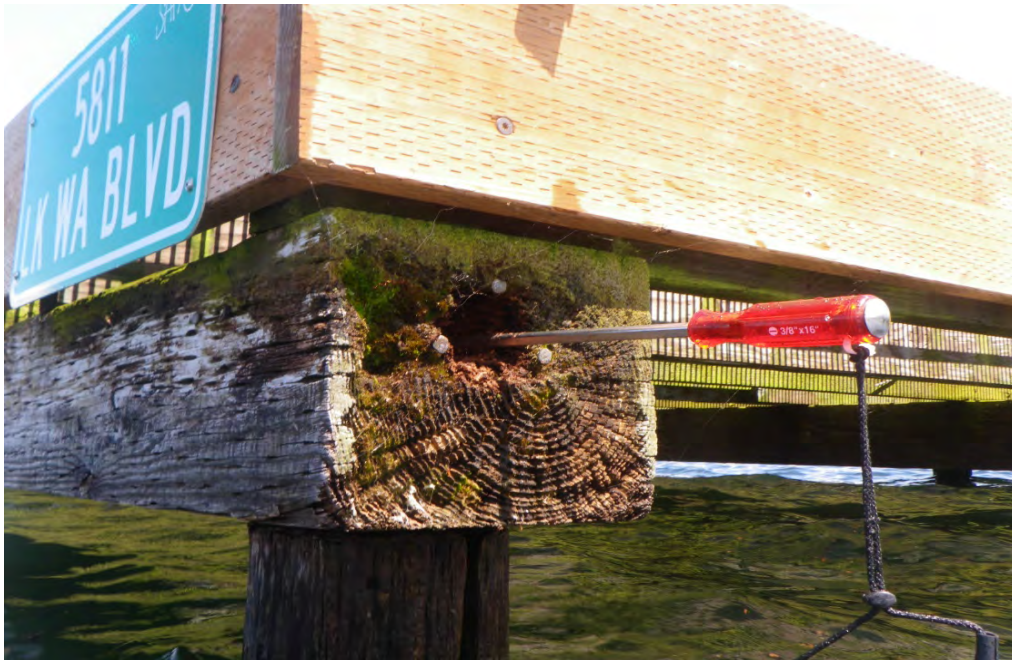
PHOTO No. 7: Bent 33, Row E Pile - Note the screwdriver inserted into a fungal cavity in the end of the pile cap. Inspection estimated a loss of 50% of the member's cross sectional area due to the damage which extends in to the pile top.

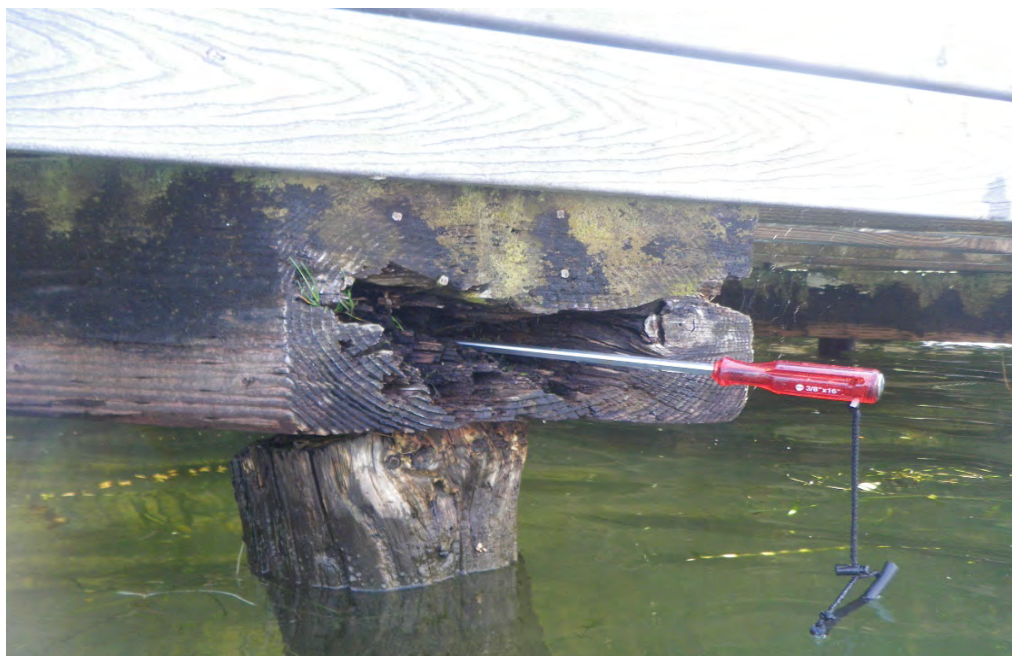
PHOTO No. 8: Bent 6, Row A Pile - Note the screwdriver inserted into the end of this cap timber. Inspection found the pile top and the cap to have sustained significant deterioration due to fungal damage resulting in an estimated 50% loss of section to the cap and a non-bearing condition at the pile top connection.

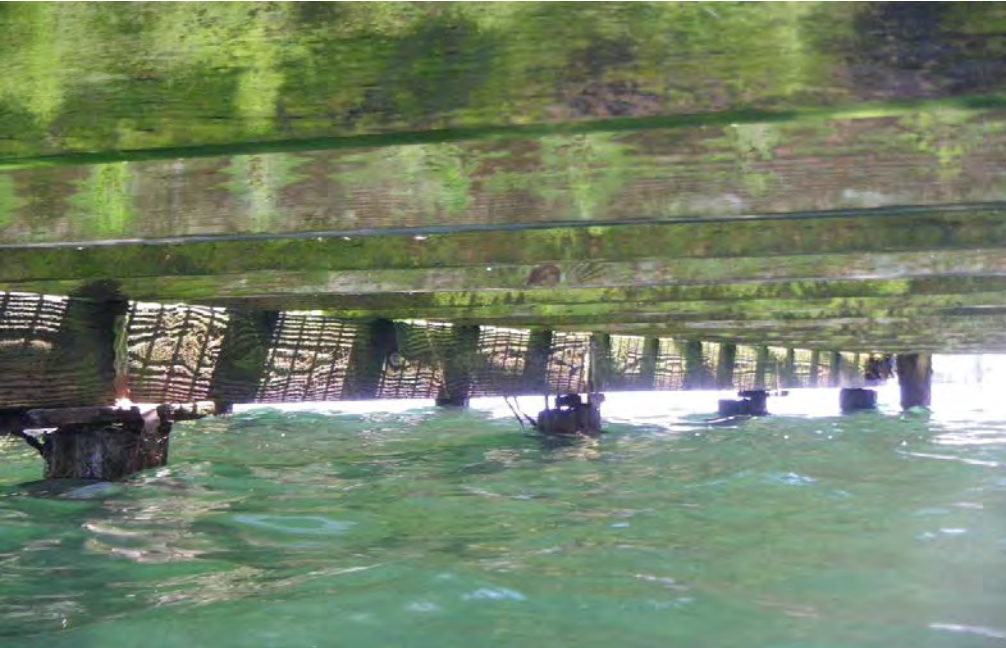
PHOTO No. 9: Bent 32, Looking Southeast - Note the multiple bearing issues at the pile top / cap connections for the substructure piles in this bent. Inspection noted significant deterioration of the tops of these piles. Inspection also noted that shims in several locations are missing or are providing only partial bearing. Also note the generally good condition of the superstructure members with weathering, algae, and water staining.

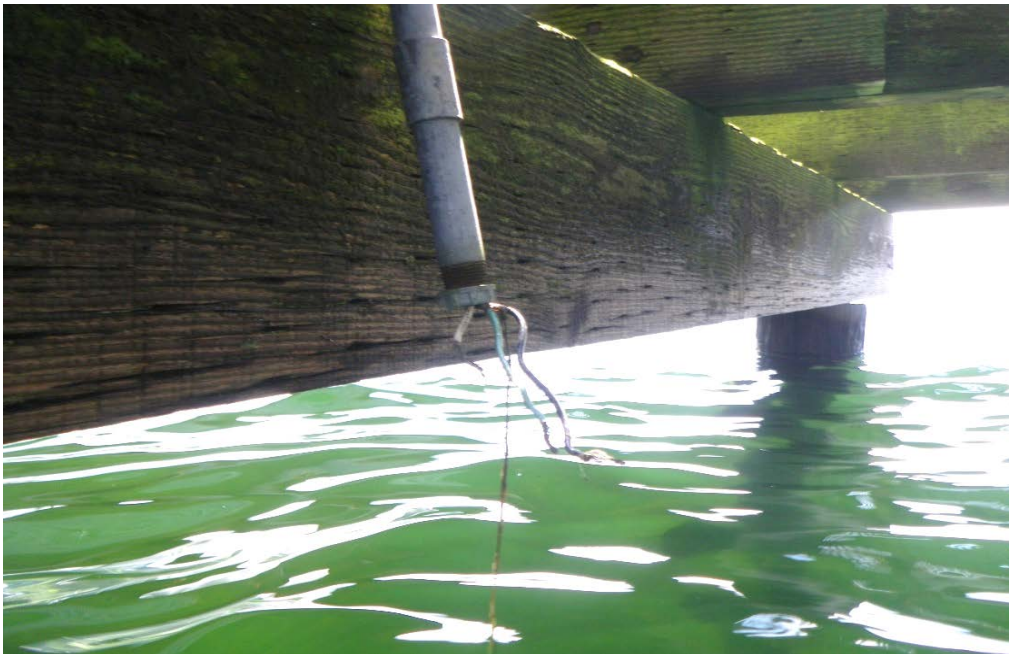
PHOTO No. 10: Bent 26, West Side, Looking South - Note the typical good condition of the treated cap and stringers in the central portion of the structure. Also note the broken electrical conduit hanging down with exposed wires.

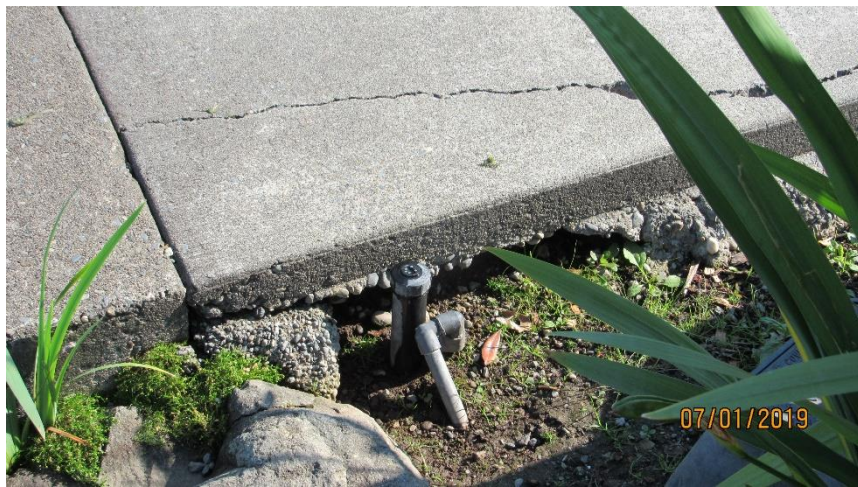
Photo 8. Cracked and Undermined Sidewalk (4), Houghton Beach Park.

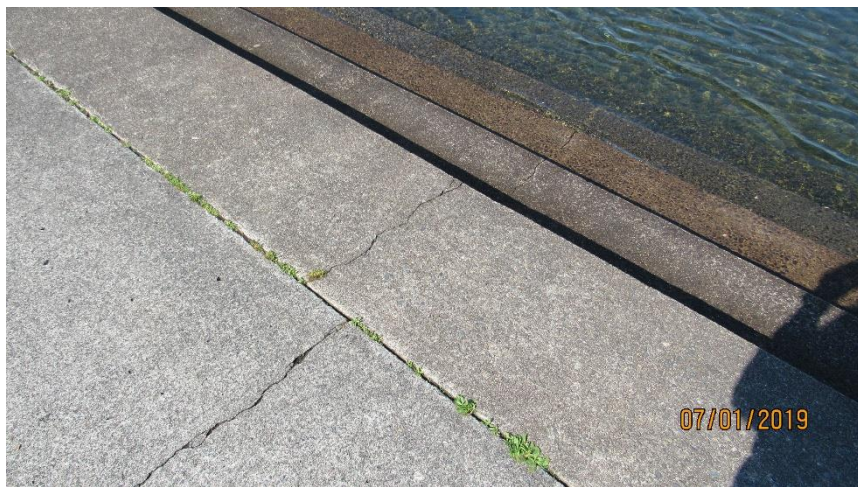
Photo 9. Cracked Steps (4), Houghton Beach Park.

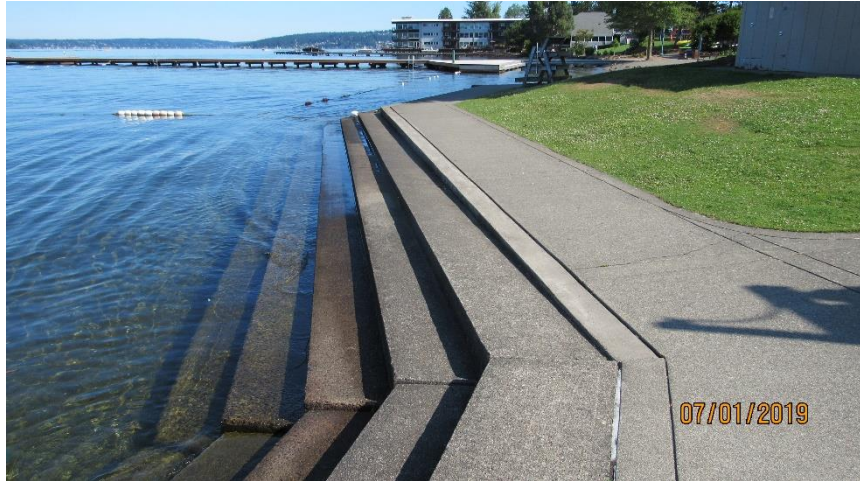
Photo 10. Curved Concrete Steps and Sidewalk (5), Houghton Beach Park.

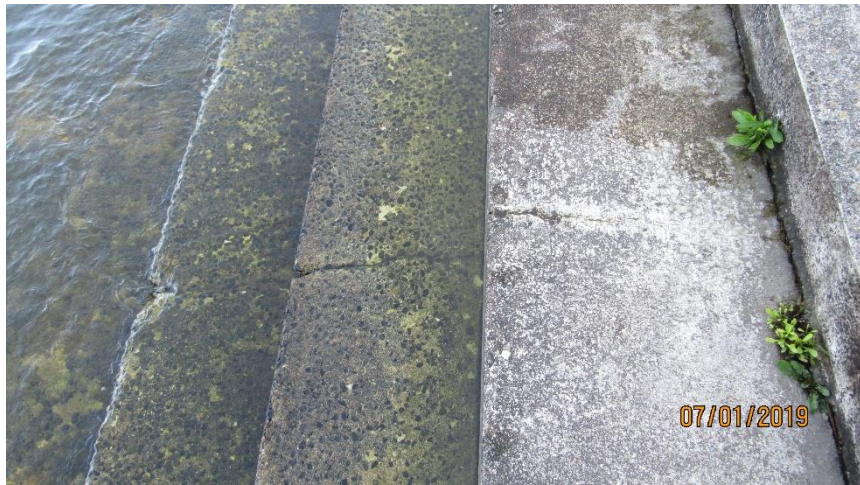
Photo 11. Conc. Crack and Spall damage on Curved Conc. Steps (5), Houghton Beach Park.

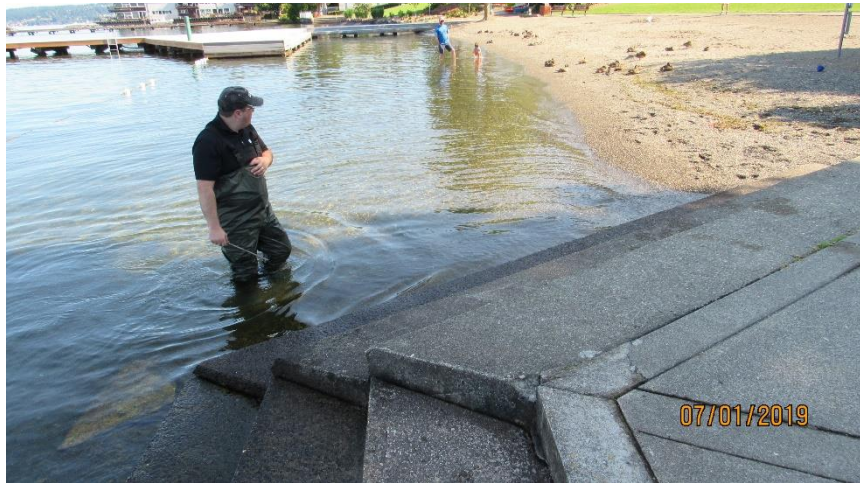
Photo 12. Conc. Crack and Spall damage on Conc. Steps (6), Houghton Beach Park.

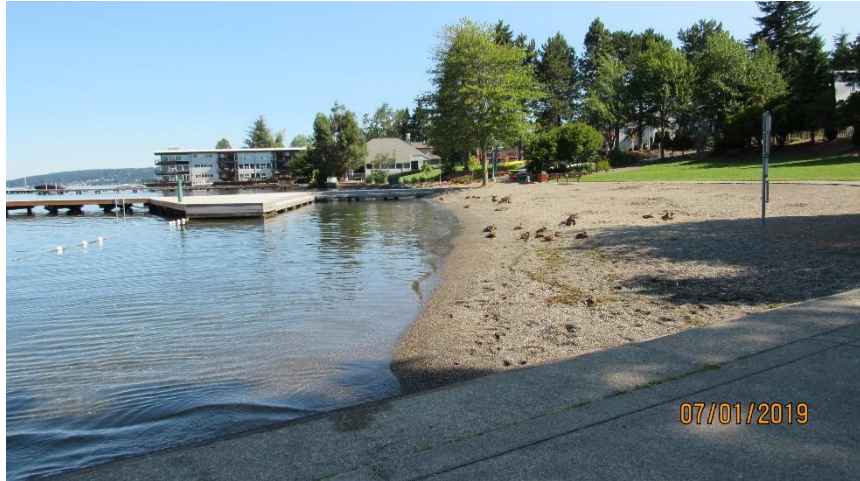
Photo 13. Beach (7) Looking North, Houghton Beach Park.

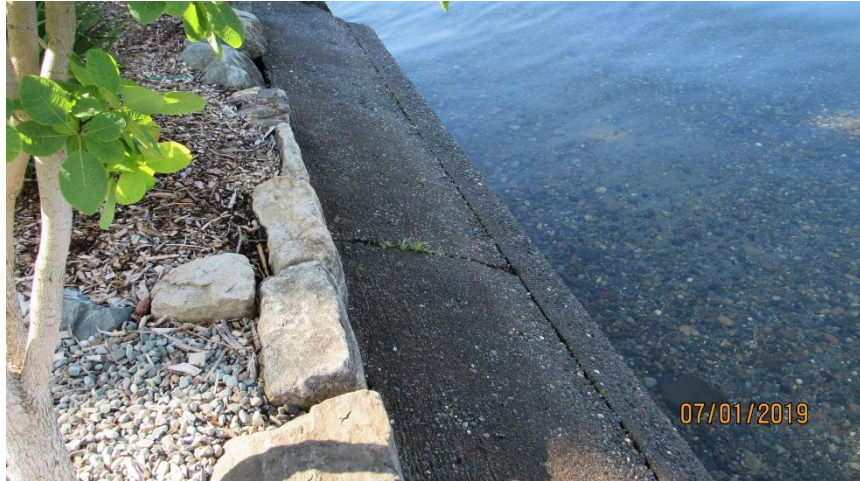
Photo 16. Cracked Concrete Revetment (8), Houghton Beach Park.

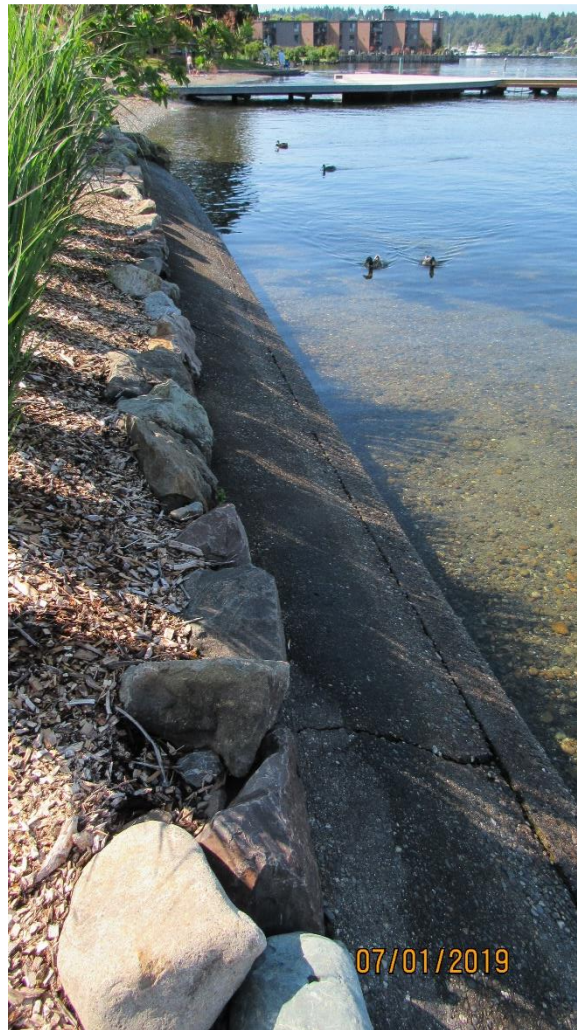
Photo 17. Concrete Revetment (8) Looking South, Houghton Beach Park.

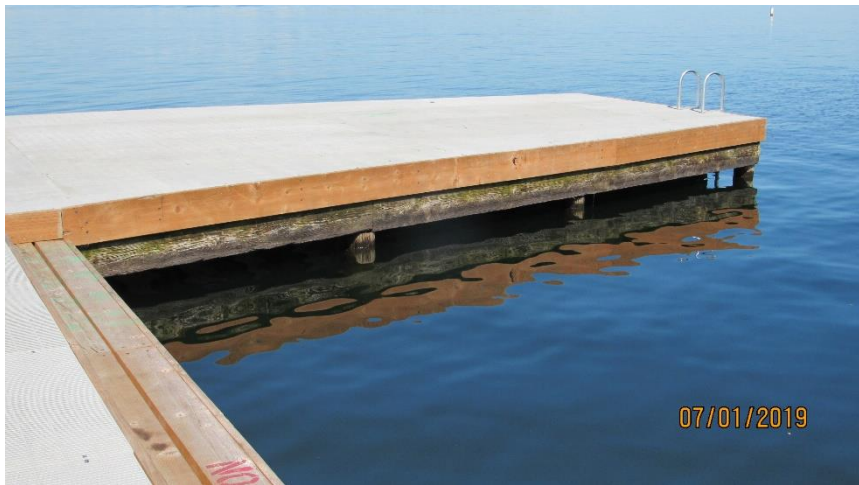
Photo 23. Deteriorated Piles and Pile Caps (8), Houghton Beach Park.

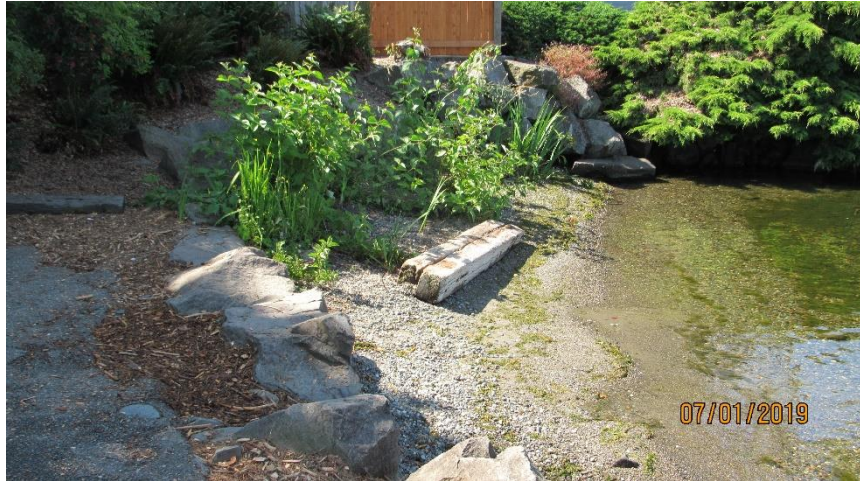
Photo 24. Beach (1) Looking South, Marsh Park.

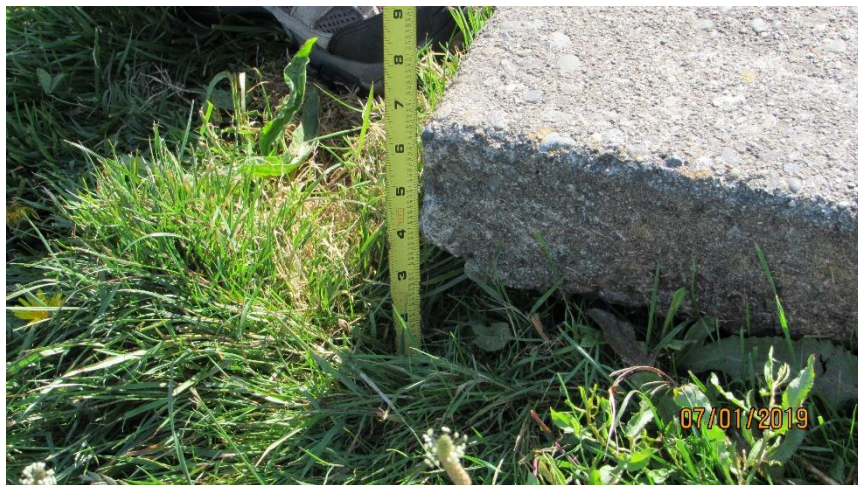
Photo 28. A Void below Concrete Bench Foundation (2), Marsh Park.

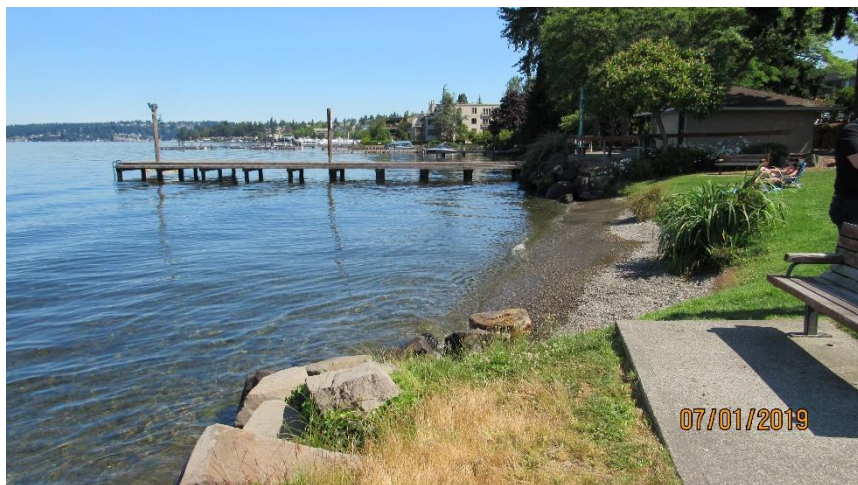
Photo 29. Beach (3) Looking North, Marsh Park.

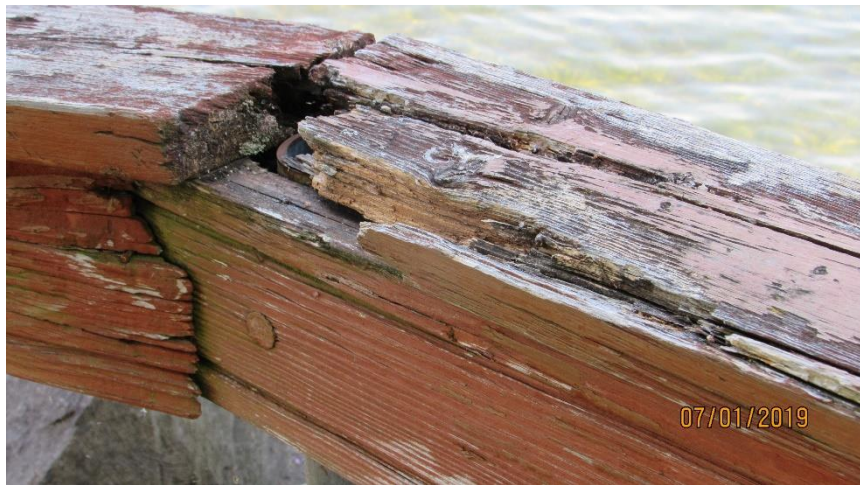
Photo 32. Deteriorated Handrail (4), Marsh Park.

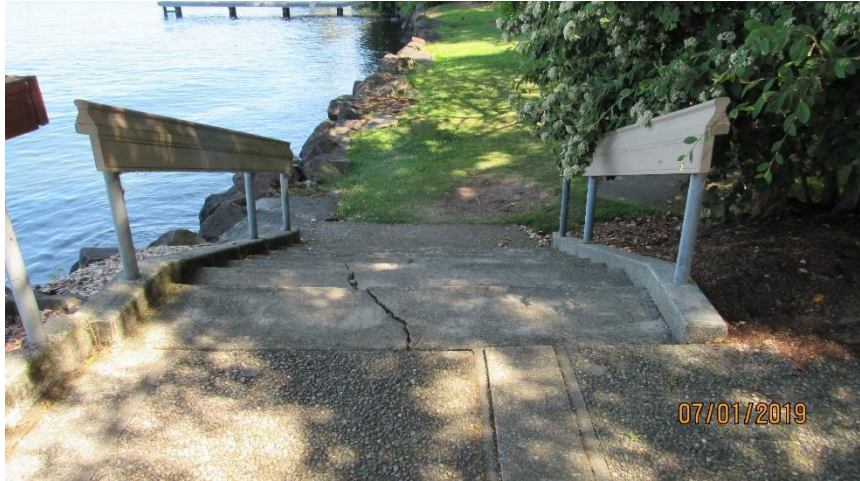
Photo 33. Cracked Concrete Steps (4), Marsh Park.

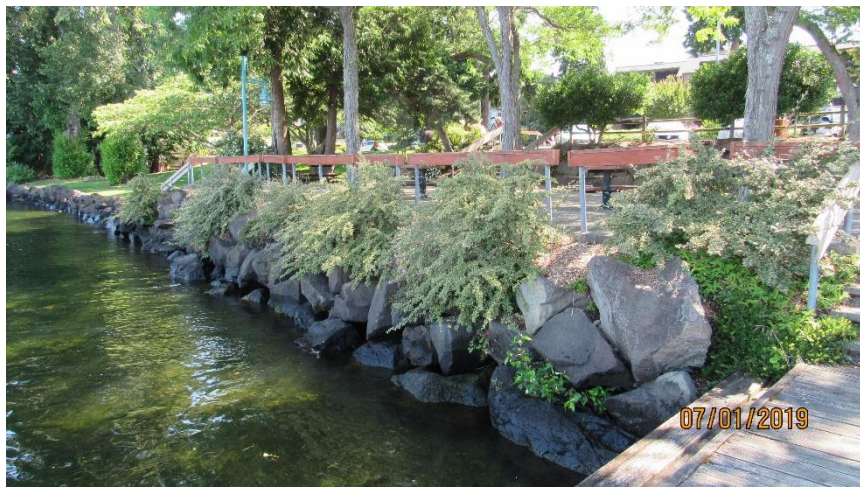
Photo 34. Riprap Bulkhead (5), Marsh Park.

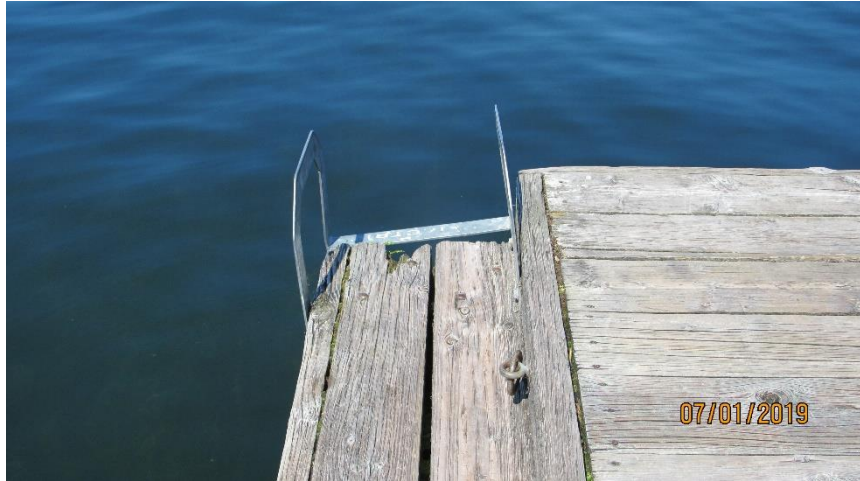
Photo 38. Deteriorated Step Down on Pier (6), Marsh Park.

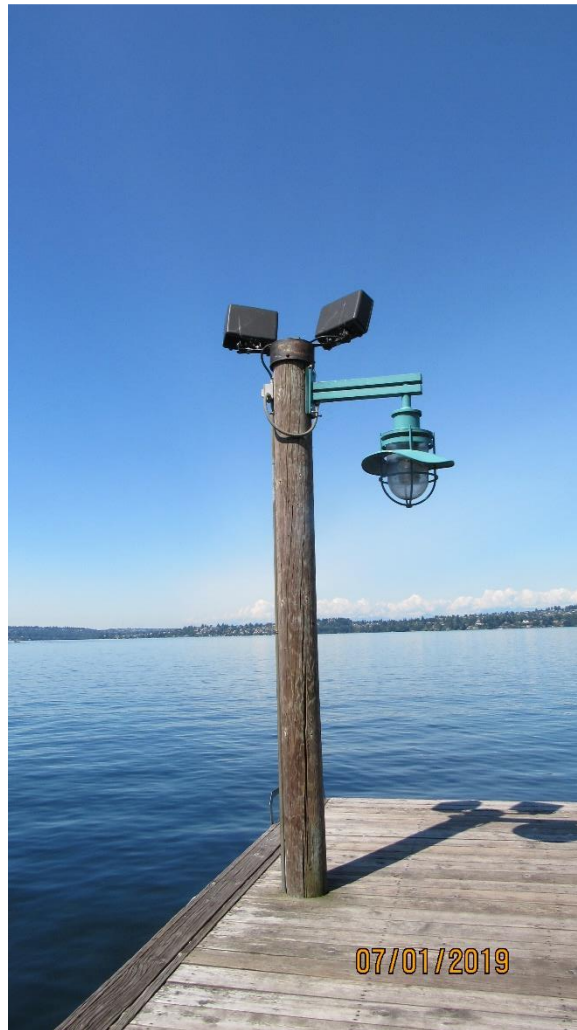
Photo 39. Damaged Light Fixture on Pier (6), Marsh Park.

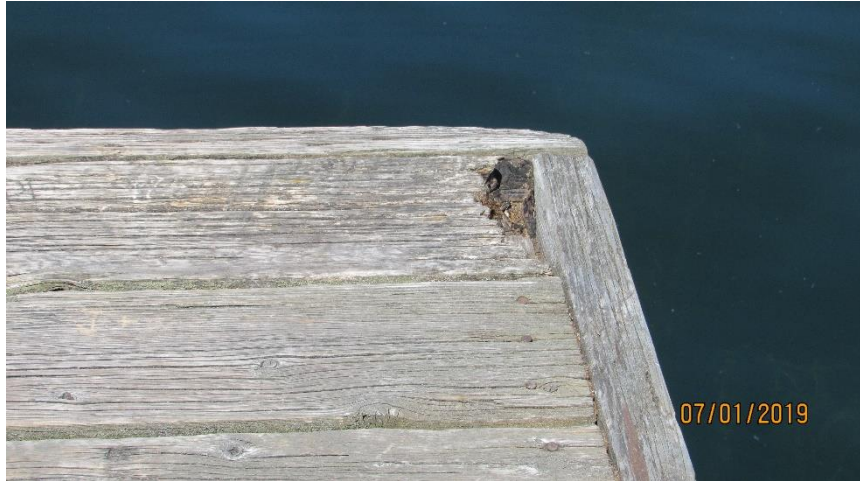
Photo 40. Deteriorated Decking and Fascia Board on Pier (6), Marsh Park.

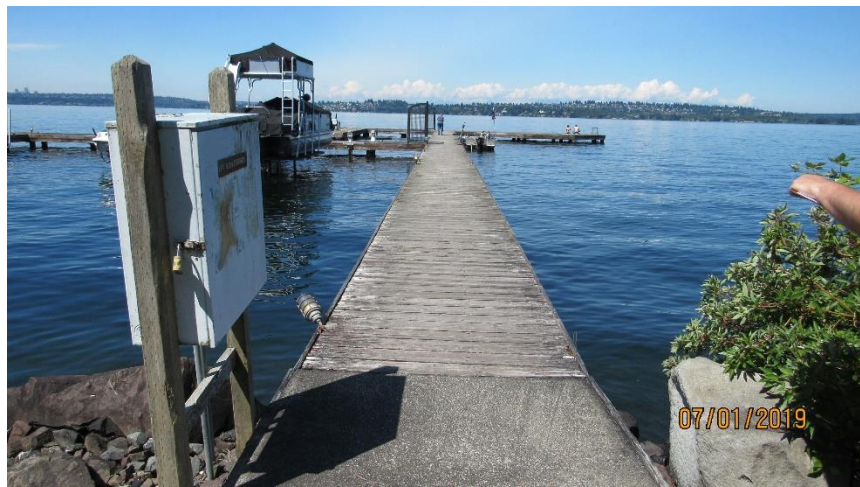
Photo 41. Pier (6) Looking West, Settlers Landing.

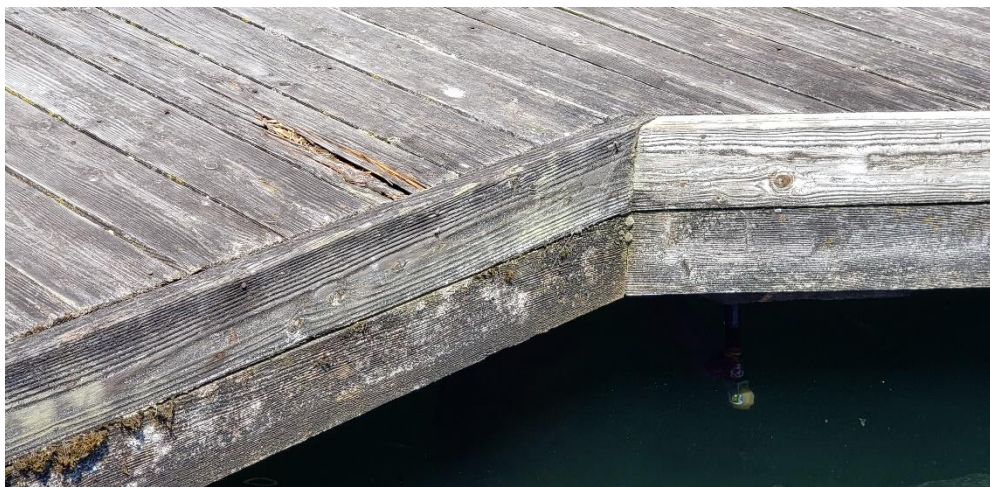
Photo 42. Deteriorated Decking and Fascia Boards on Pier (6), Settlers Landing.

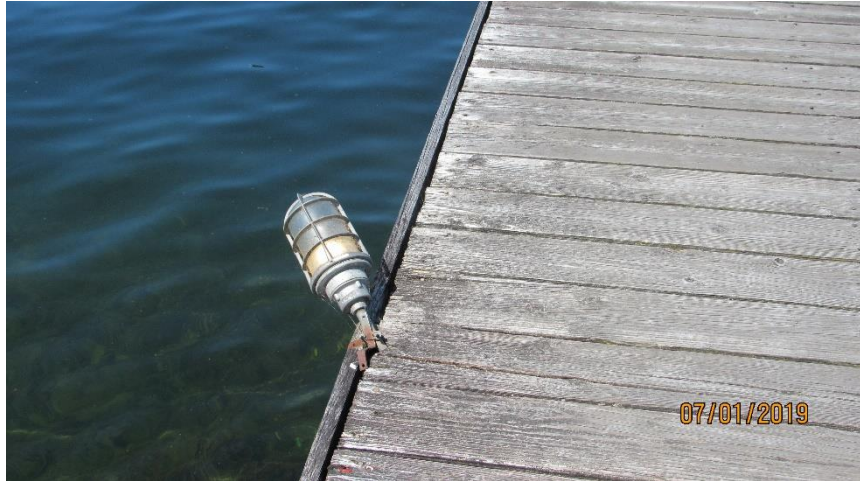
Photo 43. Damaged Light Fixture on Pier (6), Settlers Landing.

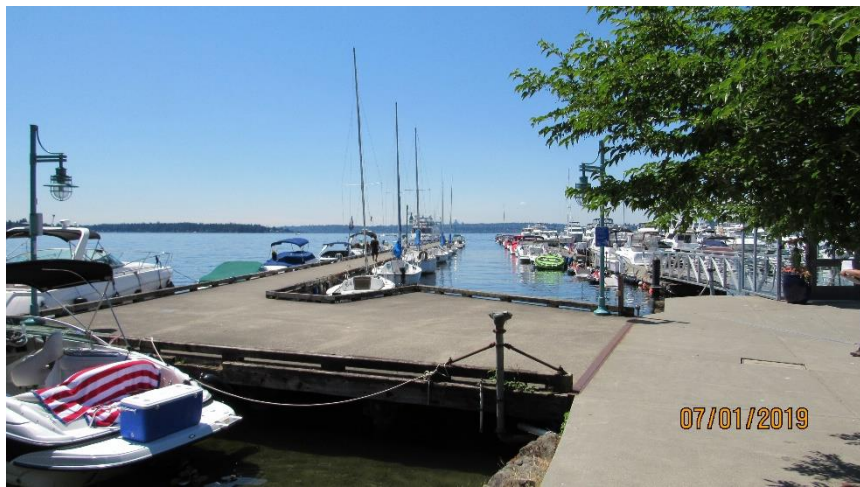
Photo 44. Pier (1) Looking West, 2nd Ave. South Dock.

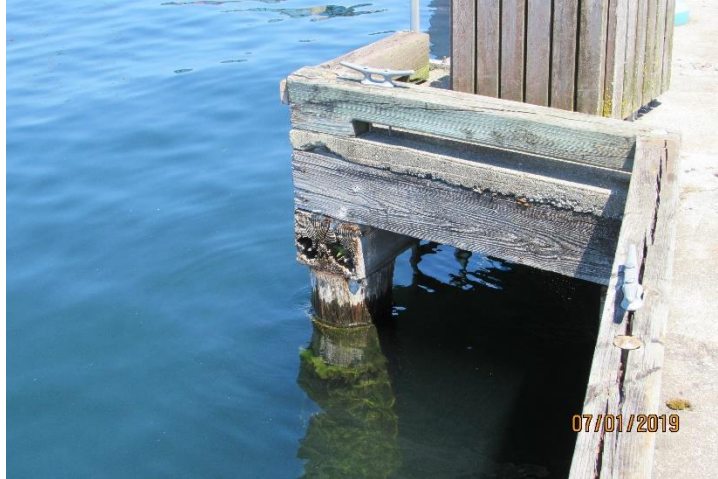
Photo 46. Deteriorated Pile Cap and Bull Rail on Pier (1), 2nd Ave. South Dock.

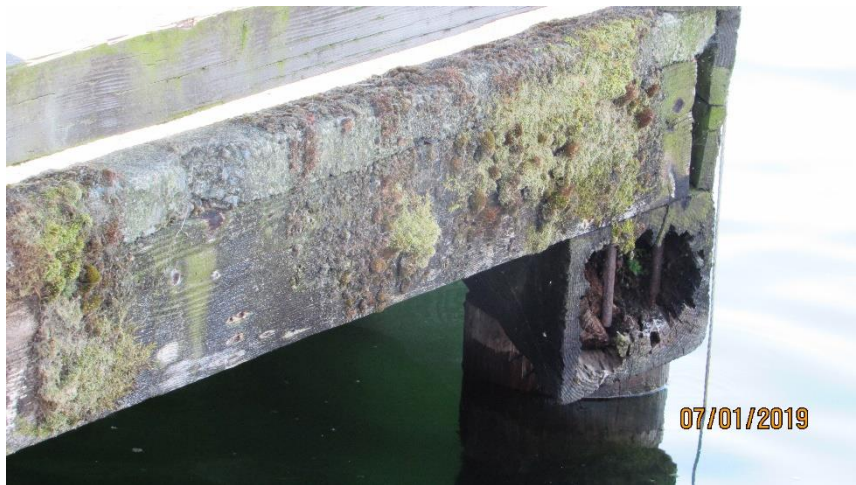
Photo 46. Deteriorated Pile Cap and Fascia Boards on Pier (1), 2nd Ave. South Dock.

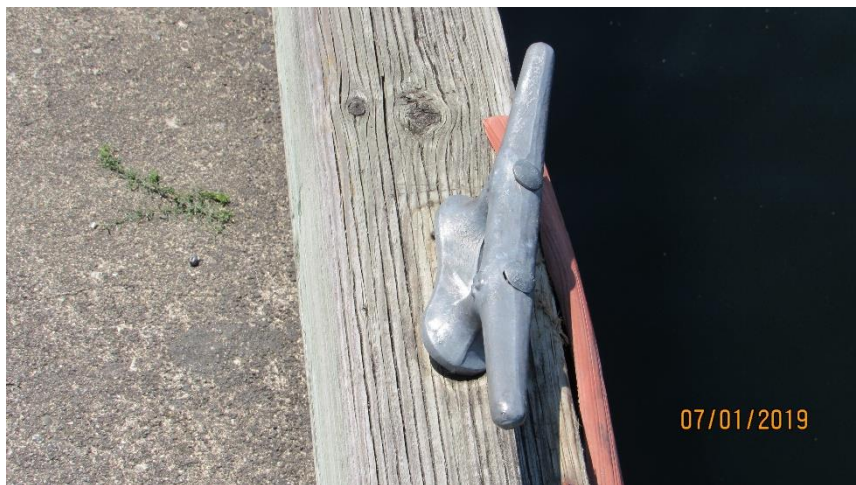
Photo 46. A Loose Cleat on Pier (1), 2nd Ave. South Dock.

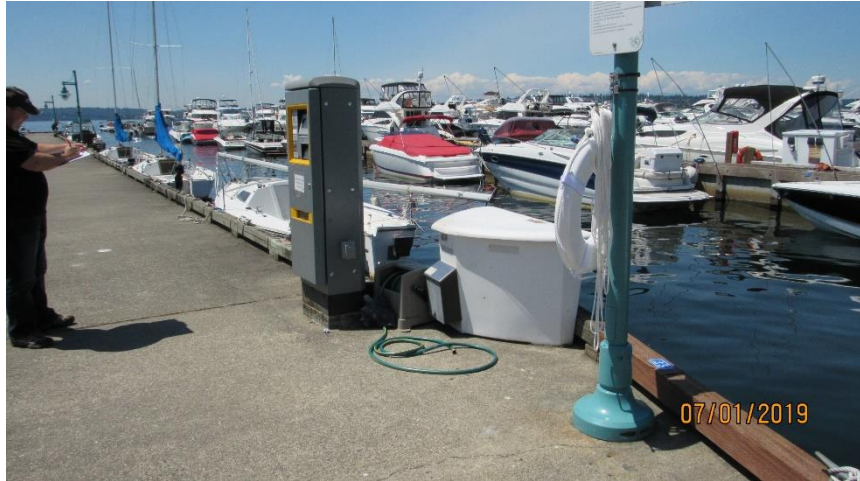
Photo 47. Pay Kiosk and Light Fixture on Pier (1), 2nd Ave. South Dock.

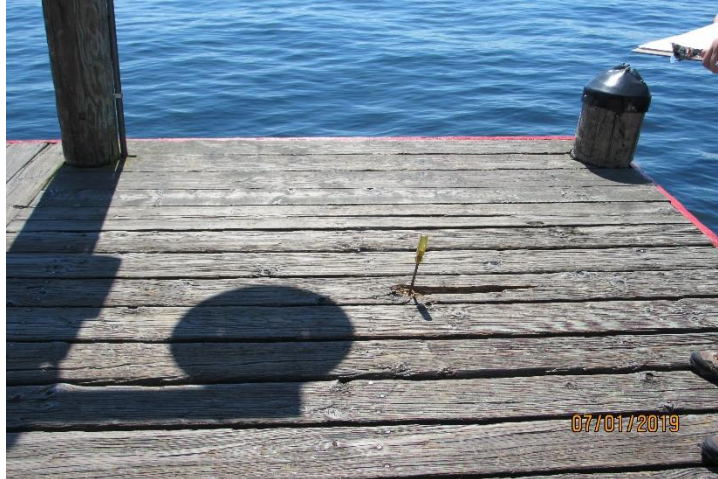
Photo 62. Deteriorated Decking on Boat Ramp Pier (7), Marina Park.
