KIRKLAND PARKS & COMMUNITY SERVICES

Shoreline Structures Assessment Kirkland, Washington

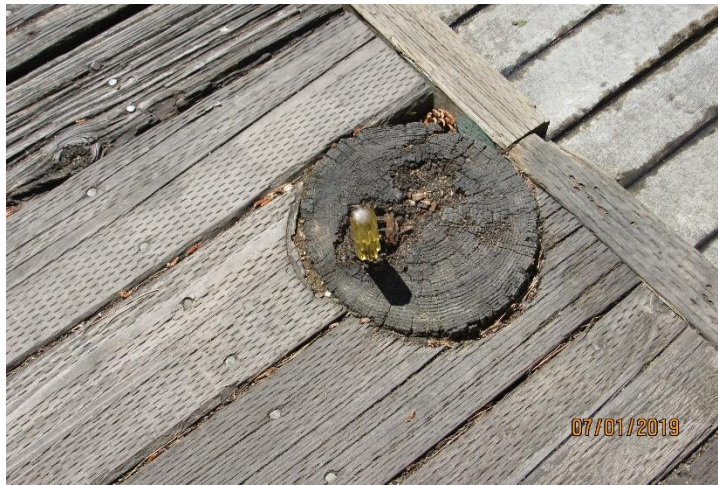
Photo 63. Deteriorated Pile Top on Boat Ramp Pier (7), Marina Park.

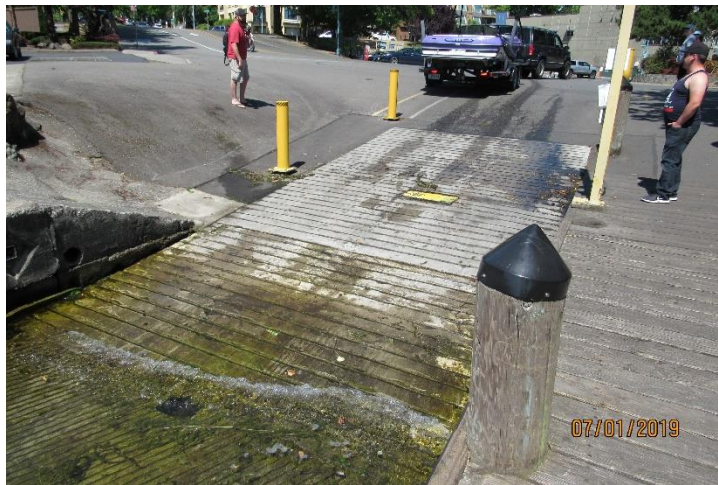
Photo 64. Conc. Boat Ramp (7), Marina Park.

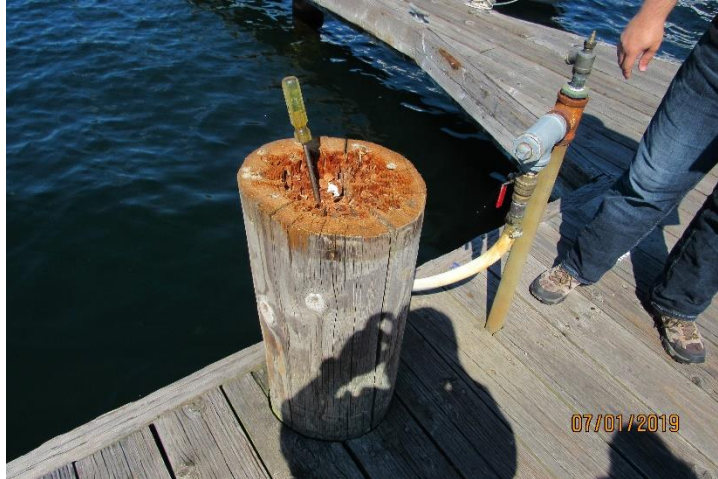
Photo 68. Deteriorated Pile Top on Pier (8), Marina Park.

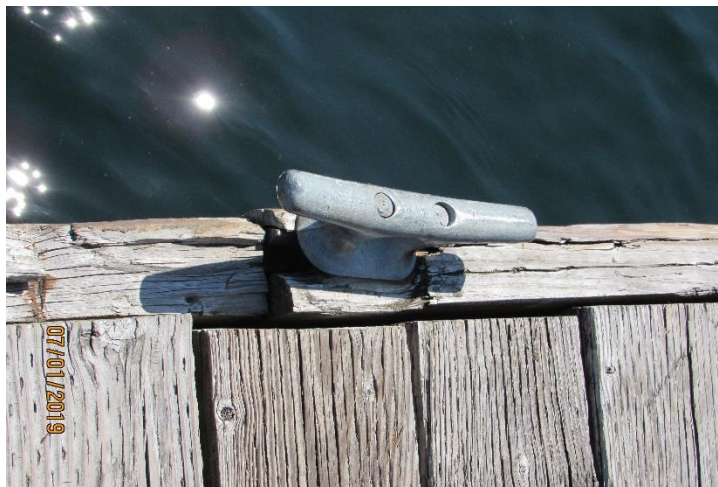
Photo 69. Damaged Fascia Board at a Mooring Cleat Mount Location on Pier (8), Marina Park.

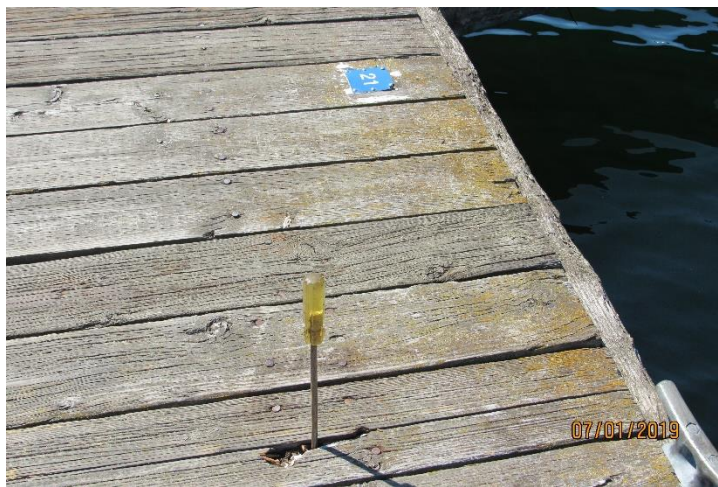
Photo 70. Deteriorated and Damaged Fascia Board and Decking on Pier (8), Marina Park.

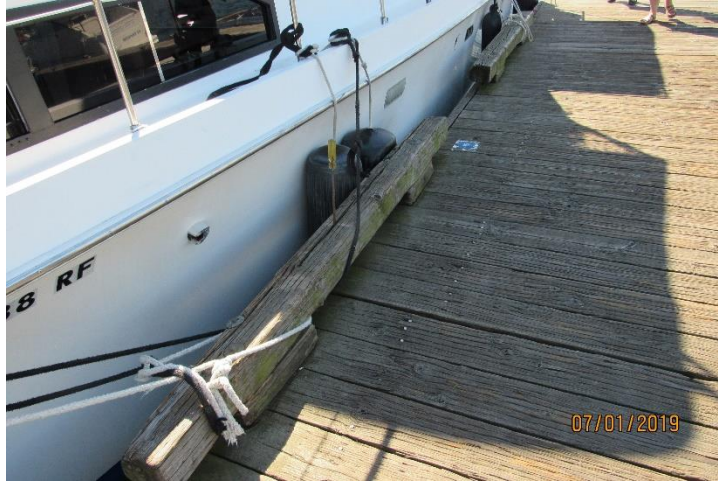
Photo 71. Deteriorated and Damaged Bull Rails and Decking on Pier (8), Marina Park.

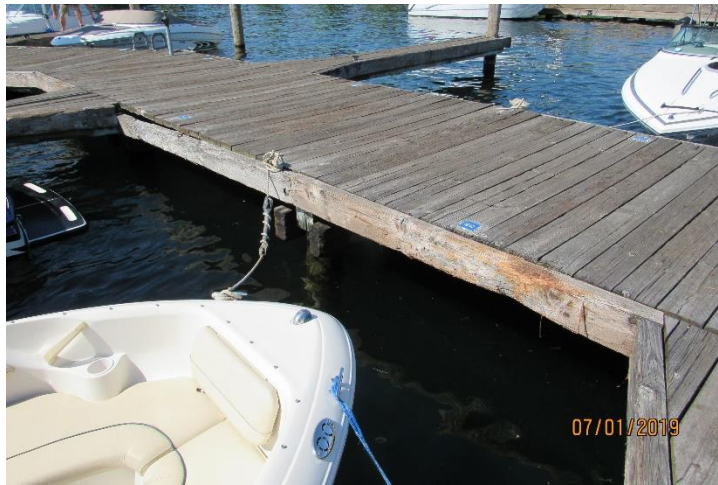
Photo 72. Deteriorated and Damaged Fascia Board and Decking on Pier (8), Marina Park.

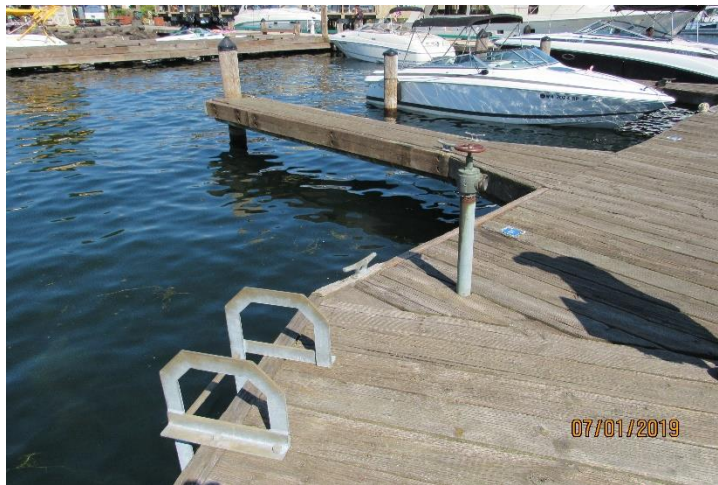
Photo 73. Safety Ladder, Cleat, and Fire Standpipe on Pier (8), Marina Park.

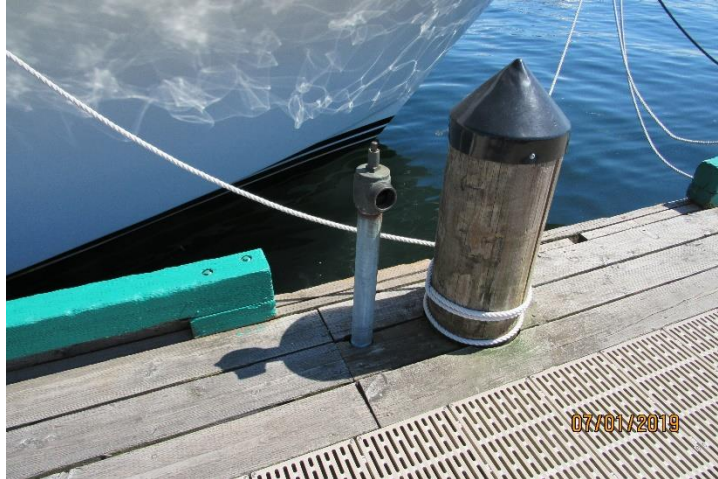
Photo 74. Fire Standpipe Missing Caps and Handles on Pier (8), Marina Park.

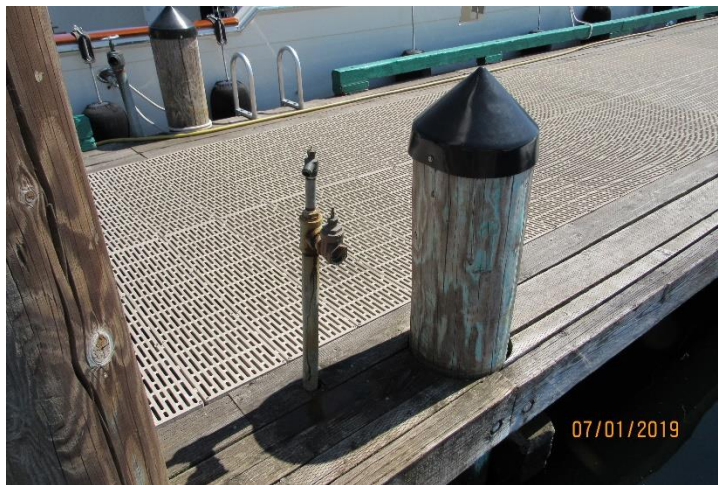
Photo 75. Hose Bib for Potable Water without Handles on Pier (8), Marina Park.

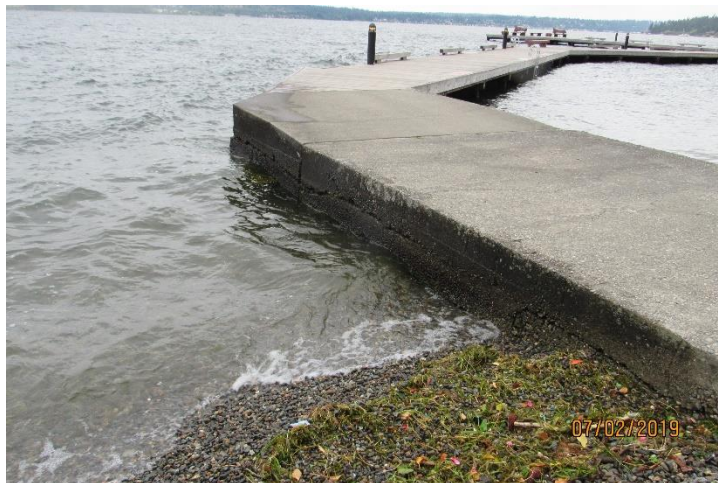
Photo 82. Concrete Pier Cracked (3), Waverly Park.

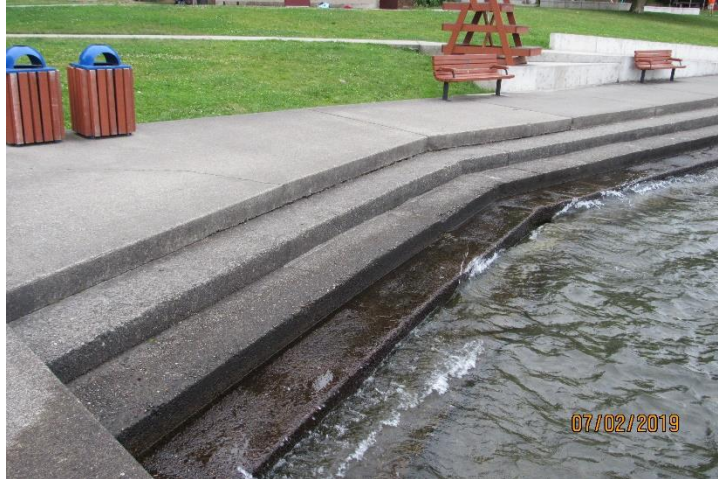
Photo 82. Concrete Steps & Sidewalk (4) Looking South, Waverly Park.

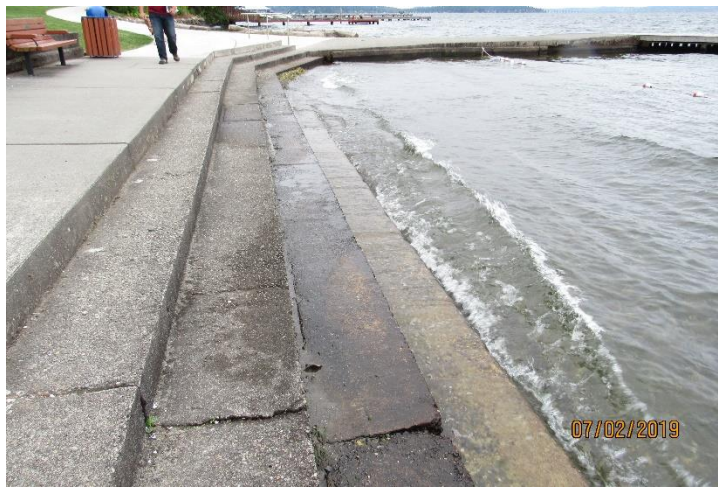
Photo 83. Concrete Steps & Sidewalk Cracked (4), Waverly Park.

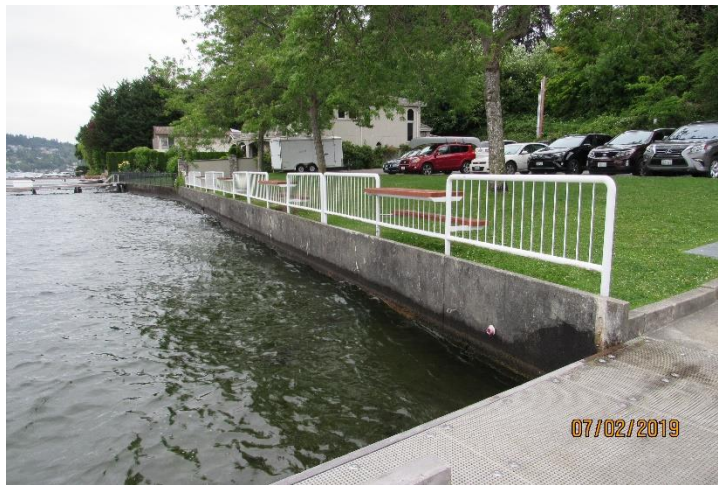
Photo 84. Ecology Block Bulkhead (5) Looking North, Waverly Park.

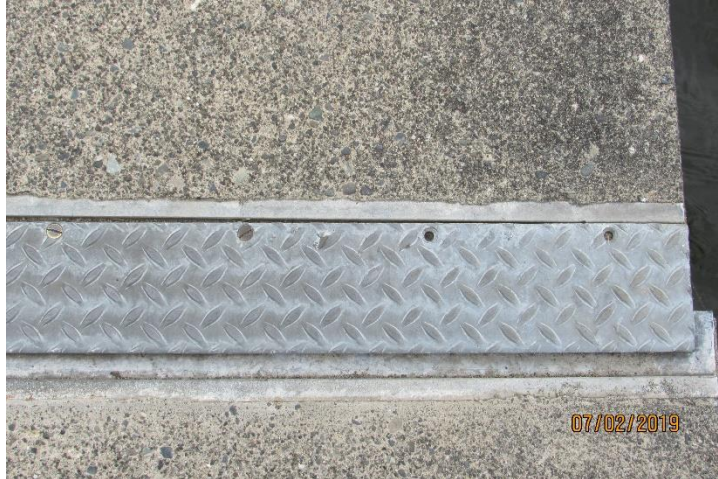
Photo 91. Missing Screws on a Steel Plate at an Expansion Joint on Pier (1), Juanita Beach Park.

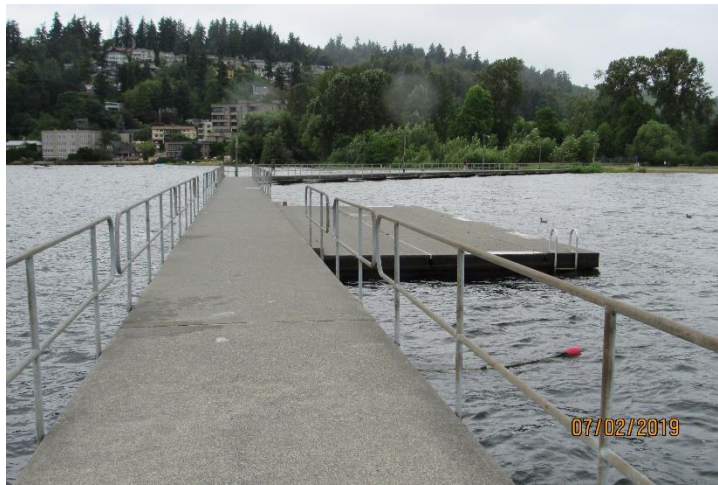
Photo 92. Concrete Swim Float on Pier (1), Juanita Beach Park.

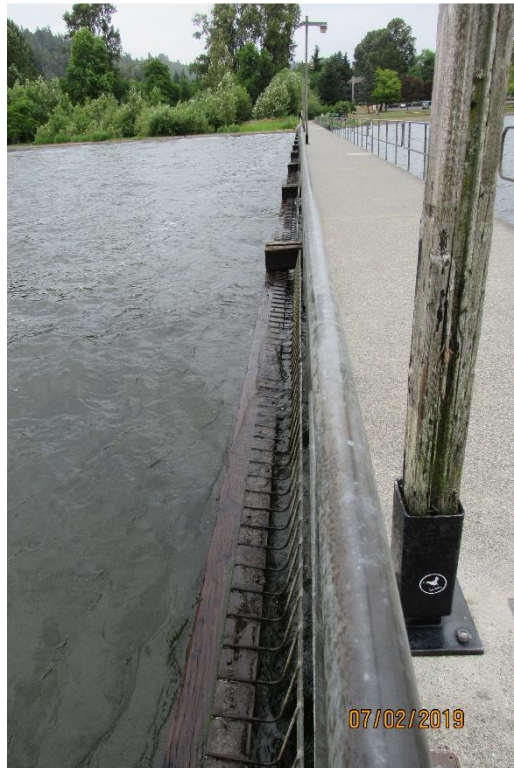
Photo 93. Deteriorated Post of Light Fixture on Pier (1), Juanita Beach Park.

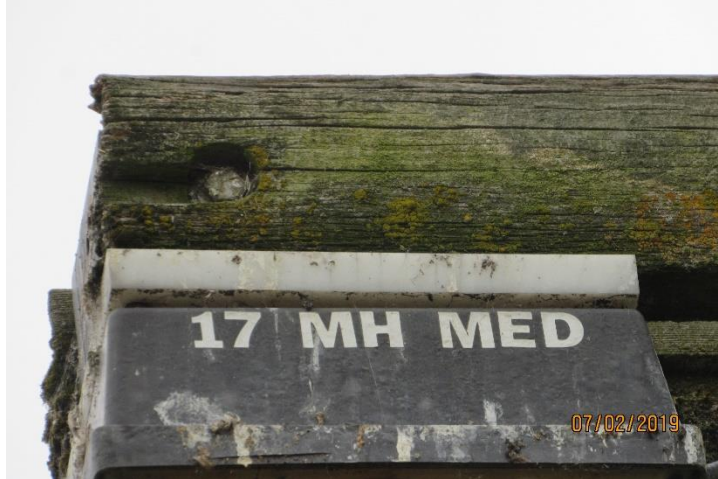
Photo 93. Deteriorated Light Fixture on Pier (1), Juanita Beach Park.

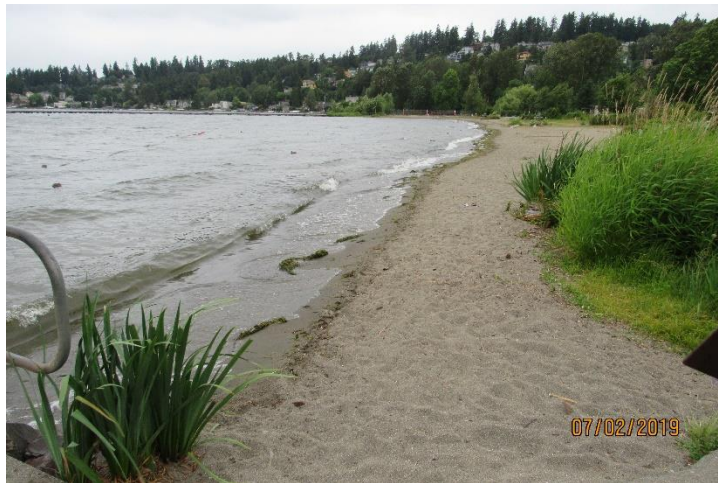
Photo 94. Beach (2) Looking West, Juanita Beach Park.
